SOUTH DAKOTA STATE HISTORIC PRESERVATION OFFICE
HISTORIC SITES SURVEY STRUCTURE FORM

*ADDRESS: 45924 300th Street

HISTORIC FUNCTION: Elevator/ ear corn and

ROOF SHAPE: Gothic round roof

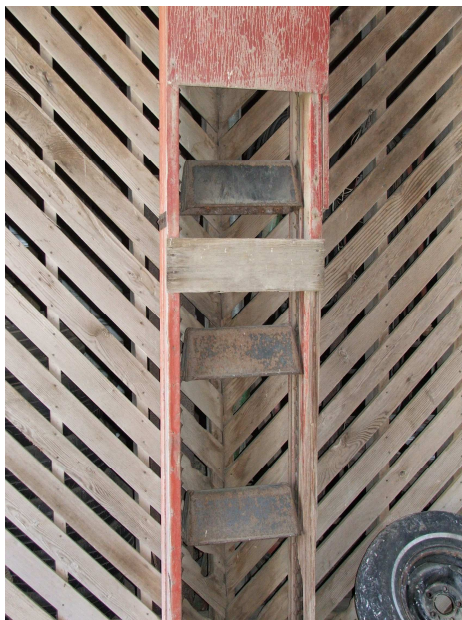
ROLL NUMBER: _____
PHOTO NUMBER: 5

INTERIOR NOTES: 2x6 walls on each side in drive alley. Studs are 12" O.C. with 1x4 spaced diagonal
boards. 3x12 floor joists above alley 12" O. C. for granaries above. 2x6 walls 12' high with shiplap are the
East and West walls for the granaries. Elevator leg coming down on the West wall and going up on the
East side. Grain pit in floor with hinged doors.

First floor, looking West,
grain leg coming down
on West wall in alley,
note diagonal spaced
1x4's on wall.

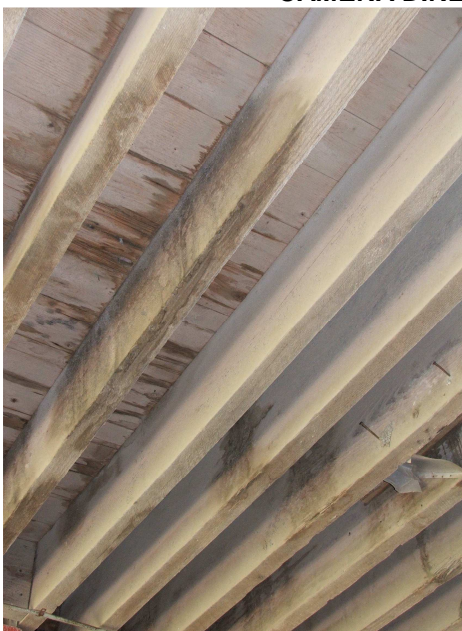
ROLL NUMBER: _____
PHOTO NUMBER: 6

First floor, looking up
and NW, 3x12 floor joists
12"O. C. supporting
granaries above alley

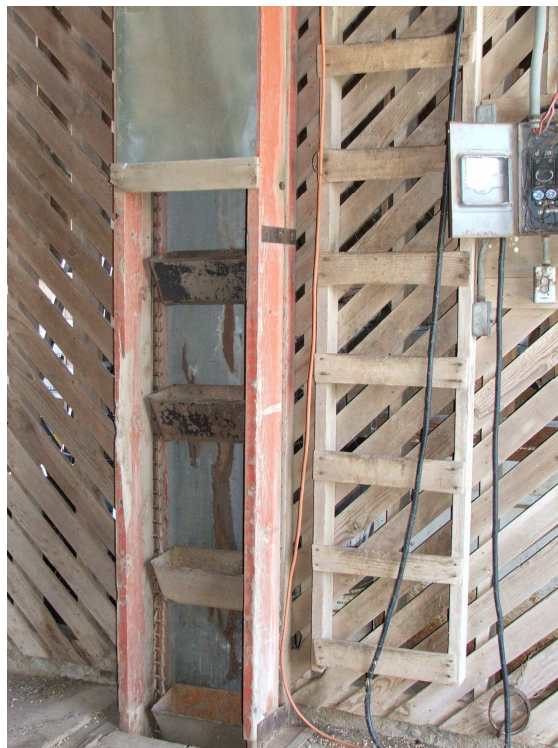
ROLL NUMBER: _____
PHOTO NUMBER: 7

CAMERA DIRECTION: First floor, looking East,
grain leg going up on
East wall in alley.
