**SOUTH DAKOTA STATE HISTORIC PRESERVATION OFFICE
HISTORIC SITES SURVEY STRUCTURE FORM**

*SURVEY DATE: June 11, 2013 *ADDRESS: 29757 460th Ave.
 *SURVEYOR: Jim Stone *COUNTY: Clay
 *CITY: Centerville

CURRENT FUNCTION:	<u>Cow calf barn</u>	FOUNDATION:	<u>Poured concrete</u>
CURRENT SUBFUNCTION:	<u>Storage</u>	ROOF MATERIAL:	<u>Asphalt shingles over cedar shingles</u>
HISTORIC FUNCTION:	<u>Livestock barn</u>	ROOF SHAPE:	<u>Gothic round roof</u>
HISTORIC SUBFUNCTION:	<u>Hay and grain storage</u>	STRUCTURAL SYSTEM:	<u>Balloon framing</u>
			<u>Gothic round roof</u>
		STYLE:	<u>barn</u>
OCCUPIED:	<u>Yes</u>	TYPE:	<u>Livestock barn</u>
	<u>Yes with</u>		<u>2x6 studs, 1x6 #106</u>
ACCESSIBLE:	<u>permission</u>	WALLS:	<u>drop siding</u>
STORIES:	<u>2</u>	SIGNIFICANT PERSON:	<u>T. I. Gunderson</u>
*DATE OF CONSTRUCTION:	<u>Early 1920's</u>	CULTURAL AFFILIATION:	<u>?</u>

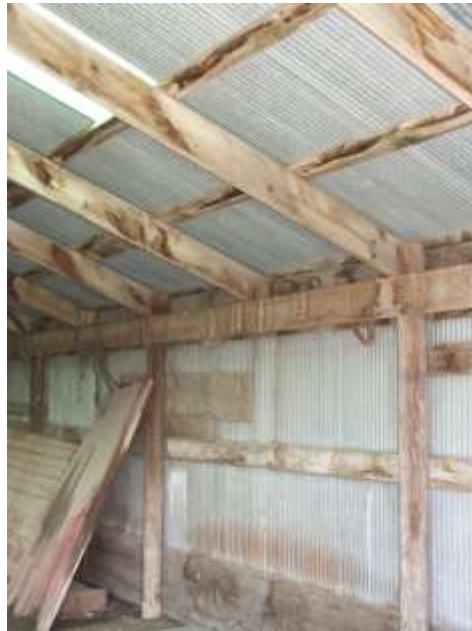
ROLL NUMBER: _____
PHOTO NUMBER: 5

First floor, East lean-to, looking NE, 5" posts 8' O. C', (2) 2x10's header, 2x6 girt, (3) 2x6 T&G and 2x8 rafters.

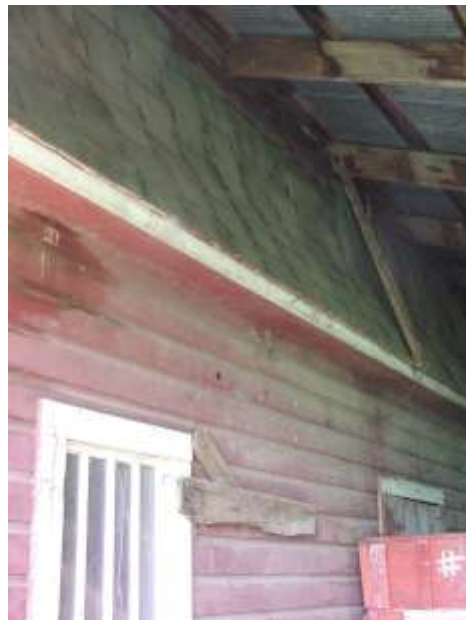
ROLL NUMBER: _____
PHOTO NUMBER: 6

First floor, East lean-to, looking NW, 2x8 rafters cut into original barn roof.

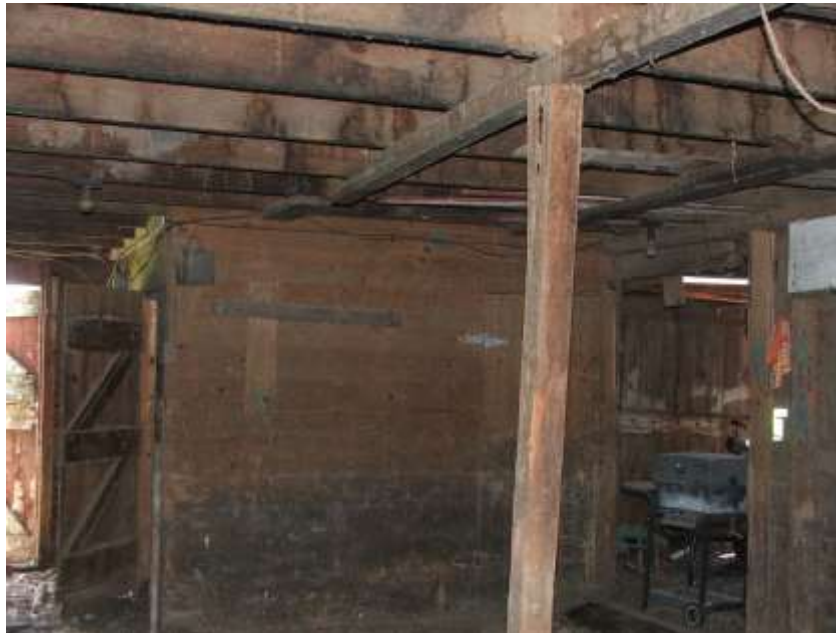
ROLL NUMBER: _____
PHOTO NUMBER: 7

INTERIOR NOTES: One row of 4"x4" posts, and 4x4 beam support the 2x8 joists for the hayloft floor in the original barn on the East side. A 2x6 stud wall in the center with 1x6 shiplap divides the West 14' from the East 14'. 2x8 floor joists are doubled to span the 14' on the West side. Milk cow stanchions were on the East side, but have been removed. Milk room and granary are still on the South side. All evidence of horse stalls has been removed.

First floor, original barn on East side, looking SW, 4x4 posts, 4x4 beam, granary and milk room.

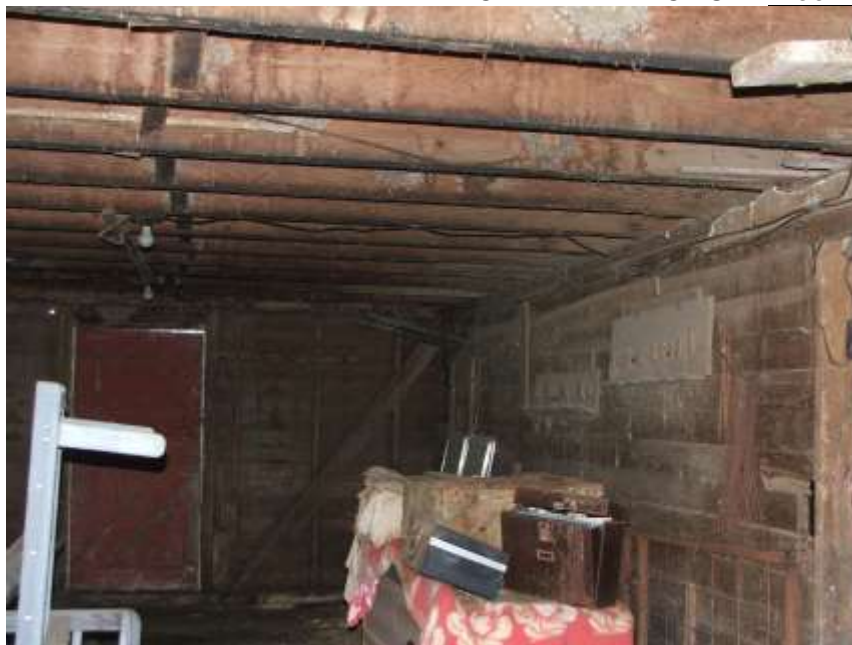
ROLL NUMBER: _____
PHOTO NUMBER: 8

Original barn, first floor, West side, 2x6 solid wall, 2x8 joists doubled on this side.

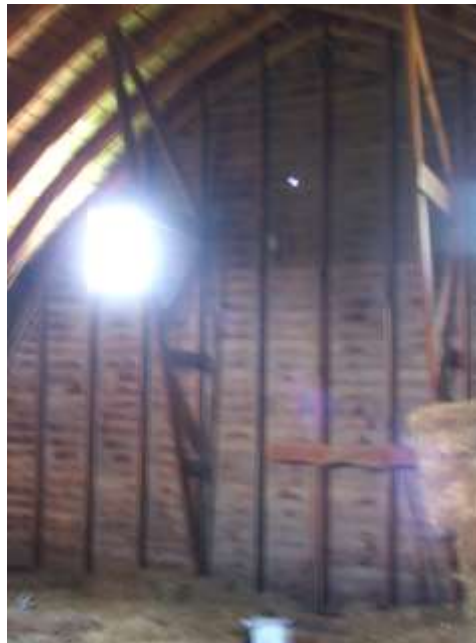
ROLL NUMBER: _____
PHOTO NUMBER: 9

**Hayloft, looking NW,
vertical trusses
reinforcing North gable
wall**

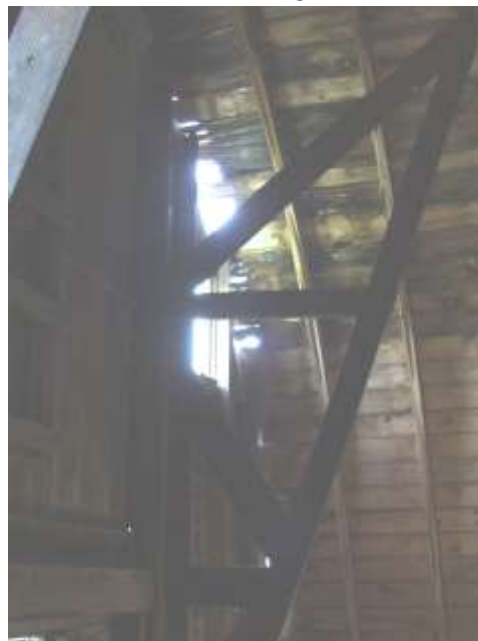
ROLL NUMBER: _____
PHOTO NUMBER: 10

**Hayloft, looking SW, one
of two vertical trusses
reinforcing South gable
wall**

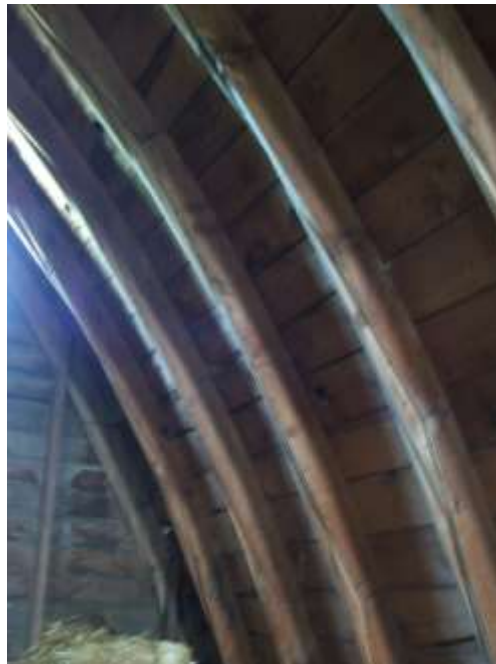
ROLL NUMBER: _____
PHOTO NUMBER: 11

OTHER NOTES: 2x6 stud walls with 1x6 #106 drop siding on all four walls of the original barn. Rafters 3 ply 1x6 x 5' - 4" on the main barn and were built on site. The lean-to's have 2x8 rafters 4' O. C.

CAMERA DIRECTION: Hayloft, looking NE, (3)
ply 1 x 6 x 5'-4" site built
gothic round rafters

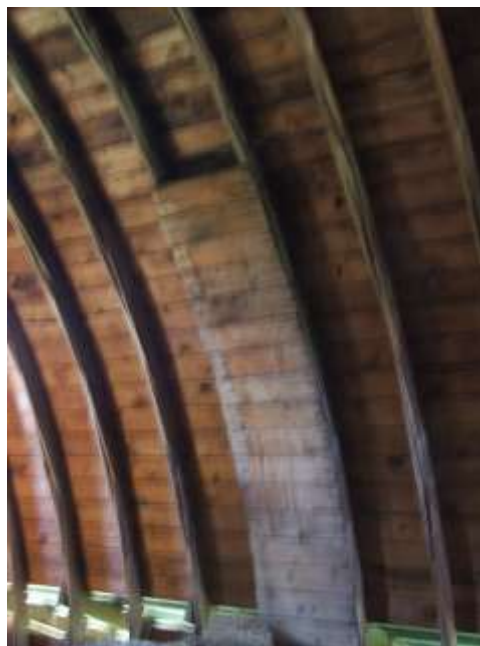
ROLL NUMBER: _____
PHOTO NUMBER: 12

Asphalt shingles over cedar shingles on original barn and steel roofing on the lean-to's. Windows are 4"x24" four light. Boards over two rafters in center of hayloft, to form an air chute from first floor up to cupola. A chute is on the East and West sides to ventilate both sides on first floor.

CAMERA DIRECTION: Hayloft, looking SW, air
ventilation chute from
first floor up to cupola.
