**SOUTH DAKOTA STATE HISTORIC PRESERVATION OFFICE
HISTORIC SITES SURVEY STRUCTURE FORM**

*SURVEY DATE: July 13, 2012 *ADDRESS: 45587 307th Street
*SURVEYOR: Jim Stone *COUNTY: Clay
*CITY: Volin

CURRENT FUNCTION:	<u>Farm machinery storage</u>	FOUNDATION:	<u>Native rock, sand and lime mortar</u>
CURRENT SUBFUNCTION:	<u>Storage</u>	ROOF MATERIAL:	<u>Cedar shingles</u>
HISTORIC FUNCTION:	<u>Livestock barn</u>	ROOF SHAPE:	<u>Gable</u>
HISTORIC SUBFUNCTION:	<u>Hay and grain storage</u>	STRUCTURAL SYSTEM:	<u>Balloon framing Gable roof bank barn</u>
		STYLE:	<u>barn</u>
OCCUPIED:	<u>Yes</u>	TYPE:	<u>Livestock barn</u>
	<u>Yes with permission</u>	WALLS:	<u>2x6, 1x8 ? drop siding</u>
ACCESSIBLE:			
STORIES:	<u>2</u>	SIGNIFICANT PERSON:	<u>T. T. Orton</u>
*DATE OF CONSTRUCTION:	<u>Pre - 1900</u>	CULTURAL AFFILIATION:	<u>Norwegian</u>

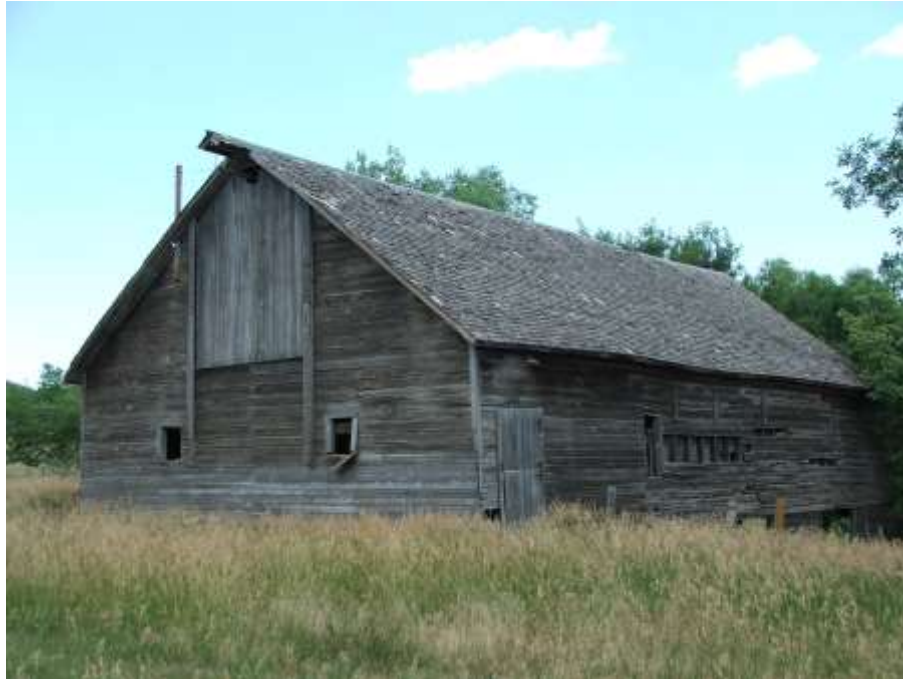
ROLL NUMBER: _____
PHOTO NUMBER: 1
CAMERA DIRECTION: Looking NE, SW corner

*PHYSICAL NOTES: Barn is in poor condition. The rock walls are crumbling. The roof is leaking and rotting out the hayloft floor over the basement.

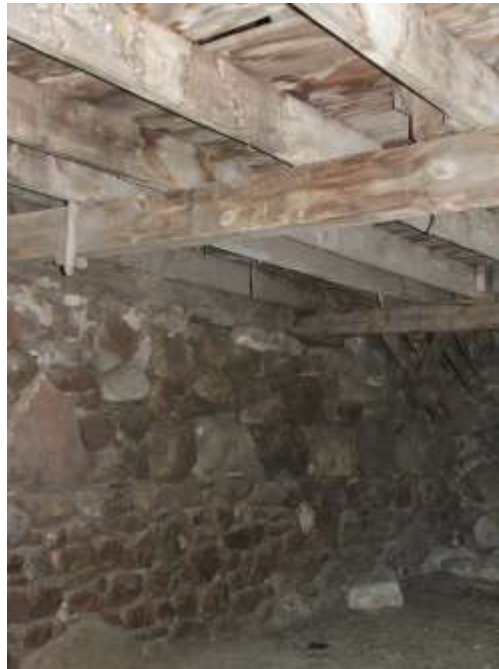
ROLL NUMBER: _____
PHOTO NUMBER: 5

SIGNIFICANCE NOTES: This barn was built before the 1900's, because of the sand and lime mortar On the native rock basement walls and foundation on the west 16'. Portland cement was not available until the late 1890's.

ALTERED/MOVED NOTES: Original site. Some of the basement walls have been repaired with Portland cement mortar and a short section has been replaced with poured concrete in the SW corner of the basement.

CAMERA DIRECTION: Basement, looking NW,
native rock walls, sand
and lime mortar

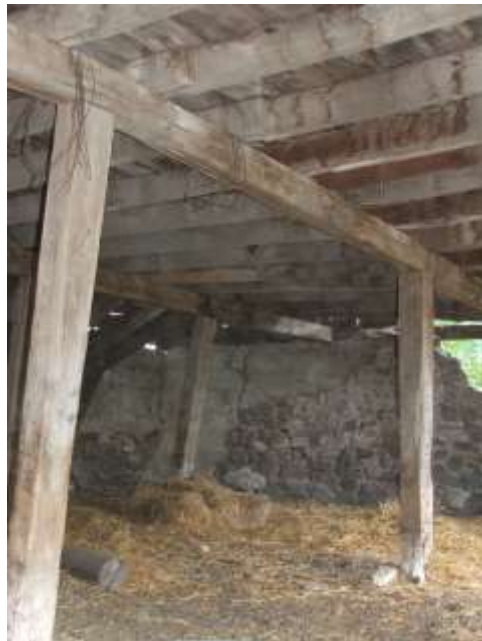
ROLL NUMBER: _____
PHOTO NUMBER: 6

INTERIOR NOTES: Has two rows 6x8 posts and 6x8 beams to support hayloft floor in the East 50' (basement area). One row 6x8 posts and 6x8 beam in the West 16', but extends 6' more over the hayloft above the hayloft over the basement. Milk cow stanchions are still in place in the West 16'

CAMERA DIRECTION: Basement, looking NE,
6x8 posts, 6x8 beams,
rock walls, note
crumbling

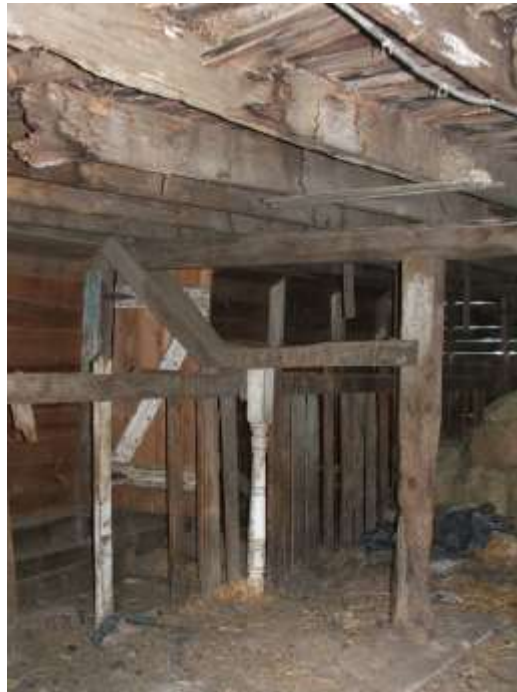
ROLL NUMBER: _____
PHOTO NUMBER: 7

First floor, West 16',
looking SE, original milk
cow stanchions

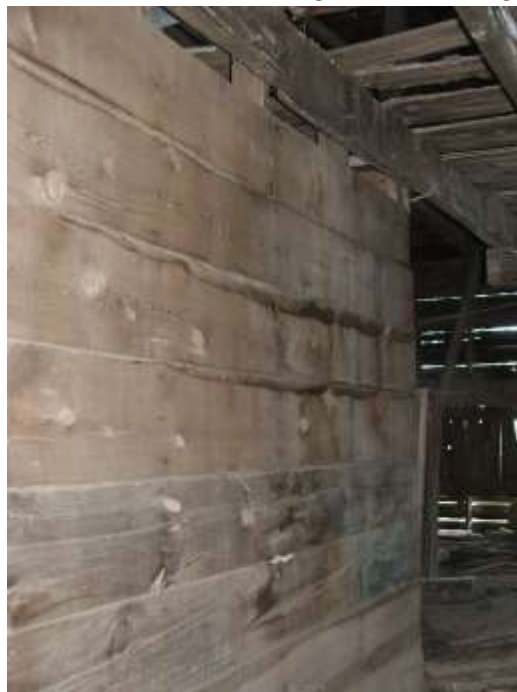
ROLL NUMBER: _____
PHOTO NUMBER: 8

First floor, looking
South, South, 14' x 11'
granary in hayloft

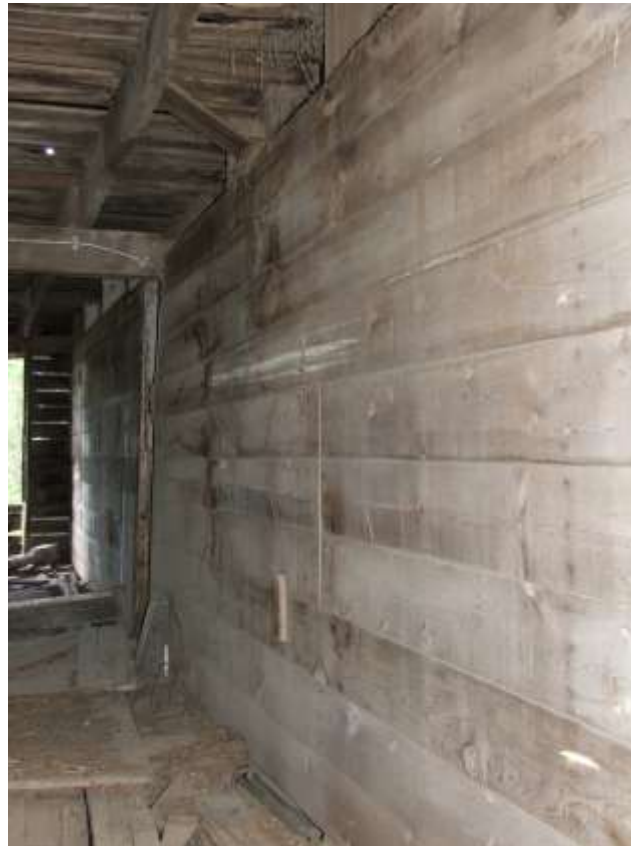
ROLL NUMBER: _____
PHOTO NUMBER: 9

CAMERA DIRECTION: First floor, looking South, South, solid stud wall dividing West 16' from the East hayloft over basement

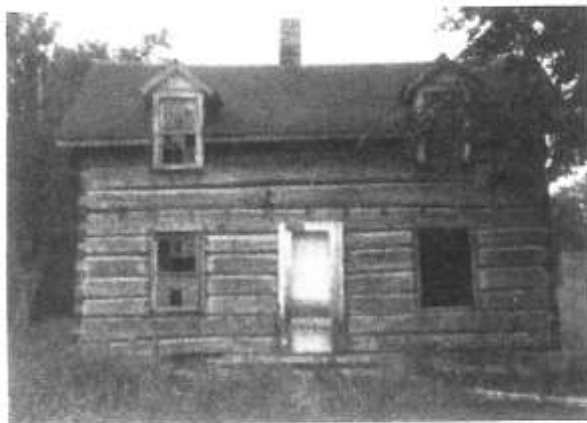
(Rice farm) Log cabin along the Bluff Road

Log cabin has dove tailed logs on the corners. It is listed on the National register. Owners are Jerry and Norma Wilson.
