**SOUTH DAKOTA STATE HISTORIC PRESERVATION OFFICE  
HISTORIC SITES SURVEY STRUCTURE FORM**

\*SURVEY DATE: June 26, 2013 \*ADDRESS: 29811 455<sup>th</sup> Ave.  
\*SURVEYOR: Jim Stone \*COUNTY: Clay  
\*CITY: Irene

CURRENT FUNCTION: <u>Calving barn</u>	FOUNDATION: <u>Poured concrete</u>
CURRENT SUBFUNCTION: <u>Vacant</u>	ROOF MATERIAL: <u>Steel roofing over cedar shingles</u>
HISTORIC FUNCTION: <u>Livestock barn</u>	ROOF SHAPE: <u>Gable roof</u>
HISTORIC SUBFUNCTION: <u>Hay storage</u>	STRUCTURAL SYSTEM: <u>Balloon framing</u>
	STYLE: <u>Gable roof barn</u>
OCCUPIED: <u>Yes</u>	TYPE: <u>Livestock barn</u>
	<u>2x4 studs, 1"x6"</u>
ACCESSIBLE: <u>Yes with permission</u>	WALLS: <u>#106 drop siding and steel roofing</u>
STORIES: <u>2</u>	SIGNIFICANT PERSON: <u>Thomas J. Hood</u>
*DATE OF CONSTRUCTION: <u>1910-1920</u>	CULTURAL AFFILIATION: <u>Irish</u>

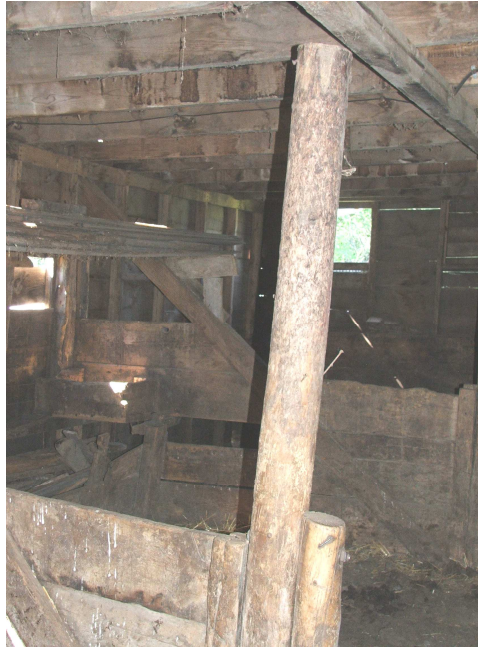
**ROLL NUMBER:** 5  
**PHOTO NUMBER:** 5

INTERIOR NOTES: One row of 6" round posts, and 6x6 beam support the 2x6 joists for the hayloft floor. Three double horse stalls were on the West wall of the center barn. The lean-tos have no evidence of what they were used for. The East lean-to and the center original barn are used for calving now.

**First floor, looking NW,  
6" round post, 6x6 beam,  
2x6 joists, remains of  
double horse stalls.**

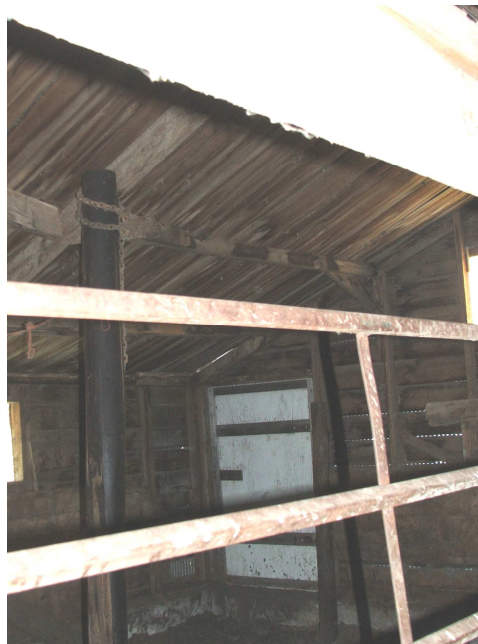
**ROLL NUMBER:** 6  
**PHOTO NUMBER:** 6

OTHER NOTES: 2x4 stud walls, 1x6 #106 drop siding and 1-1/4" x 26" corrugated, galvanized steel applied vertically. Rafters are 2x6's in the original barn and in the West lean-to. They are 2x8's, 9' O. C. in the East lean-to, 2x4 purlins and sheathing up and down on the roof and with steel roofing. Windows were 8" x 10" four light, but all are gone or covered with steel roofing

**First floor, looking SE,  
Into East lean-to, note  
roof sheathing running  
up and down.**

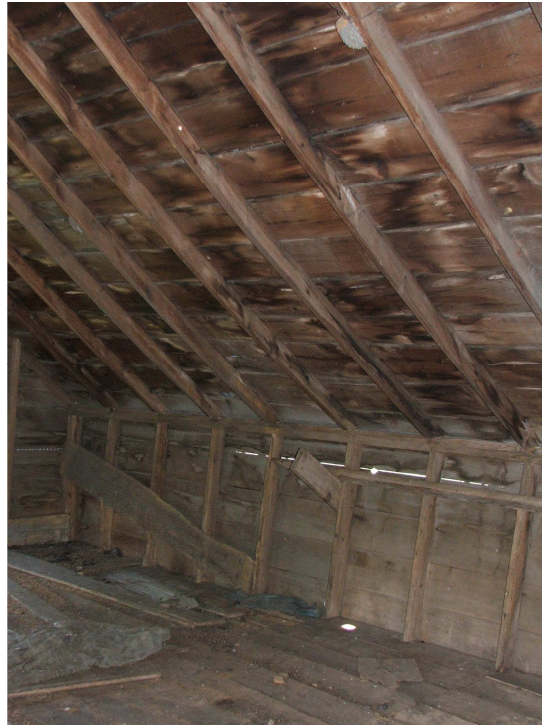
**ROLL NUMBER:** \_\_\_\_\_  
**PHOTO NUMBER:** 7

**CAMERA DIRECTION:** Hayloft, looking NE, 2x6 rafters and 3'-8" wall in hayloft.

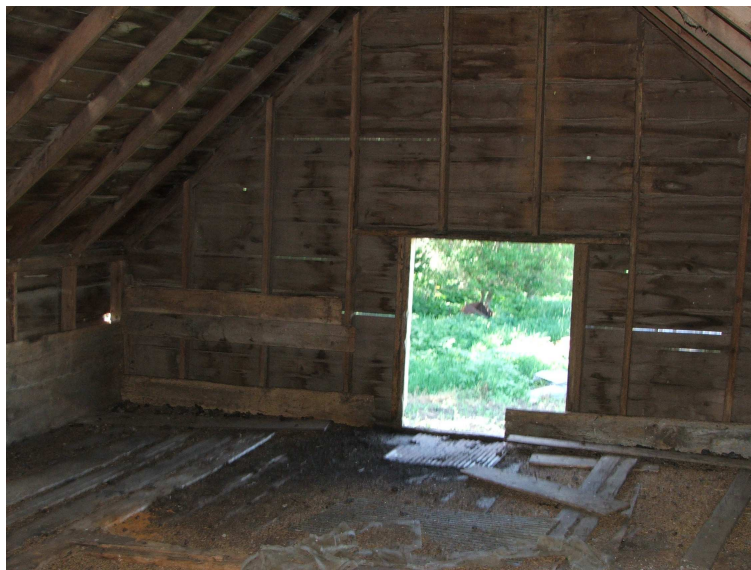
**ROLL NUMBER:** \_\_\_\_\_  
**PHOTO NUMBER:** 8

**CAMERA DIRECTION:** Hayloft, looking North, North gable end and hayloft door.
