**SOUTH DAKOTA STATE HISTORIC PRESERVATION OFFICE**  
**HISTORIC SITES SURVEY STRUCTURE FORM**

\*ADDRESS: 45754 Timber Road  
\*COUNTY: Clay  
\*CITY: Vermillion

SHPO ID: _____	
*PROPERTY NAME: _____	
OTHER NAME: _____	
CURRENT FUNCTION: _____	Farm machinery storage
CURRENT SUBFUNCTION: _____	Storage
HISTORIC FUNCTION: _____	Livestock barn
HISTORIC SUBFUNCTION: _____	Hay and grain storage
FOUNDATIONS: _____	Poured concrete
ROOF MATERIAL: _____	Steel
ROOF SHAPE: _____	Gambrel
STRUCTURAL SYSTEM: _____	Balloon framing
STYLE: _____	Gambrel roof barn
TYPE: _____	Livestock barn
WALLS: _____	2x6, sheathing & steel roofing
OCCUPIED: _____	Yes
ACCESSIBLE: _____	Yes with permission
STORIES: _____	2
SIGNIFICANT PERSON: _____	Thomas Knutson
*DATE OF CONSTRUCTION: _____	1920's
CULTURAL AFFILIATION: _____	Norwegian

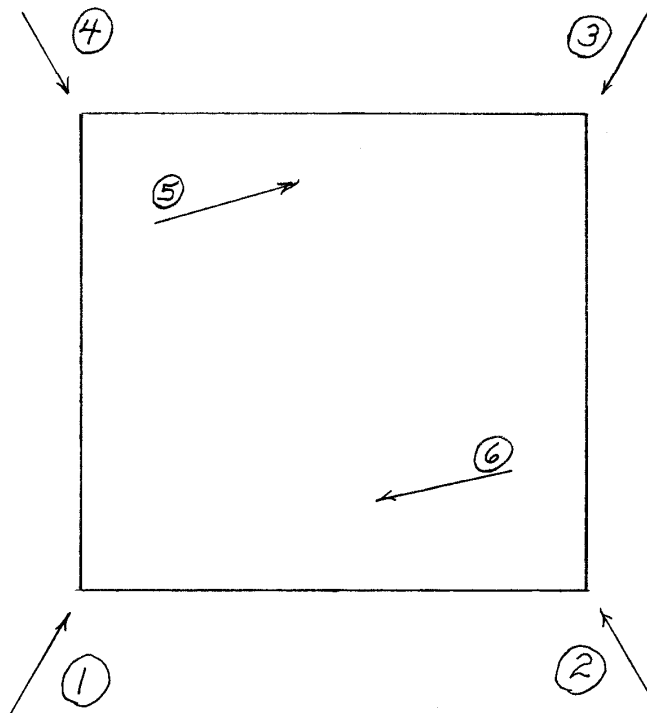
**PHOTOGRAPH**

\*PHYSICAL NOTES: Barn is in excellent condition. A very good idea to continue the use of an old barn for today's agriculture needs.

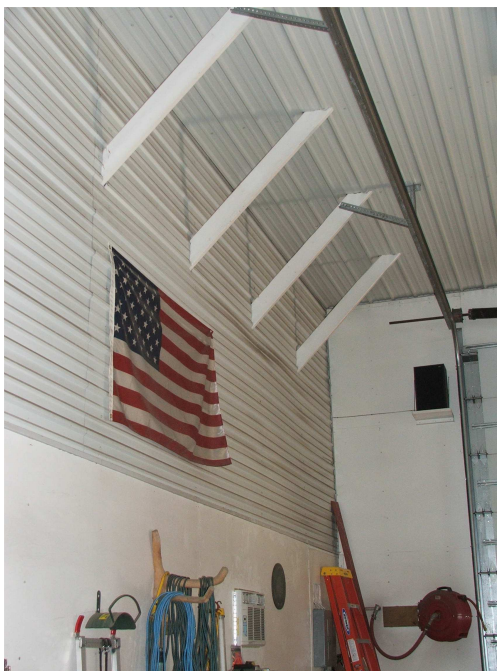
ROLL NUMBER: \_\_\_\_\_  
PHOTO NUMBER: 5

Looking East, North wall,  
wall insulated and  
covered, rafter bracing

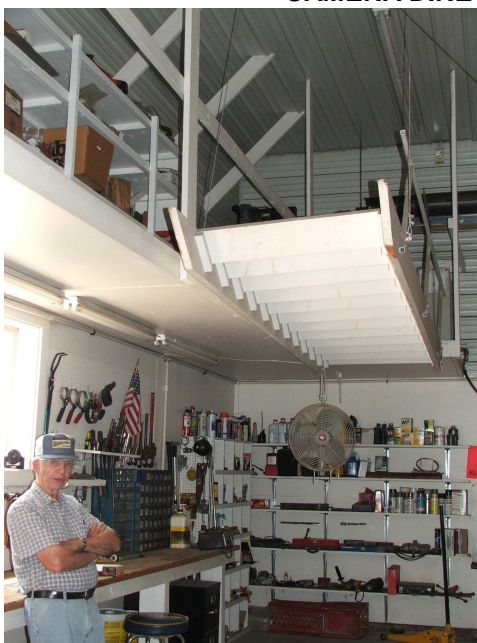
ROLL NUMBER: \_\_\_\_\_  
PHOTO NUMBER: 6

Looking West, South  
wall, cat walk for storage  
and counter weighted  
stairs

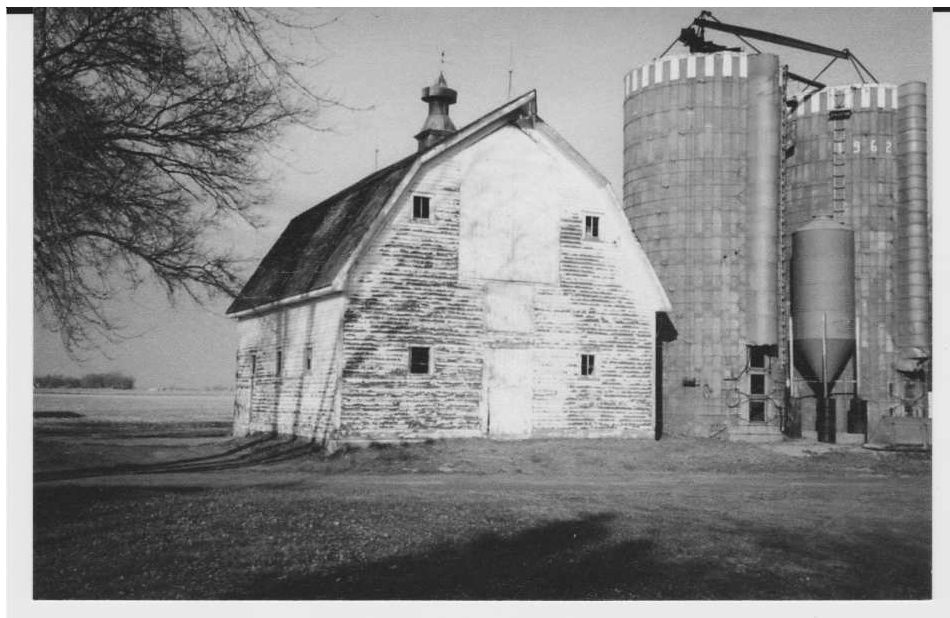
ROLL NUMBER: \_\_\_\_\_  
PHOTO NUMBER: \_\_\_\_\_ 7

ALTERED/MOVED NOTES: Original site. Gambrel roof was removed. Manufactured trusses were used for new roof. Walls and roof are covered with steel roofing. All stalls, stanchions, calf pen, granary and hayloft floor have been removed. Barn has been remodeled into a machinery storage building. The 2x6 walls 14'-6" high and 2x6 rafter to wall bracing are all that is still in use. Three feet of wall was added to top of existing wall to make a 16' high wall for combine storage and shop work.

CAMERA DIRECTION: \_\_\_\_\_  
Original barn before  
remodeling, looking  
West, East side
