**SOUTH DAKOTA STATE HISTORIC PRESERVATION OFFICE**  
**HISTORIC SITES SURVEY STRUCTURE FORM**

\*ADDRESS: 45776 Jetly Park Street

SHPO ID: _____	
*PROPERTY NAME: _____	
OTHER NAME: _____	
CURRENT FUNCTION: <u>Vacant</u>	FOUNDATION: <u>Poured concrete</u>
CURRENT SUBFUNCTION: _____	ROOF MATERIAL: <u>Cedar shingles</u>
HISTORIC FUNCTION: <u>Livestock barn</u>	ROOF SHAPE: <u>Gambrel</u>
HISTORIC SUBFUNCTION: <u>Hay and grain storage</u>	STRUCTURAL SYSTEM: <u>Balloon framing</u>
	STYLE: <u>Gambrel roof barn</u>
OCCUPIED: <u>Yes</u>	TYPE: <u>Livestock barn</u>
	<u>2x4, 1x6 #106 drop</u>
ACCESSIBLE: <u>Yes with permission</u>	WALLS: <u>siding</u>
STORIES: <u>2</u>	SIGNIFICANT PERSON: <u>Tillie Rask</u>
*DATE OF CONSTRUCTION: <u>1900-1915</u>	CULTURAL AFFILIATION: <u>Norwegian</u>

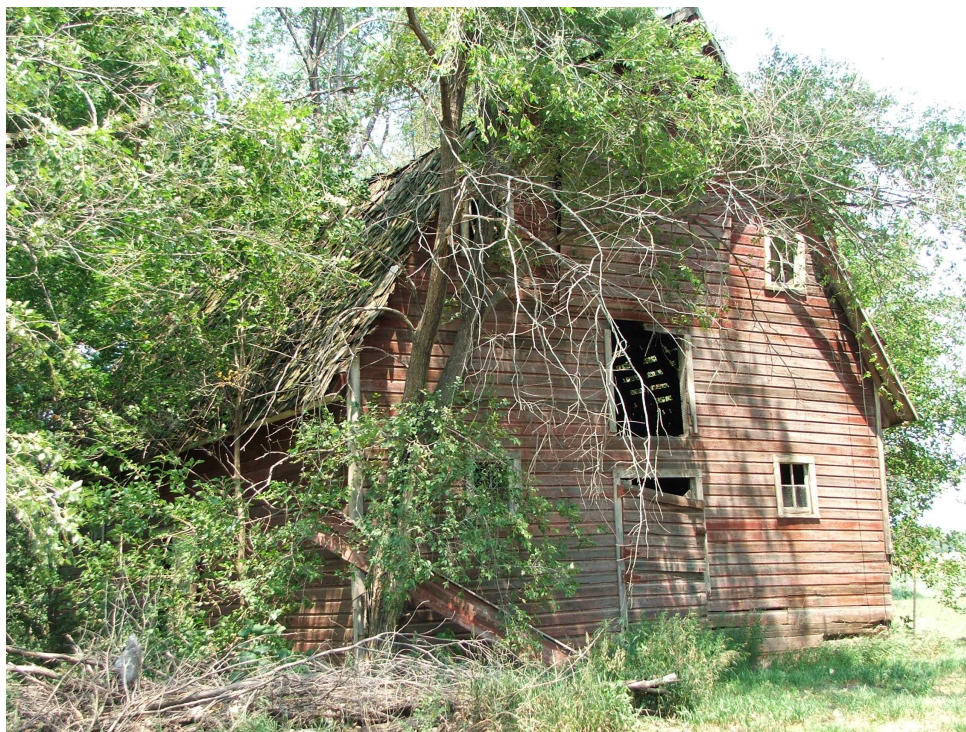
ROLL NUMBER: \_\_\_\_\_  
PHOTO NUMBER: 1  
CAMERA DIRECTION: Looking NE, SW corner

\*PHYSICAL NOTES: Barn is in very poor condition. Roof has been leaking and hayloft floor is starting rot out. Gable eaves are falling off.

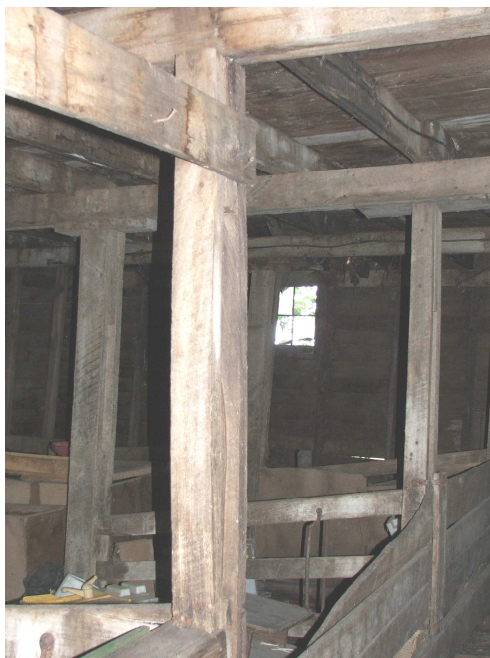
ROLL NUMBER: \_\_\_\_\_  
PHOTO NUMBER: 5

INTERIOR NOTES: Had double 2x4 and double 2x6 posts and double 2x6 beams to support hayloft floor. Joists were 2x6. All of the 2x4's for studs, rafters and bracing, 2x6 floor joists, double 2x6 posts and double 2x6 beams were rough sawn cottonwood.

CAMERA DIRECTION: First floor, looking East,  
horse stalls, double 2x4  
posts and 2x6 beam

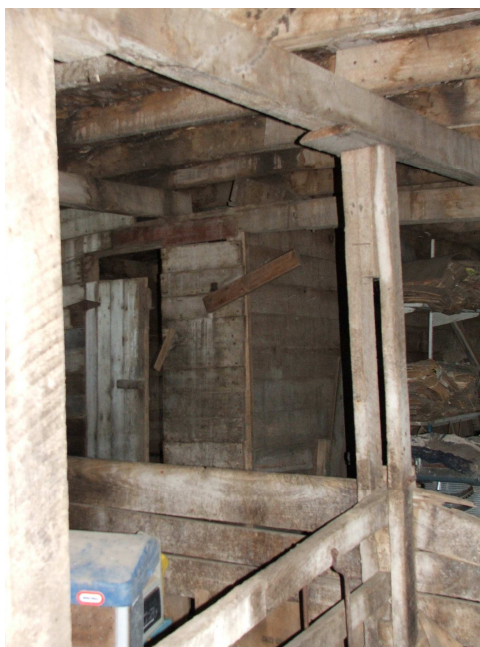
ROLL NUMBER: \_\_\_\_\_  
PHOTO NUMBER: 6

OTHER NOTES: Windows were 8"x10" four light. Horse stalls and granary are still in place.

CAMERA DIRECTION: First floor, looking SE,  
granary on East wall

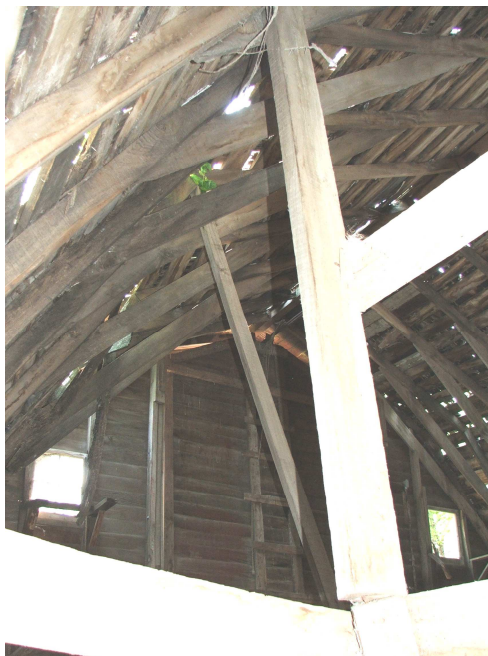
ROLL NUMBER: \_\_\_\_\_  
PHOTO NUMBER: 7

CAMERA DIRECTION: Hayloft, looking North,  
upper rafter bracing

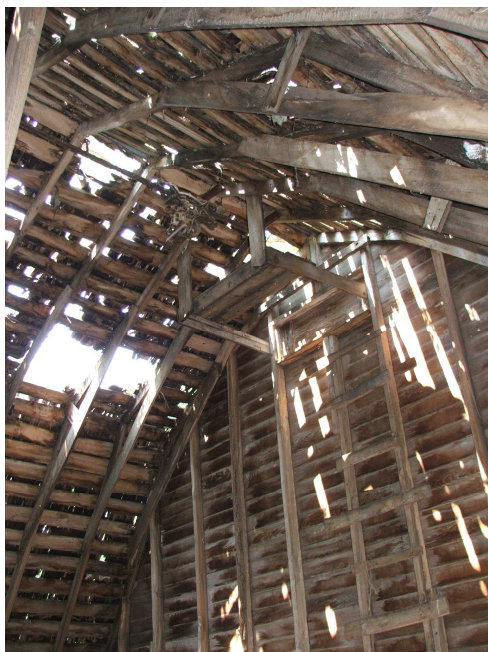
ROLL NUMBER: \_\_\_\_\_  
PHOTO NUMBER: 8

CAMERA DIRECTION: Hayloft, looking South,  
2x4 posts and rafter  
bracing
