**SOUTH DAKOTA STATE HISTORIC PRESERVATION OFFICE
HISTORIC SITES SURVEY STRUCTURE FORM**

*SURVEY DATE: February 1, 2013 *ADDRESS: 30007 University Road
*SURVEYOR: Jim Stone *COUNTY: Clay
*CITY: Beresford

CURRENT FUNCTION:	<u>Liquid fertilizer storage</u>	FOUNDATION:	<u>Poured concrete foundation</u>
CURRENT SUBFUNCTION:	<u>Storage</u>	ROOF MATERIAL:	<u>Steel roofing</u>
HISTORIC FUNCTION:	<u>Livestock barn</u>	ROOF SHAPE:	<u>Gambrel</u>
HISTORIC SUBFUNCTION:	<u>Hay storage</u>	STRUCTURAL SYSTEM:	<u>Balloon framing</u>
		STYLE:	<u>Gambrel roof barn</u>
OCCUPIED:	<u>Yes</u>	TYPE:	<u>Livestock barn</u>
	<u>Yes with</u>		<u>2x6 studs, 1x6 #106</u>
ACCESSIBLE:	<u>permission</u>	WALLS:	<u>drop siding</u>
STORIES:	<u>2</u>	SIGNIFICANT PERSON:	<u>Victor Nelson</u>
*DATE OF CONSTRUCTION:	<u>1915-1925</u>	CULTURAL AFFILIATION:	<u>?</u>

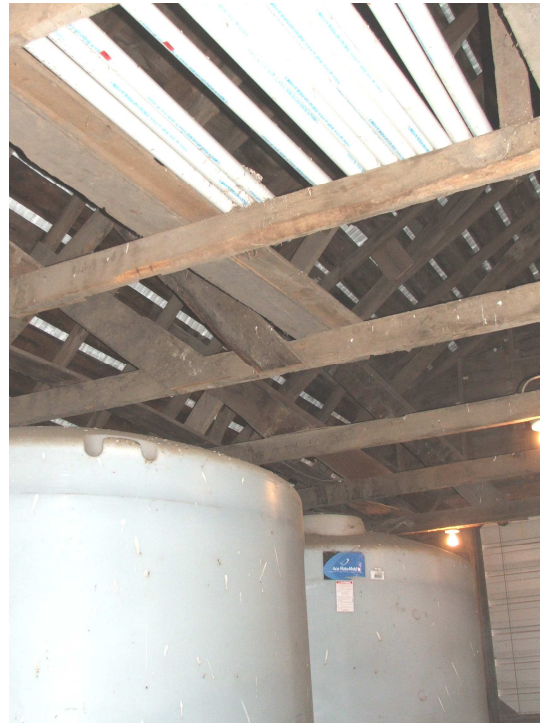
ROLL NUMBER: _____
PHOTO NUMBER: 5

ALTERED/MOVED NOTES: Original site. Any evidence of milk cow stanchions or horse stalls has been removed. Posts, beams and hayloft floor removed. Floor joists raised to 11' and are 4' O. C. Bracing added to re-enforce roof to raised floor joists. 14' x 12' overhead door added on East wall.

CAMERA DIRECTION: First floor, looking up and NE, rafter bracing

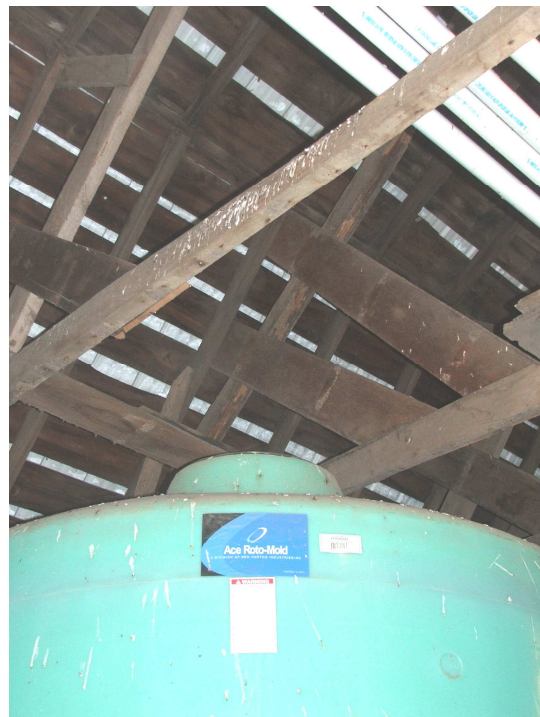
ROLL NUMBER: _____
PHOTO NUMBER: 6

CAMERA DIRECTION: First floor, looking up and NE, rafter bracing.
