**SOUTH DAKOTA STATE HISTORIC PRESERVATION OFFICE**  
**HISTORIC SITES SURVEY STRUCTURE FORM**

\*ADDRESS: 106 South Dakota Highway 50  
\*COUNTY: Clay  
\*CITY: Vermillion,

HISTORIC FUNCTION: Horse barn

TYPE: Horse barn

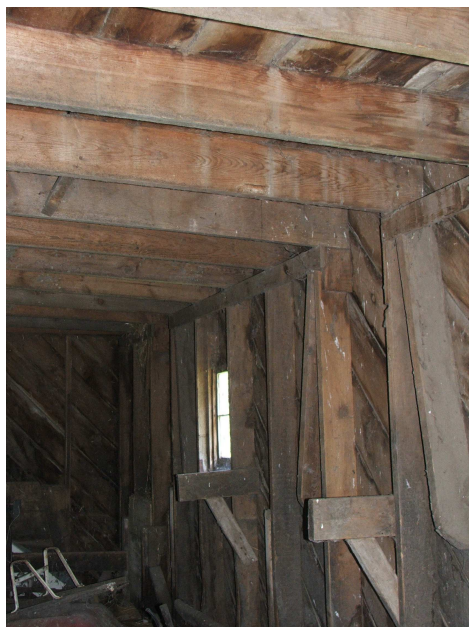
ROLL NUMBER: \_\_\_\_\_  
PHOTO NUMBER: 5

First floor, looking North,  
East wall, had special  
2.6's to direct the hay  
into two stalls from the  
hayloft

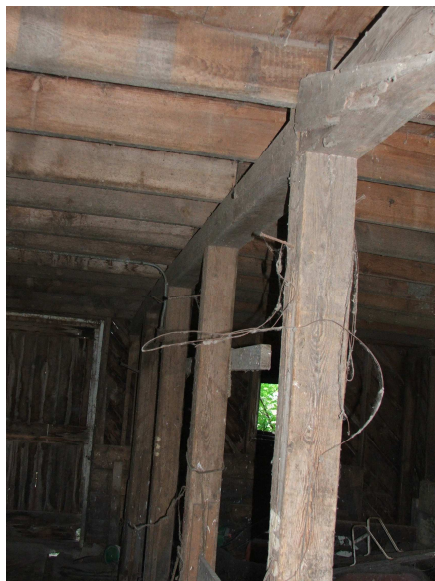
ROLL NUMBER: \_\_\_\_\_  
PHOTO NUMBER: 6

INTERIOR NOTES: Two rows of 6x6 posts 5' O. C. supporting a 6x6 beam which supports 2x8 floor joists for the hay loft floor.

First floor, looking North,  
6x6 posts, 6x6 beam and  
2x8 floor joists

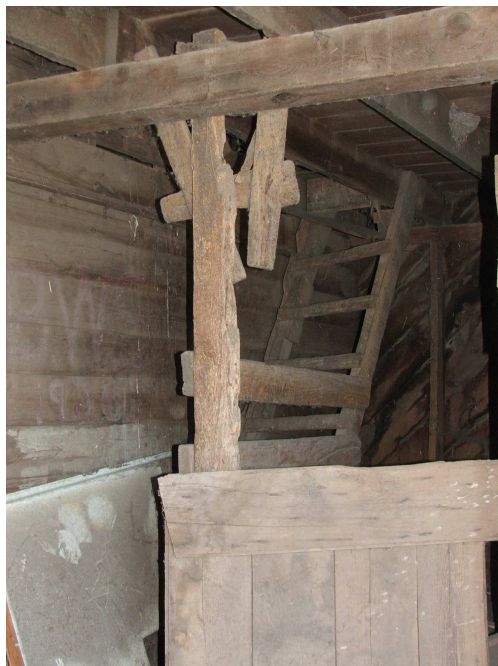
ROLL NUMBER: \_\_\_\_\_  
PHOTO NUMBER: 7

CAMERA DIRECTION: First floor, looking East,  
stairs to the hayloft

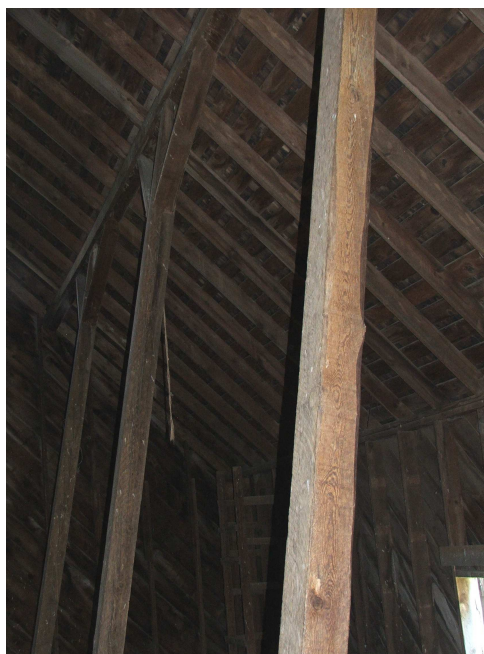
ROLL NUMBER: \_\_\_\_\_  
PHOTO NUMBER: 8

CAMERA DIRECTION: Hayloft, looking North,  
4x6 posts supporting  
roof

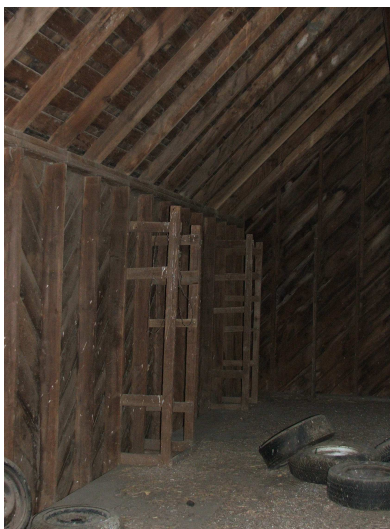
**ROLL NUMBER:** \_\_\_\_\_  
**PHOTO NUMBER:** 9

**CAMERA DIRECTION:** Hayloft, looking North,  
special hay chutes to  
feed horses.
