**SOUTH DAKOTA STATE HISTORIC PRESERVATION OFFICE  
HISTORIC SITES SURVEY STRUCTURE FORM**

\*SURVEY DATE: April 7, 2013 \*ADDRESS: 46711 298<sup>th</sup> Street  
\*SURVEYOR: Jim Stone \*COUNTY: Clay  
\*CITY: Beresford

CURRENT FUNCTION: Storage FOUNDATION: Poured concrete  
 CURRENT SUBFUNCTION: Vacant ROOF MATERIAL: Steel over spaced sheathing  
 HISTORIC FUNCTION: Grain elevator ROOF SHAPE: Gable  
 HISTORIC SUBFUNCTION: Grain storage STRUCTURAL SYSTEM: Balloon framing  
 OCCUPIED: Yes STYLE: Grain Elevator  
 TYPE: Grain Elevator  
 ACCESSIBLE: Yes with permission WALLS: 2x6 studs, 1x10 diagonal sheathing and embossed brick steel siding

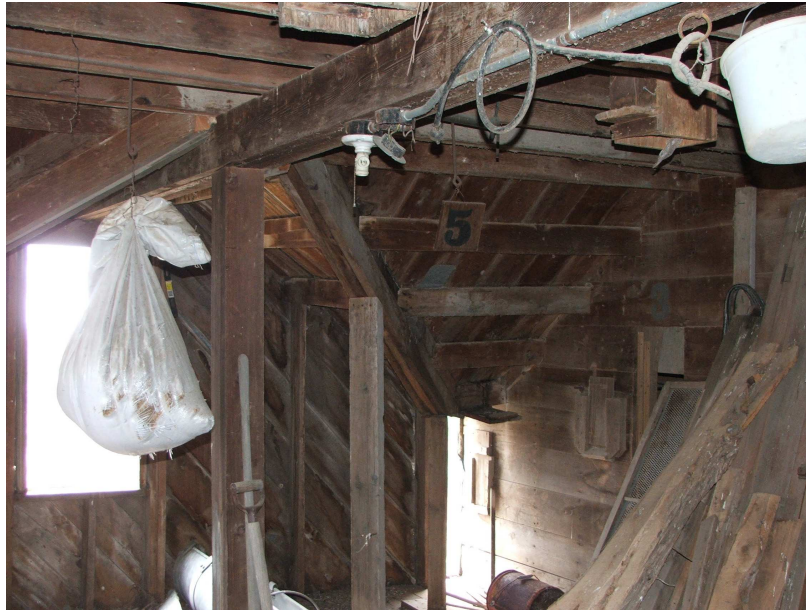
**ROLL NUMBER:** \_\_\_\_\_  
**PHOTO NUMBER:** 5

**CAMERA DIRECTION:** First floor, looking SW,  
drop for overhead bin 5,  
6x8 post and 6x8 beam.

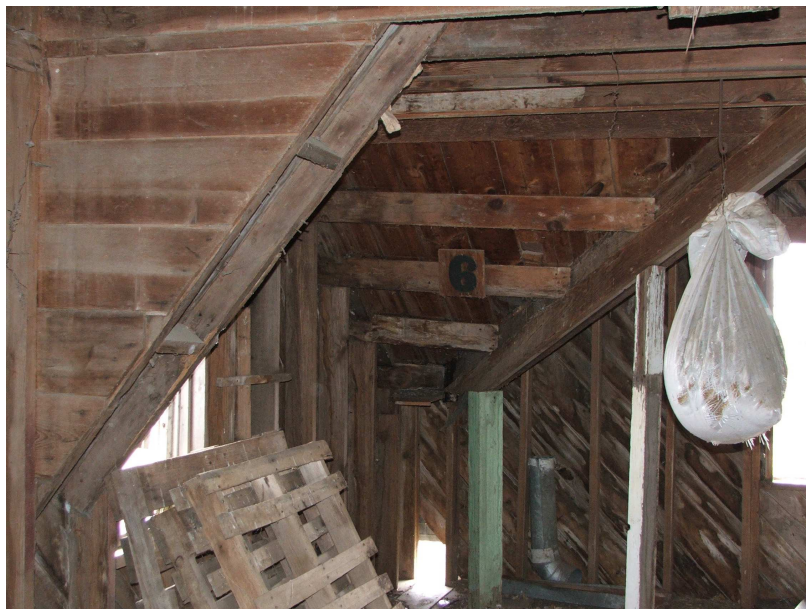
**ROLL NUMBER:** \_\_\_\_\_  
**PHOTO NUMBER:** 6

**CAMERA DIRECTION:** First floor, looking SE,  
drop for overhead bin 6,  
gravity flow, note  
opening in wall to direct  
the grain out into a  
wagon.

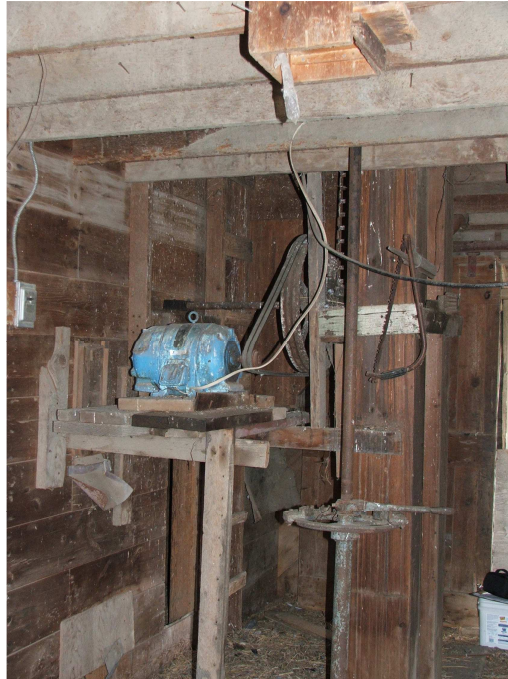
**ROLL NUMBER:** 7  
**PHOTO NUMBER:** 7

**First floor, looking NW,  
grain leg, 3 HP electric  
motor and lever to  
control turning the spout  
on the third floor to fill  
any of 10 bins.**

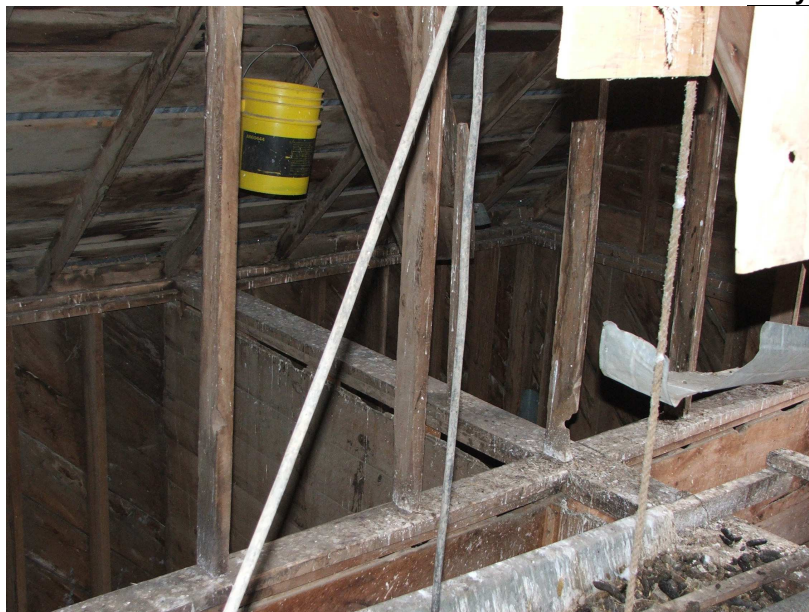
**ROLL NUMBER:** 8  
**PHOTO NUMBER:** 8

**Third floor, looking down  
into bins 6 and 8 on  
second floor**

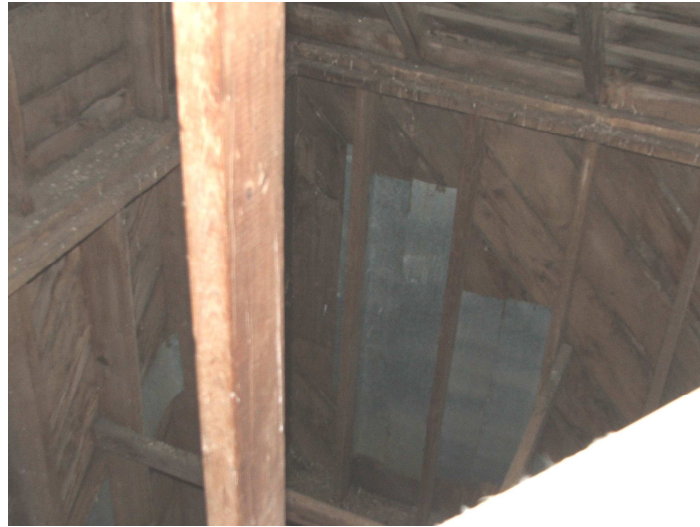
**ROLL NUMBER:** \_\_\_\_\_  
**PHOTO NUMBER:** 9

**CAMERA DIRECTION:** Third floor, looking down into bin 9 (NE corner)

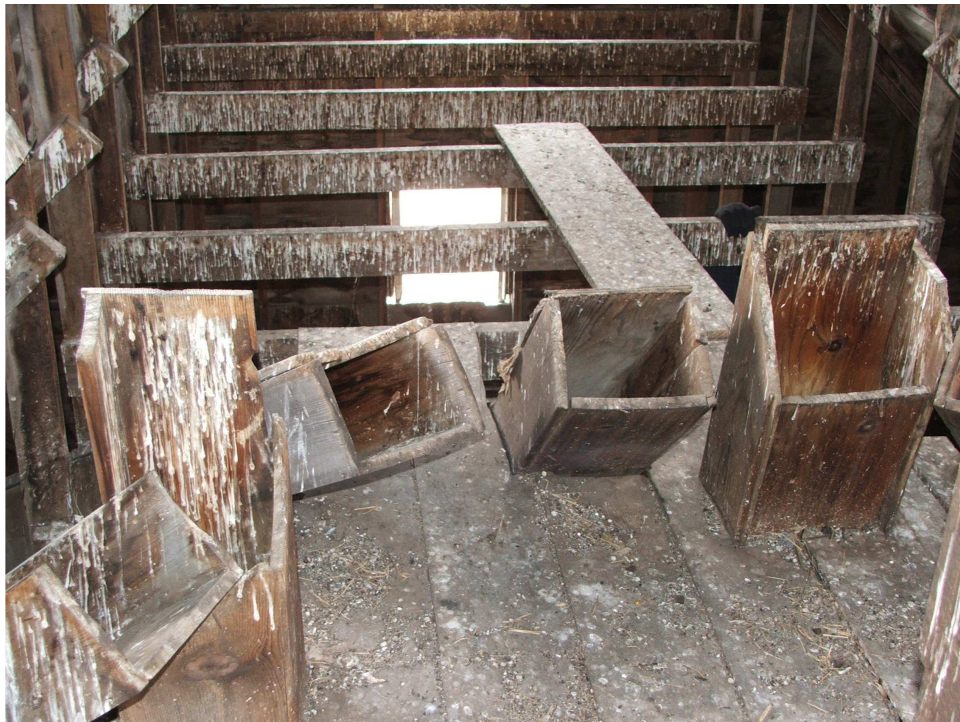
**ROLL NUMBER:** \_\_\_\_\_  
**PHOTO NUMBER:** 9

**CAMERA DIRECTION:** Third floor, looking South, chutes to bins 3,4,5,6,8 and 9, controls on first floor swing spout to any of these chutes to fill bins.
