*Restoring the Thompson House Fireplace at
the W. H. Over Museum*

By Evelyn Schlenker and Jim Stone

First Edition, 2021

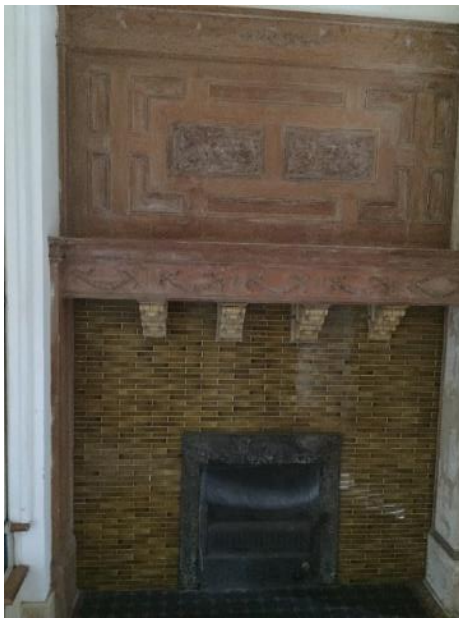
The fireplace in the Thompson House.

In the Thompson house the fireplace was dismantled in pieces. The amber-colored fireplace-surround tiles, and hearth tiles were removed individually as were the oak mantle and overmantel, four large ceramic corbels, and the cast-iron firebox-insert and the bronze-plated surround. At the W. H. Over Museum the large fireplace was reconstructed in parts. Prior to reassembly of the fireplace, each component was thoroughly cleaned and restored. The methods used for the restoration of the tiles, wood, and metal elements are described separately. Photographs depict each part of the restoration. Finally, the fireplace took shape, hopefully resembling its past glory.

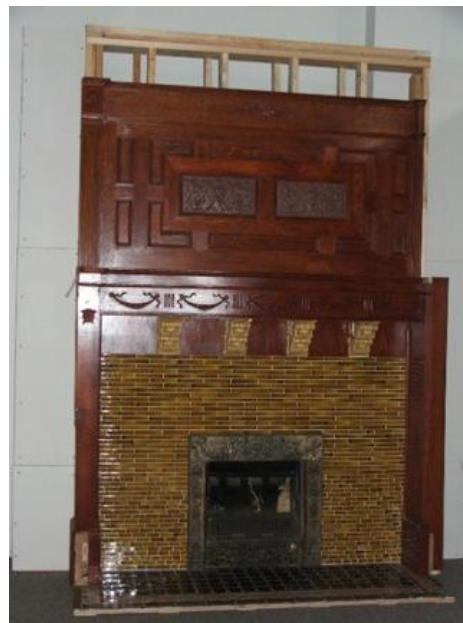
The restored fireplace in the W. H. Over Museum.

To support the fireplace in the exhibit, a series of 2-by-4s were constructed to accept the different components of the fireplace. The first part of the fireplace assembled was the fireplace insert. Next the tiled fireplace surround, and the insert surround were put in place, the hearth was positioned, and the corbels inserted and anchored. Then mantel was fastened to the exhibit supports. Finally, the overmantel was placed on top of the mantel and fastened to the mantel and supports. An oak floor taken from the Thompson house was placed around the hearth and comprises the floor of the exhibit. Below are pictures to illustrate the supports and the restored fireplace.

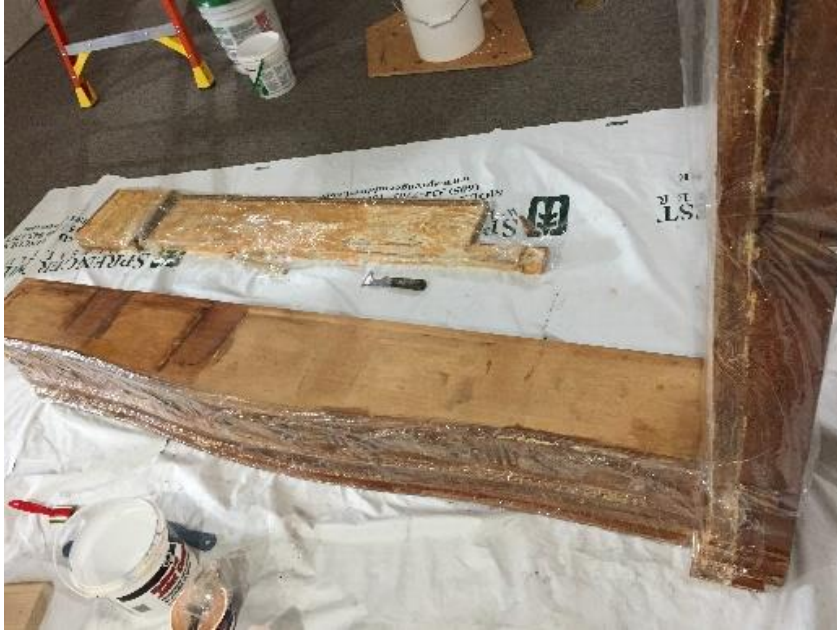
Part of the mantel was gelled and then wrapped in plastic wrap to aid in removal of the paint.

Firstly, the mantel and the decorative carved columns were removed. To remove the remaining paint, we used Citristrip stripping gel and covered the gelled area with saran wrap that was left on overnight. Then the detail work began to remove the paint in carved pieces and numerous recessed places. Scrapers, sanding, and finally dental picks were used to remove the last tiny particles of paint. These processes required many days of tedious work. In addition, parts of the mantel were missing, and replacements were constructed. To replicate the color of the oak and constructed additions, the wood was stained with Minwax Wood finish Gunstock 231, which resembled the original reddish-brown color of the fireplace. When the correct hue was obtained and dried, the mantel was covered with Minwax fast-drying polyurethane.

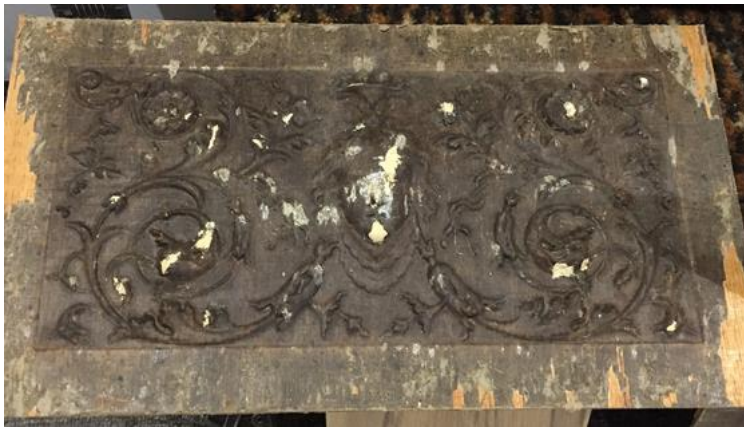
Plastic wood was used to reconstruct missing parts of the Lincrusta design.

To restore the design of the Lincrusta panels, missing sections that were replaced with plastic wood, which was dried overnight. Subsequently, the replaced plastic wood sections were sanded with increasingly finer sandpaper, the last was 1000 grade. Looking at a variety of overmantels that contained carved panels, we mixed paint to customize the simulate carved wood. Once the paint was dried, the raised embossed elements were lightly brushed with brown paint to help contrast the raised elements

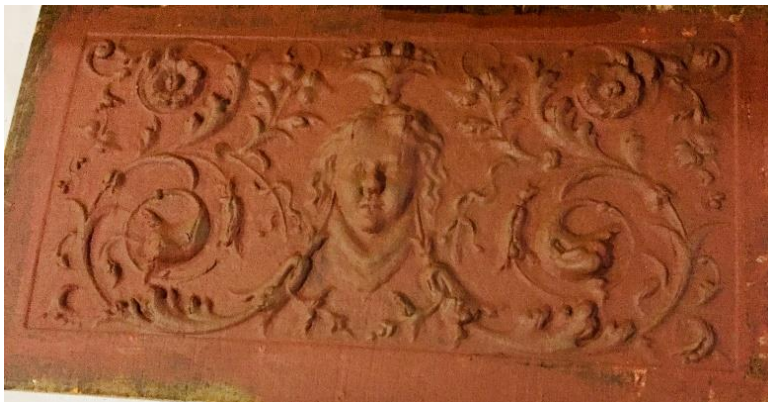
The sanded and painted panel reveals the decorative pattern.

from the background. After the paint was dried, the panel was covered with a coat of polyurethane. After the refurbished panels dried, they were replaced into the overmantel.

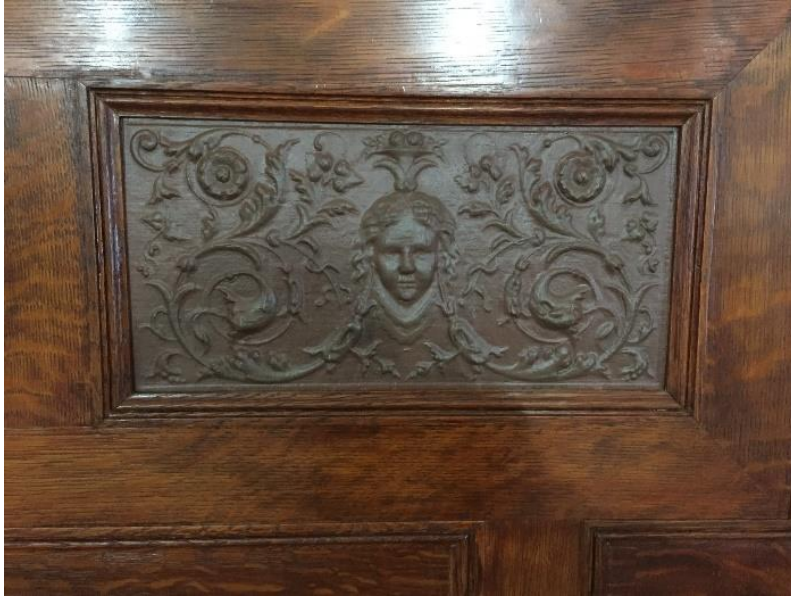
The varnished and restored panel placed back into the renovated overmantel.

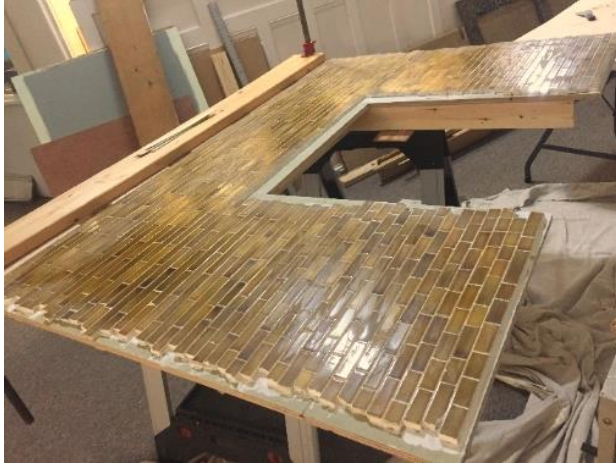
Fireplace surround tiles were adhered to the plywood. Note that some tiles were shorter than 6 inches toward the bottom of the surround.

When the fireplace was in the Thompson building, amber glazed ceramic tiles (6 inches long, 1 inch wide) surrounded the fireplace insert. According to Caleb Hobbs, a local master tiler, the original brick fireplace was covered with cement. To adhere tiles to the cement, the tiles were soaked in water and then placed onto the wet cement. Removal of tiles revealed the cement, and some adhered tiles. Some tiles were broken during removal from the cement. These were cut into smaller tiles. Before the tiles were assembled into the pattern of the surround, each tile was cleaned and trimmed. In some cases, the cement adhered to the back and all four edges of a tile. For the exhibit, tiles were placed on $\frac{3}{4}$ -inch-thick plywood. First, the plywood was prepared with a coat of Laticrete Hydro Ban, to form a basis for the tile adhesive, TEC Super Flex, to adhere. Tiles were positioned to develop the pattern for the fireplace surround noted in the original fireplace. The area that was to be tiled received a coat of TEC adhesive and each tile was generously dabbed with the adhesive prior to being positioned on the prepared plywood. We estimated that over 700 tiles were needed to complete the pattern.

Unfortunately, many of the ceramic tiles were broken during removal necessitating adjustment of the final pattern. To establish the pattern, we started at the top center of the plywood with the 1" x 6" tiles and placed shorter tiles towards the bottom. When the tile placement was completed, the tiled surround rested for several days.

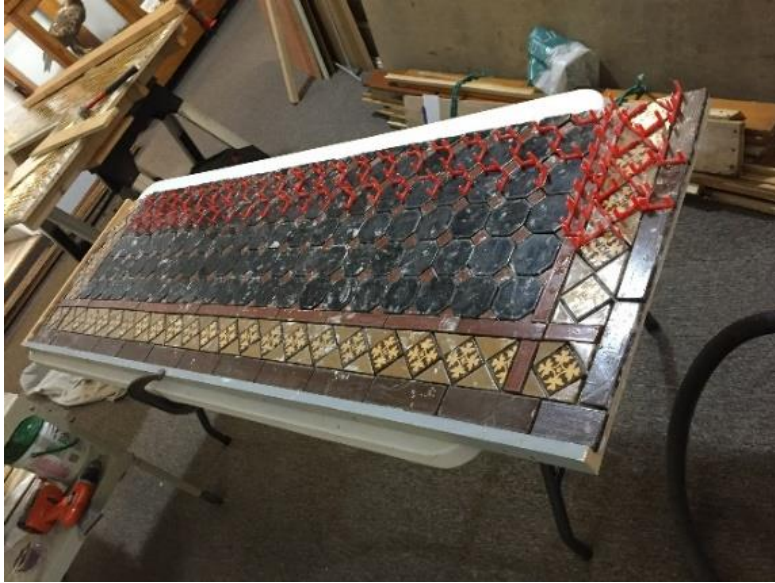
Hearth tiles placed on plywood prior to grouting. Note the red plastic spacers between some tiles.

Unlike the relative uniform characteristics of the fireplace surround tiles, the ceramic hearth tiles made by the US Encaustic Tile Company (Indianapolis, Indiana), were of several sizes and colors to form a distinct pattern. First tiles were cleaned and then positioned to determine placement. During this process, several tiles were determined to be missing necessitating the construction of substitute “tiles” out of wood, matching colors of the native tiles, and varnishing the tiles. To determine the size of the plywood platform needed, tiles were placed with spacers needed for grouting. Subsequently, the plywood was prepped with the Laticrete Hydro Ban, and let dry. Areas to be tiled were prepared with the adhesive TEC Super Flex and the bottom of each tile covered with the adhesive and placed on the plywood. Spacers were located where the grout would go. The spacers removed once the adhesive started to harden. After all tiles were placed on the hearth, they were dried for several days. Then the hearth was grouted with premixed gray Simple Grout, the tiles cleaned, and the completed hearth let dry.

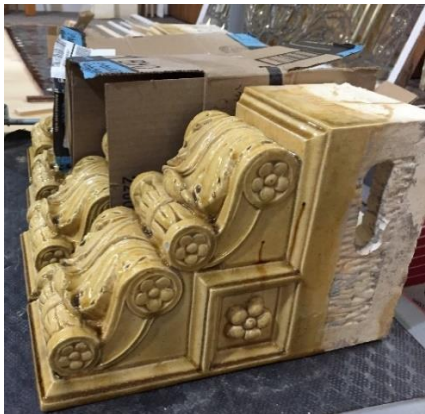
Note the many decorative elements in the cleaned corbels. The unglazed sections were anchored into holes above the fireplace surround tiles.

A unique feature of the Thompson house fireplace is its four large ceramic, amber glazed corbels that are ornamental mantel supports and compliment the colors of the fireplace surround tiles. In the Thompson house the corbels were held in place with cement. Most of the corbels are intact with just a few missing pieces. Unfortunately, when the fireplace was painted, paint got into the intricate corbel designs. To remove the paint, the corbels were soaked in sudsy water and much of the paint removed with a toothbrush, a small scraper, and dental picks. Holes in the plywood containing the fireplace surround tiles were used to help anchor the corbels. Because there were not enough tiles recovered to fill the area between the corbels, oak panels were treated like the mantel using the same stain and polyurethane coating and placed between the corbels.

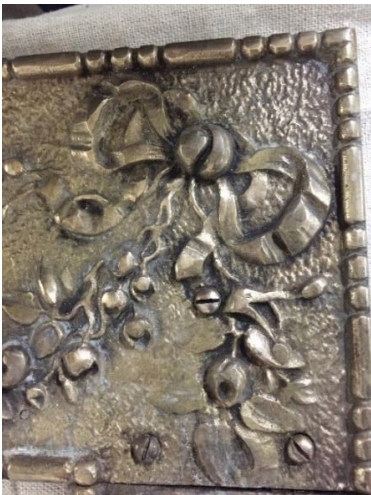
Details of the cleaned insert surround. Note that the screws were incorporated into the design.

The cast iron fireplace insert, which was used to burn wood and coal, and its bronze plated surround were made by the Peerless Manufacturing Company (Louisville, Kentucky) according to the name found in the inner part of the insert. The highly decorated surround needed to be cleaned to remove paint lodged in crevasses using the stripper gel, water, and a bronze brush. The pattern of the surround resembled that found in a surround in two of the fireplaces in the Cross house built in 1894 in Emporia, Kansas that is being restored by Ross MacTaggart

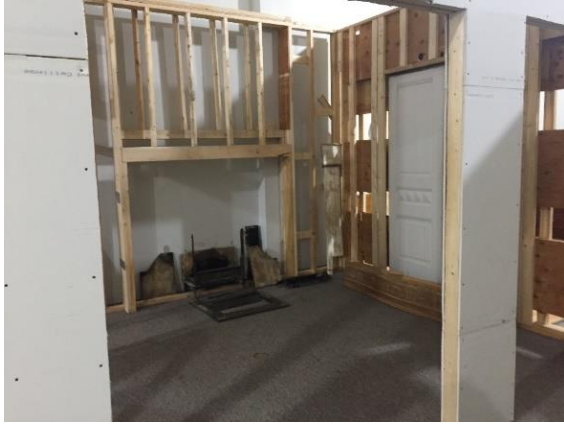
The supports for the fireplace mantel and overmantel with the fireplace insert shown in pieces.

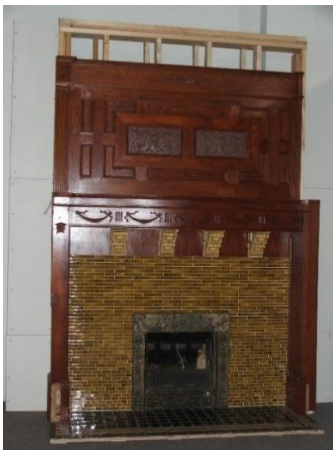
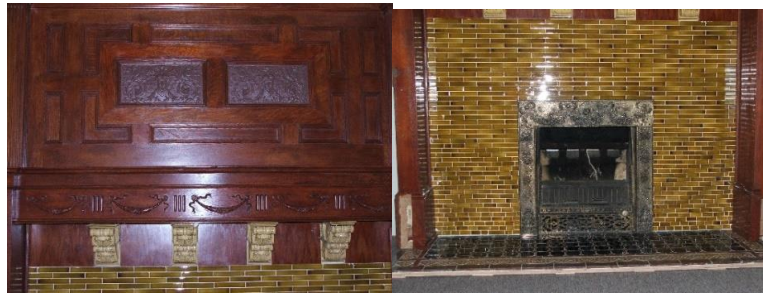
The entire restored fireplace with details of the mantel, overmantel, panels, corbels, fireplace and insert surrounds, insert, and the hearth.
