SOUTH DAKOTA STATE HISTORIC PRESERVATION OFFICE
HISTORIC SITES SURVEY STRUCTURE FORM

*ADDRESS: 30536 469th Ave.

HISTORIC FUNCTION: Livestock barn

TYPE: Livestock barn

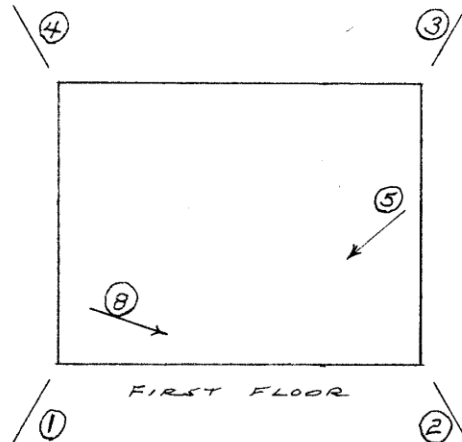
HAYLOFT

*PHYSICAL NOTES: Barn is in fair condition. The roof is leaking. Needs roof re-roofed and repairs
on the doors.
