SOUTH DAKOTA STATE HISTORIC PRESERVATION OFFICE
HISTORIC SITES SURVEY STRUCTURE FORM

*ADDRESS: 45894 Norway Street

HISTORIC FUNCTION: Draft horse barn

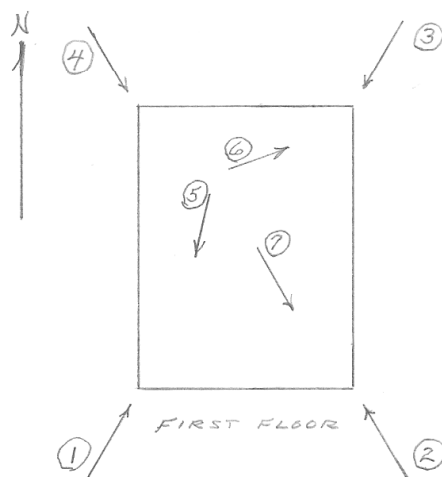
HAYLOFT

*PHYSICAL NOTES: Barn is in fair condition. The roof is leaking. Doors and windows need maintance.
Concrete foundation is cracked and spreading, needs replacing
