**SOUTH DAKOTA STATE HISTORIC PRESERVATION OFFICE  
HISTORIC SITES SURVEY STRUCTURE FORM**

\*SURVEY DATE: March 23, 2012 \*ADDRESS: 31494 453<sup>rd</sup> Ave.  
\*SURVEYOR: Jim Stone \*COUNTY: Clay  
\*CITY: Meckling

\*PROPERTY NAME: Johnsen, Calle Nissen / Hansen farmstead

SCALE - 1/8" = 1'-0" DANISH BRICK BARN  
31494 453RD AVE.  
MECKLING, SO. DAK.

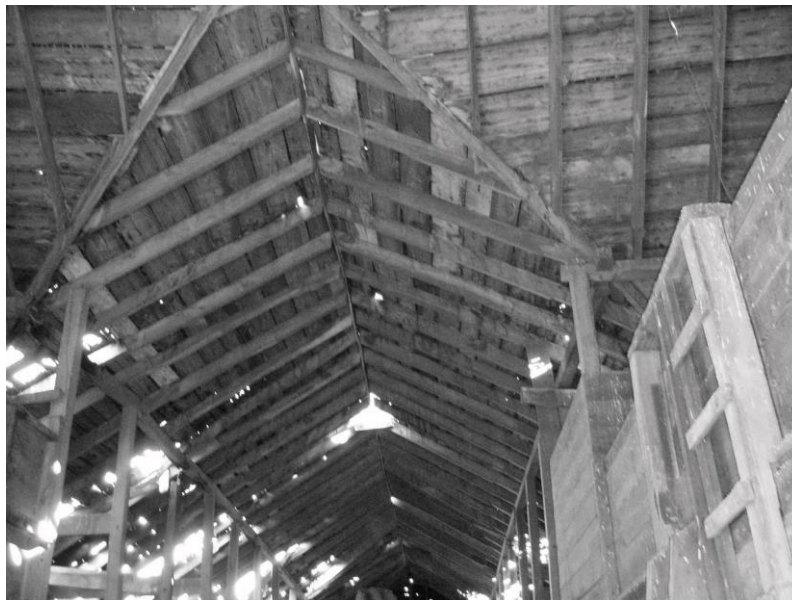
**ROLL NUMBER:** \_\_\_\_\_  
**PHOTO NUMBER:** 30

**\*PHYSICAL NOTES:** Barn is in very poor condition. Roof is rotted out on North side and some of the beams are rotting . East wall is bowed out about one half way up. Very ornate brick work with soldier brick arches over each window and a large brick arch doorway on West. This doorway is 12'-3" wide and 11' tall and has two doors 6'-6" wide which swing in. These doors are in good condition. There was no hay track to lift hay into the hayloft. There are three awning hayloft doors on the South and North sides and one on the East side. All of the hay had to be manually pitched up into the hayloft.

**CAMERA DIRECTION:** Looking East, roof framing at the intersection of the East and West wings and down the East wing.
