SITE INFORMATION

*SURVEY DATE:	, 2012	*ADDRESS: 31339 463rd Ave.										
*SURVEYOR:		*COUNTY:	Clay									
	*CITY:	Vermillion										
LOCATION DESCRIPTIO	N: Vermillio	n, from the inters	ection of Sout	th Dako	ta H	ighw	ay 5	0 bi-	pass	and		
South Dakota Highway 19, North 3 miles to 314 th Street, turn right (East) ½ mile to 463 rd Ave., turn left												
(North) about ¾ mile on the left (West) side. LEGAL DESCRIPTION: Andersen Tract 2, NE ¼, 26 – 93 – 52 Spirit Mound Twp.												
LEGAL DESCRIPTION:	Andersen T	ract 2, NE 1/4, 26	– 93 – 52 Spi	rit Mou	nd T	wp.						
*QUARTER 1: NE	≣ 1/4	OW	NER NAME:	l iea V		C						
			R ADDRESS:									
	·			Sioux City								
	52		•	lowa								
				51106

STRUCTURE DETAILS

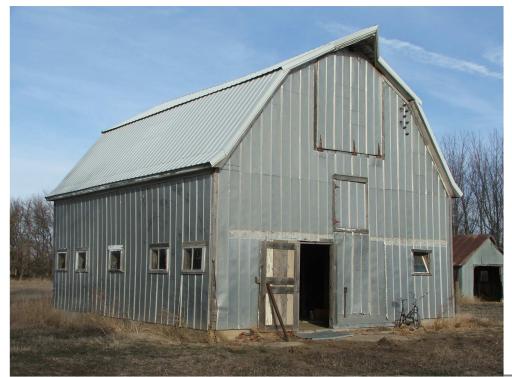
PHOTOGRAPHER: Jim Stone ROLL NUMBER: DATE OF PHOTO: December 5, 2012 PHOTO NUMBER: 2

CAMERA DIRECTION: Looking NW, SE corner
