**SOUTH DAKOTA STATE HISTORIC PRESERVATION OFFICE  
HISTORIC SITES SURVEY STRUCTURE FORM**

\*SURVEY DATE: March 10, 2014 \*ADDRESS: 30031 461<sup>st</sup> Ave.  
\*SURVEYOR: Jim Stone \*COUNTY: Clay  
\*CITY: Centerville

CURRENT FUNCTION: Vacant FOUNDATION: Poured Concrete  
 CURRENT SUBFUNCTION: Vacant ROOF MATERIAL: Steel roofing over cedar shingles  
 HISTORIC FUNCTION: Livestock barn ROOF SHAPE: Gable roof  
 HISTORIC SUBFUNCTION: Hay and grain storage STRUCTURAL SYSTEM: Balloon framing  
 OCCUPIED: no STYLE: Western feeder barn  
Yes with TYPE: Livestock barn  
 ACCESSIBLE: permission WALLS: 2x6 studs, 1x6 # 106 drop siding

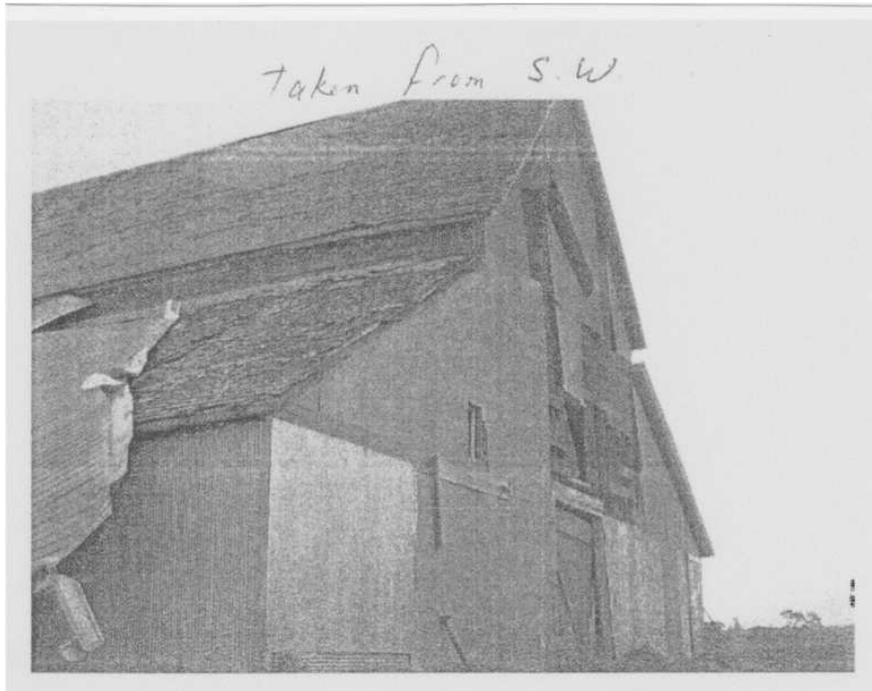
**ROLL NUMBER:** \_\_\_\_\_  
**PHOTO NUMBER:** 5

**CAMERA DIRECTION:** Looking NE, SW corner, before the barn burned down.

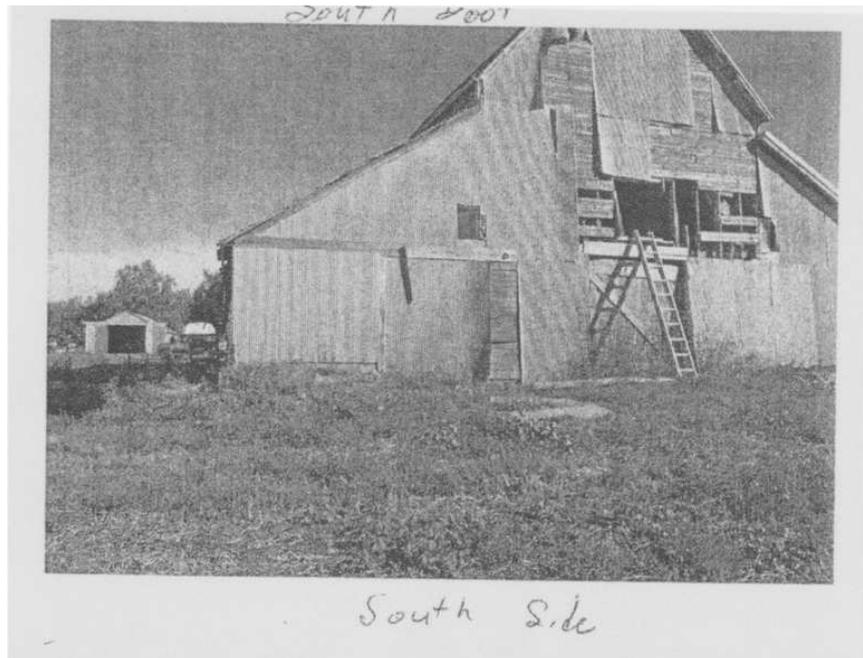
**ROLL NUMBER:** \_\_\_\_\_  
**PHOTO NUMBER:** 6

**CAMERA DIRECTION:** Looking North, before the barn burned down.

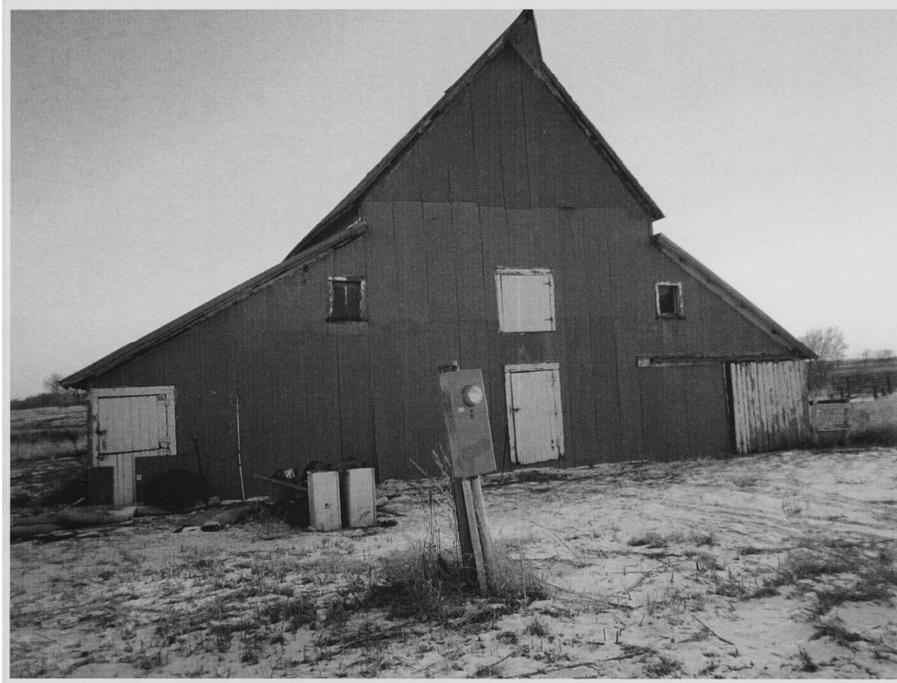
**ROLL NUMBER:** \_\_\_\_\_  
**PHOTO NUMBER:** 7

**CAMERA DIRECTION:** Looking South, North side, before the barn burned down.

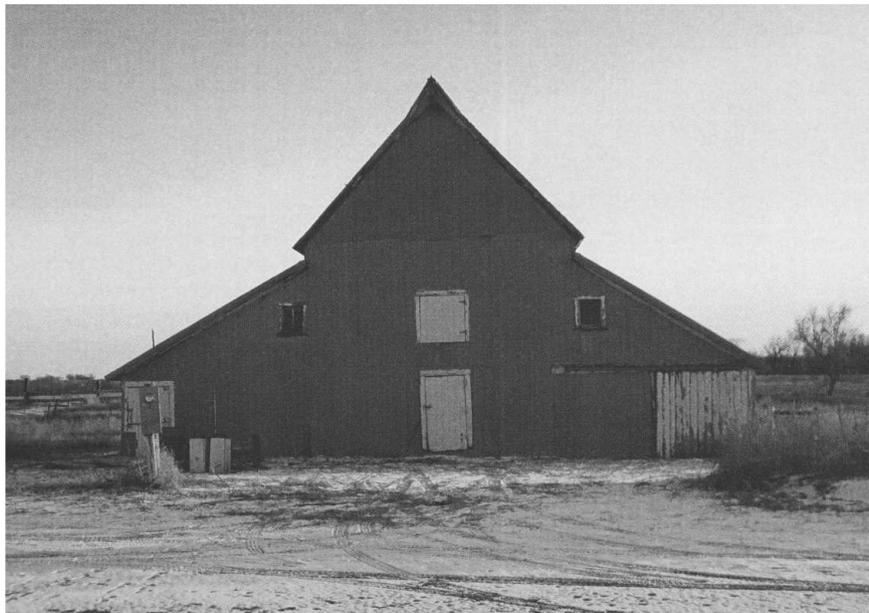
**ROLL NUMBER:** \_\_\_\_\_  
**PHOTO NUMBER:** 8

**CAMERA DIRECTION:** Looking South , North side, before the barn burned down.

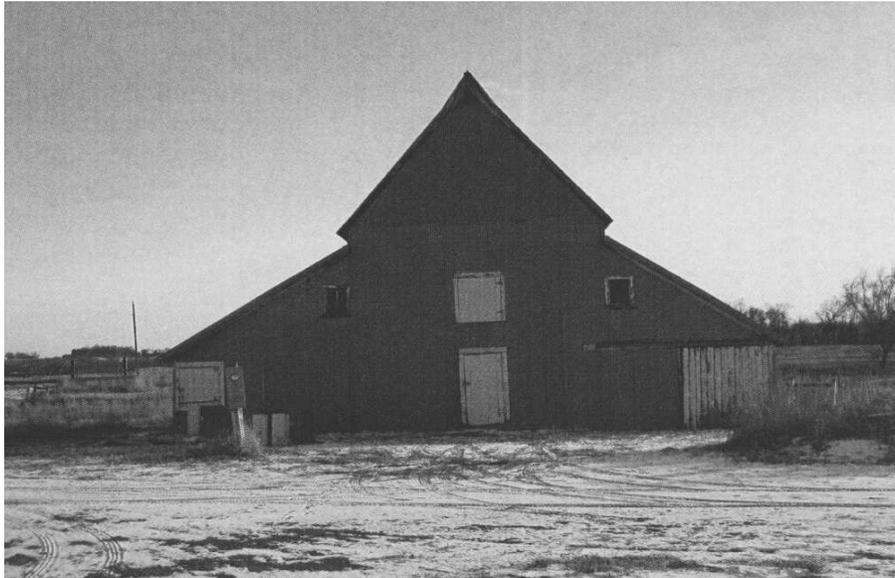
**ROLL NUMBER:** \_\_\_\_\_  
**PHOTO NUMBER:** 9

**CAMERA DIRECTION:** Looking South, North side, before the barn burned down.

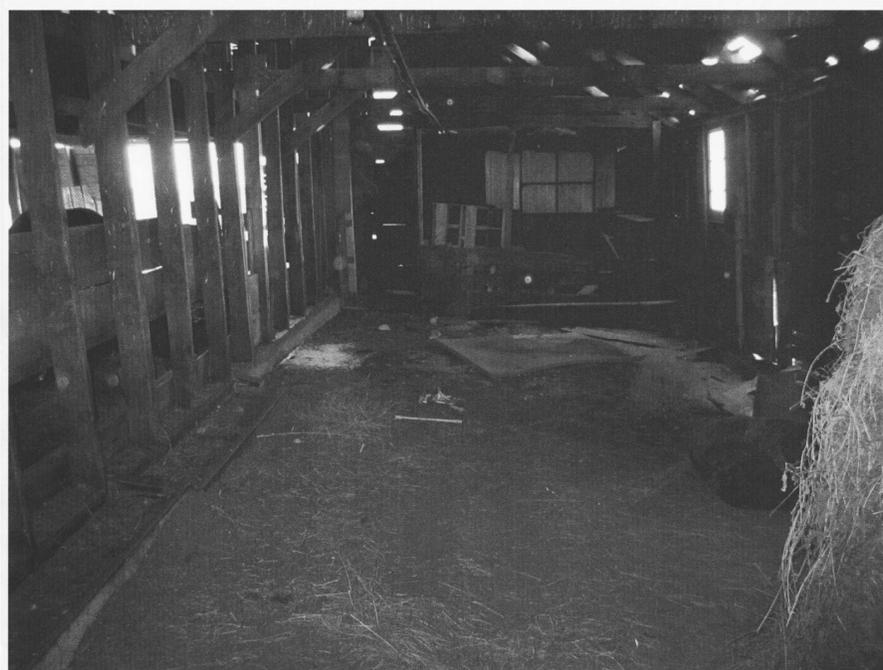
**ROLL NUMBER:** \_\_\_\_\_  
**PHOTO NUMBER:** 10

**CAMERA DIRECTION:** First floor, center area of barn, looking North, before the barn burned down.
