SITE INFORMATION				
*SURVEY DATE: August 12,	2013 *ADDRESS: 30533 457 <sup>th</sup> Ave.			
*SURVEYOR:Jim Stone	*COUNTY: Clay			
	*CITY: Wakonda			
LOCATION DESCRIPTION: From Vermillion, intersection of South Dakota Highway 50 bi-pass and				
South Dakota Highway 19, North about 11 miles to 306th Street, turn left (West) about 5 miles to 457th Ave.,				
turn right, (North) about 3/4 mile, on the left (West) side.				
LEGAL DESCRIPTION: SE 1/4, NE 1/4, 14 – 94 – 53 Bethel Twp.				
*QUARTER 1: <u>NE 1/4</u>	OWNER NAME: Donald H. & Janice D. Lyso			
*QUARTER 2:	OWNER ADDRESS: 30520 458th Ave.			
*TOWNSHIP: Bethel	OWNER CITY: Wakonda			
*RANGE:53	OWNER STATE: South Dakota			
*SECTION:14	OWNER ZIP: <u>57073</u>			
ACRES: 40.24	QUAD NAME:			
OWNER CODE 1: P				
OWNER CODE 2:				
OWNER CODE 3:				
LISTODIC SIGNIFICANCE				
HISTORIC SIGNIFICANCE				
*DOE: REGISTER NAME:				
*DOE DATE:	MULTIPLE PROPERTY NAME:			
REASON INELIGIBLE:

SHPO ID:				
*PROPERTY NAME:				
OTHER NAME:				
CURRENT FUNCTION:	Vacant	FOUNDATION:	Poured concrete	
CURRENT CURFUNCTION.	Vocant	DOOF MATERIAL	Asphalt shingles over	
CURRENT SUBFUNCTION:	Vacant	ROOF MATERIAL:		
HISTORIC FUNCTION:	Livestock barn	ROOF SHAPE	-	
H

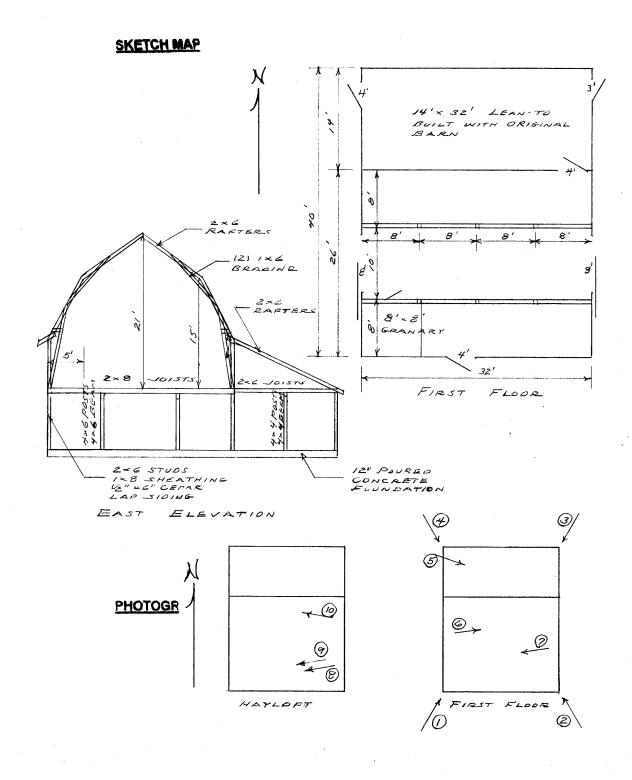
8' x8' granary still in the SW corner. One row 4x4 posts, 8' O. C., with 4x4 beam supporting 2x6 floor joists,				
4' O. C., in North lean-to.				
OTHER NOTES: 2x6 stud walls with 1x8 #1x6 drop siding and ½"x6" cedar lap siding. Rafters are 2x6's				
with 2x6 bracing at the roof hip. A 2x6 brace from the center of lower rafter down to hayloft wall at the				
floor level. This bracing is 2' O. C., which is very unusual. Windows were 8" x10" four light over 8"x 10"				
four light, double hung. No cupola. 14' x 32' lean-to on the North appears to have been built at the same				
time as the barn. 2x6 studs, 2x6 rafters and bracing, 2x8 floor joists, 4x6 posts and roof sheathing are all rough sawn cottonwood.				
*PHYSICAL				
	n fair condition.	*RESTRICTED: Y	or N	
*UTM EASTING:				
*UTM NORTHING:
