""SITE INFORMATION				
*SURVEY DATE: June 26, 2013	*ADDRESS: 45450 299th Street			
*SURVEYOR: Jim Stone	*COUNTY: Clay			
-	*CITY: Irene			
LOCATION DESCRIPTION: From Vermillion, the intersection of South Dakota Highway 50 bi-pass and				
South Dakota Highway 19, North 15 miles to 302 <sup>nd</sup> Street, turn left (West) about 7 miles, turn right (North)				
3 miles to 299th Street, turn left (West) about ¼ mile on the right (North) side.				
LEGAL DESCRIPTION: SE ¼, 9 – 95 – 53 Star Twp.				
*QUARTER 1: SE 1/4	OWNER NAME: Charles T. & Suzanne Stockland			
	NER ADDRESS: 45327 299th Street			
*TOWNSHIP: Star	OWNER CITY: Irene			
*RANGE: 53	OWNER STATE: South Dakota			
*SECTION: 9	OWNER ZIP: 57037			
ACRES: 163.89	QUAD NAME:			
OWNER CODE 1: P				
OWNER CODE 2:				
OWNER CODE 3:				
HISTORIC SIGNIFICANCE				
*DOE:	REGISTER NAME:			
*DOE DATE:	MULTIPLE PROPERTY NAME:			
REASON INELIGIBLE:				
MEAGON INCLIGIBLE.

#### STRUCTURE DETAILS

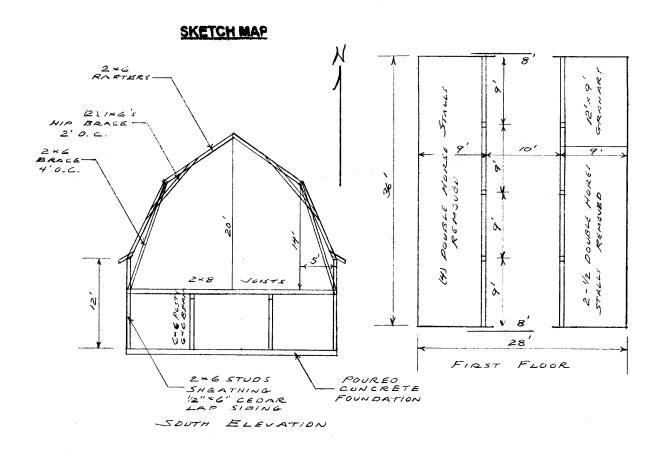
C. (2) 1x6 braces on each hip, 2' O. C. Windows are 8" x 10" four light on the first floor and 8"x 10" four				
light over 8"x 10" four light in the hayloft. Very ornate cupola from the 19-teens.				
*PHYSICAL NOTES: Barn is in fair condition. Needs new roof.				
*UTM ZONE:		*RESTRICTED: Y o	r N	
*UTM EASTING:				
*UTM NORTHING:
