SITE INFORMATION

STRUCTURE DETAILS									
SHPO ID:									
*PROPERTY NAME:		•							
OTHER NAME:									
O THER TO MILE									
			Native rock						
CURRENT FUNCTION:	Vacant	FOUNDATION:	mortared						
CURRENT SUBFUNCTION:		ROOF MATERIAL:	Cedar shingles						
HISTORIC FUNCTION:	Livestock barn	ROOF SHAPE:	Gambrel						
HISTORIC SUBFUNCTION:	Hay and grain storage	STRUCTURAL SYSTEM:	Balloon framing						
		STYLE:	Gambrel roof barn						
OCCUPIED:	No	TYPE:	Livestock barn						
			2x6 & 2x10,						
400500IDI 5	Yes with	WALL 0	sheathing & ½" x						
ACCESSIBLE:	permission	WALLS:	6" cedar lap siding

•						
STORIES:		SIGNIFICANT PERSON:							
*DATE OF CONSTRUCTION:	<u>1915 to 1925</u> CU	LTURAL AFFILIATION:	?						
ALTERED/MOVED NOTES: Original site. Horse stalls and milk cow stanchions have been removed.									
INTERIOR NOTES. Contactive news Coloniate and Colonian Colonia Colonian Colonia Colonian Colonia Colonian Colonia Colo									
INTERIOR NOTES: Center two rows 6x6 posts and 6x8 beams. Outer two rows of 6x6 posts and 6x6									
beams in the North 28'. South 46' has four rows 6x6 posts and (4) 2x10's laminated for beams.									
2x6 wall with solid diagonal sheathing di

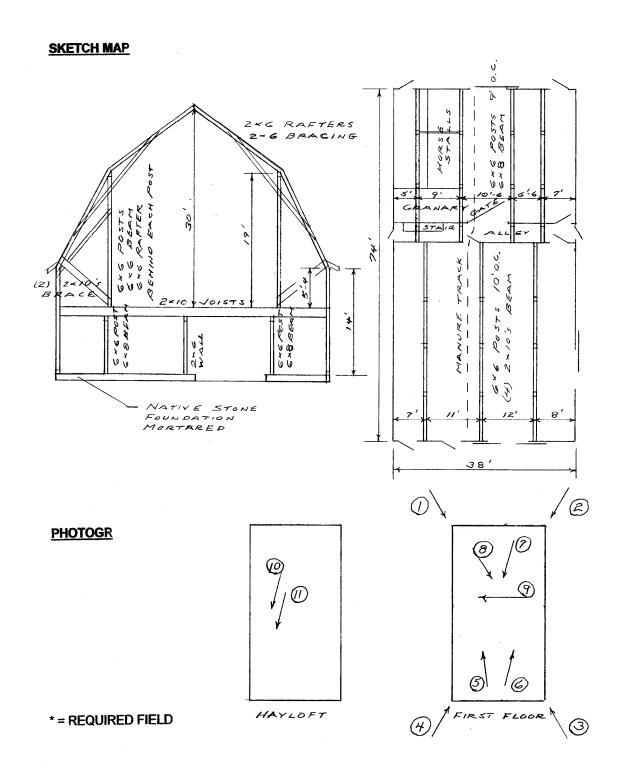
6x6 rafter down to bottom of 6x6 posts. Also a 2x6 brace from the bottom of the 6x6 rafter up to the top									
of the 6x6 post. 8"x10" four light windows over 8"x10" four light windows double hung for ventilation.									
*PHYSICAL NOTES: Metal cupola. Barn is in good condition. Doors on first floor need some repair									
and some windows need replacing. Cedar shingles on roof are in very good condition. ½ x6" cedar lap									
siding is in good condition, but should be painted.									
<u> </u>	<u>.</u>
