SITE INFORMATION

STRUCTURE DETAILS

SHPO ID:										
*PROPERTY NAME:										
OTHER NAME:										
CURRENT FUNCTION:	Cattle and calving barn	FOUNDATION:	Poured concrete foundation							
CURRENT SUBFUNCTION:	Storage	ROOF MATERIAL:	Steel roofing over cedar shingles							
HISTORIC FUNCTION:	Livestock barn	ROOF SHAPE:	Gambrel							
HISTORIC SUBFUNCTION:	Hay storage	STRUCTURAL SYSTEM:	Balloon framing							
		 STYLE:	Gambrel roof barn							
OCCUPIED:	Yes	TYPE:	Livestock barn							
ACCESSIBLE:	Yes with permission	WALLS:	2x6 studs & 2x8 studs with sheathing and ½"x6" cedar drop siding

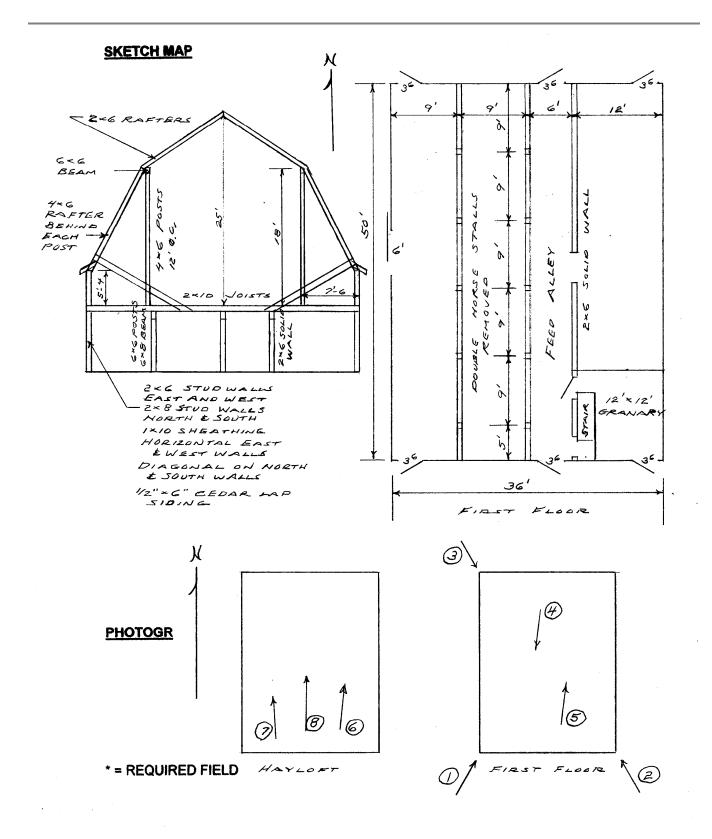
PHOTOGRAPHER: Jim Stone ROLL NUMBER:
DATE OF PHOTO: November 17, 2012 PHOTO NUMBER: 1
CAMERA DIRECTION: Looking NE, SW corner

supporting floor joists have a special scarf joint. Windows are 8"x10" four light over 8"x10" four light.										
Has two very ornate metal cupola's.										
*PHYSICAL NOTES: Barn is in good condition. Very straight and plumb because of 2x8 stud walls on										
gable ends and the diagonal sheathing. Needs some repairs on doors and windows.										
*UTM ZONE:		*RESTRICTED: Y o	r N							
*UTM EASTING:		RESTRICTED. 1 0	ı 14							
*UTM NORTHING:										
5 : III 11011 I I III 10.
