**SOUTH DAKOTA STATE HISTORIC PRESERVATION OFFICE
HISTORIC SITES SURVEY STRUCTURE FORM**

*SURVEY DATE: January 8, 2013 *ADDRESS: 46913 303rd Street
*SURVEYOR: Jim Stone *COUNTY: Clay
*CITY: Beresford

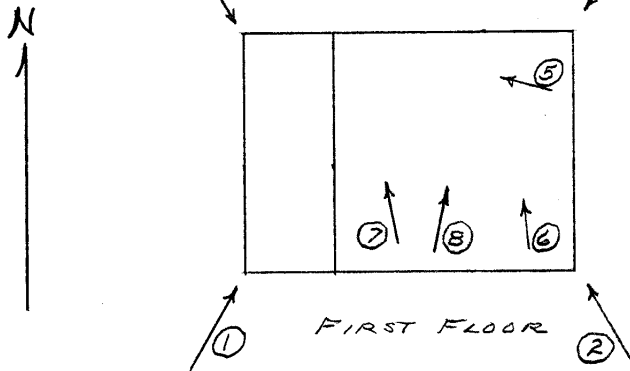
***PHYSICAL NOTES:** Barn is in very poor condition. Roof is leaking and rotting the hayloft floor. Barn is leaning a lot. Next bad windstorm will push this barn down. Note no pictures in the hayloft. As I attempted to climb the ladder up into the hayloft the 1x4 rungs came off the wall studs. I decided that is probably was not a good idea to attempt to get up into the hayloft!
