**SOUTH DAKOTA STATE HISTORIC PRESERVATION OFFICE
HISTORIC SITES SURVEY STRUCTURE FORM**

*SURVEY DATE: July 8, 2013 *ADDRESS: 30149 456th Ave.
*SURVEYOR: Jim Stone *COUNTY: Clay
*CITY: Wakonda

CURRENT FUNCTION:	<u>Calving barn</u>	FOUNDATION:	<u>Poured concrete</u>
CURRENT SUBFUNCTION:	<u>Storage</u>	ROOF MATERIAL:	<u>Steel roofing over cedar shingles</u>
HISTORIC FUNCTION:	<u>Horse barn</u>	ROOF SHAPE:	<u>Gable roof</u>
HISTORIC SUBFUNCTION:	<u>Hay and grain storage</u>	STRUCTURAL SYSTEM:	<u>Balloon framing</u>
OCCUPIED:	<u>Yes</u>	STYLE:	<u>Western feeder barn</u>
ACCESSIBLE:	<u>Yes with permission</u>	WALLS:	<u>Livestock barn</u>
			<u>2x4 studs, 1x6 #106 drop siding and steel roofing.</u>
STORIES:	<u>2</u>	SIGNIFICANT PERSON:	<u>Alvin L. Haver</u>
*DATE OF CONSTRUCTION:	<u>1890's</u>	CULTURAL AFFILIATION:	<u>Irish</u>

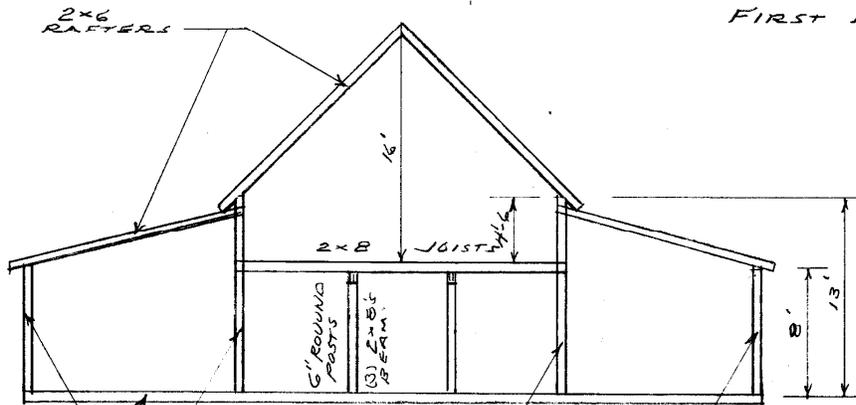
FIRST FLOOR

INTERIOR NOTES: Two rows of 6x6 posts, and (3) 2x8 for beams support the 2x8 joists for the hayloft floor.

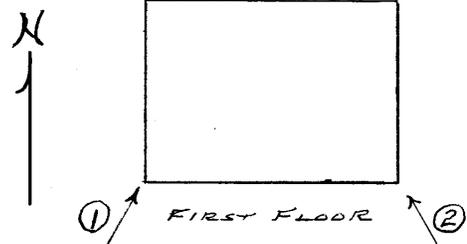
- 2x4 STUDS
 - 1x6 #102
 - DROP SIDING
 - POURED CONCRETE FOUNDATION
- EAST ELEVATION**

OTHER NOTES: 2x4 stud walls, 1x6 #106 drop siding and horizontal steel roofing. Rafters are 2x6's in main barn and lean-to's. Owner did not remember any bracing in hayloft. Windows are 4"x24" four light. Original cupola was wooden, which dates the barn before 1900.

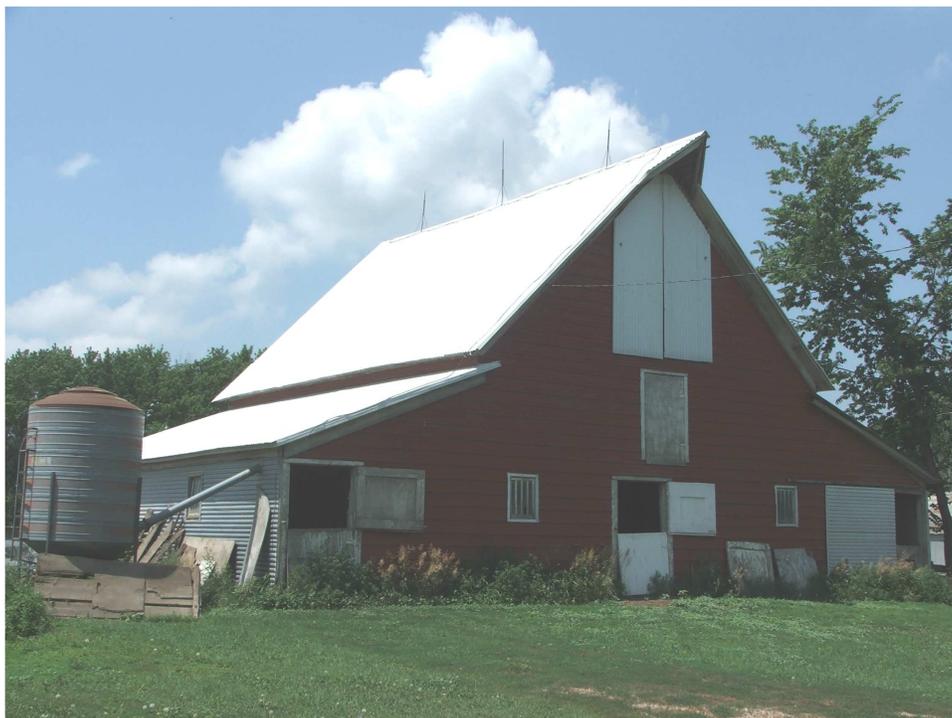
ROLL NUMBER: _____
PHOTO NUMBER: 1
CAMERA DIRECTION: Looking NW, SE corner

ALTERED/MOVED NOTES: Original site. All evidence of horse stalls and milk cow stanchions has been removed. Roof has been covered with steel roofing. Walls have been covered with horizontal steel roofing. Lean-to/s appear to have been built with original barn. Cupola is gone.

*PHYSICAL NOTES: Barn is in good condition.
