**SOUTH DAKOTA STATE HISTORIC PRESERVATION OFFICE  
HISTORIC SITES SURVEY STRUCTURE FORM**

\*SURVEY DATE: November 27, 2012 \*ADDRESS: 46470 303<sup>rd</sup> Street  
\*SURVEYOR: Jim Stone \*COUNTY: Clay  
\*CITY: Centerville

| HISTORIC FUNCTION: <u>Livestock barn</u> | ROOF SHAPE: <u>Gable</u> |

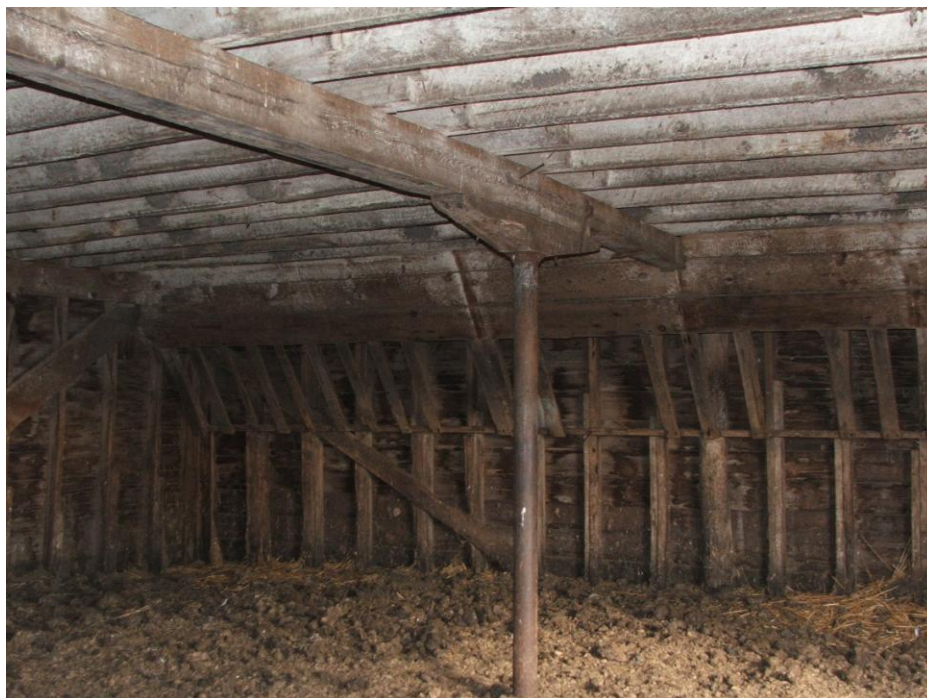
ALTERED/MOVED NOTES: Original site. Any evidence of milk cow stanchions or horse stalls has been removed. Roof has been shingled with asphalt shingles. Has been converted into a barn for cattle. Has hay feed racks on the East and West walls to feed cattle in bad weather. There are trap doors in hay-loft floor to lift up to fill hay feed racks below and then close to retain heat.

**ROLL NUMBER:** \_\_\_\_\_  
**PHOTO NUMBER:** 5  
**CAMERA DIRECTION:** First floor, looking East,  
Feed rack on East wall

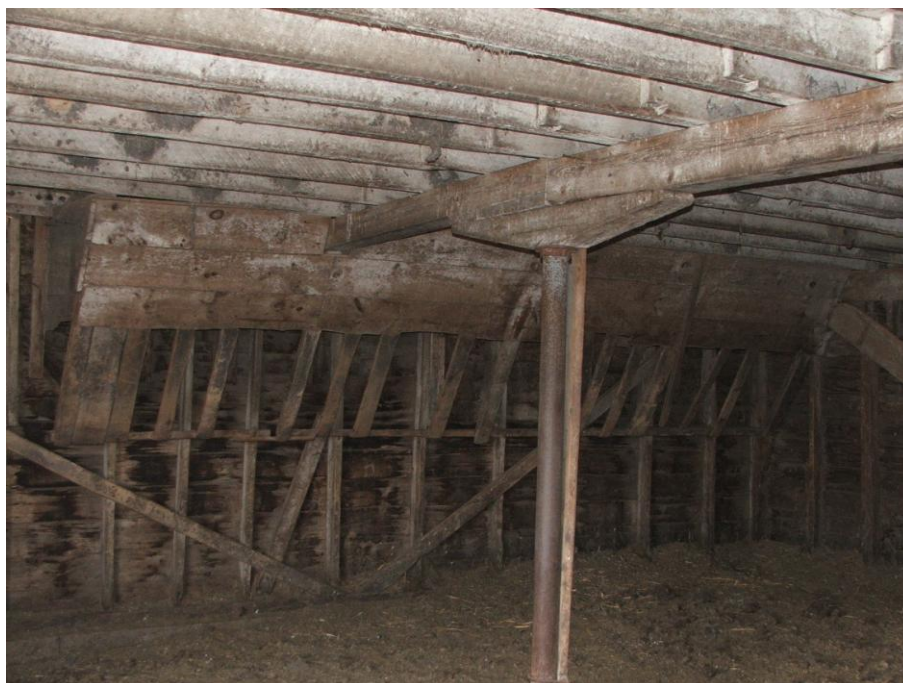
**ROLL NUMBER:** \_\_\_\_\_  
**PHOTO NUMBER:** 6  
**CAMERA DIRECTION:** First floor, looking West,  
feed rack on West wall.

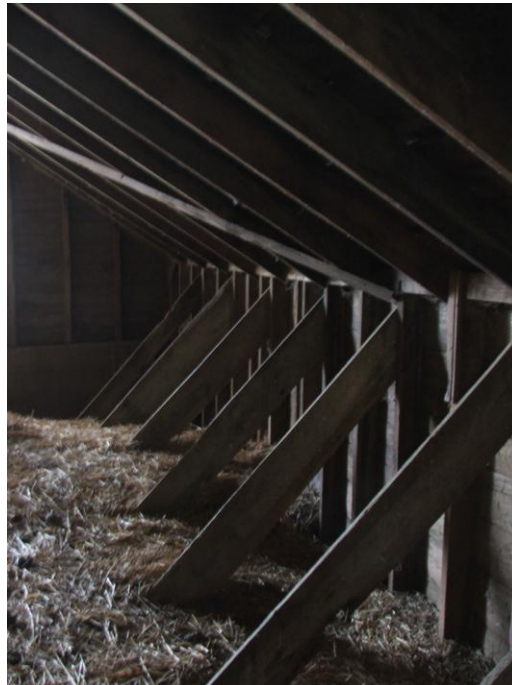
**ROLL NUMBER:** \_\_\_\_\_  
**PHOTO NUMBER:** 7

OTHER NOTES: 2x4 stud walls with 1x6 #106 drop siding. Rafters are 2x6's. 1x8 bracing from top of wall in hayloft down to floor joists, 4' O.C. Has two galvanized metal ventilators on ridge of roof. Windows are 8"x10" four light over 8"x10" four light in the East gable end. The balance of windows are 8"x10" four light.

**CAMERA DIRECTION:** Hayloft, looking East,  
2x6 rafters and 1x8  
bracing 4' O.C.

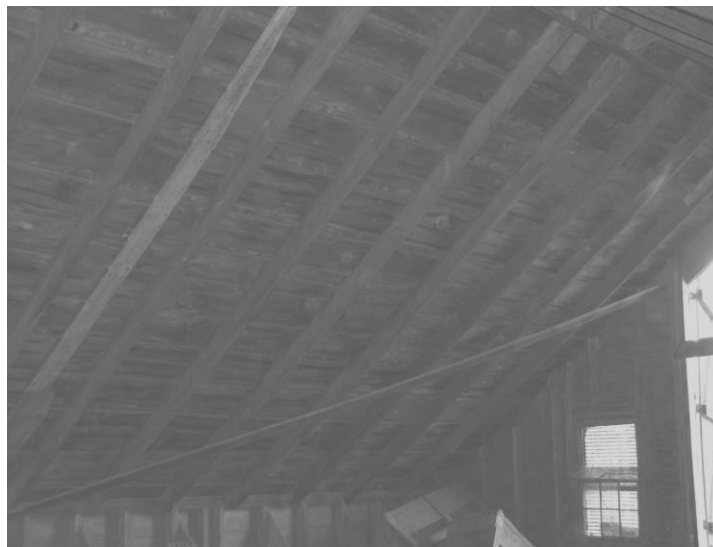
**ROLL NUMBER:** \_\_\_\_\_  
**PHOTO NUMBER:** 8

**CAMERA DIRECTION:** Hayloft, looking NE,  
rafters and diagonal  
bracing on bottom of  
rafters .
