SOUTH DAKOTA STATE HISTORIC PRESERVATION OFFICE
HISTORIC SITES SURVEY STRUCTURE FORM

*ADDRESS: 45630 Iverson Place

SHPO ID: _____			
*PROPERTY NAME: _____			
OTHER NAME: _____			
CURRENT FUNCTION: <u>Horse barn</u>	FOUNDATION: <u>Poured concrete</u>		
CURRENT SUBFUNCTION: <u>Storage</u>	ROOF MATERIAL: <u>Cedar shingles</u>		
HISTORIC FUNCTION: <u>Livestock barn</u>	ROOF SHAPE: <u>Gambrel</u>		
HISTORIC SUBFUNCTION: <u>Hay and grain storage</u>	STRUCTURAL SYSTEM: <u>Balloon framing</u>		
	STYLE: <u>Gambrel roof barn</u>		
OCCUPIED: <u>Yes</u>	TYPE: <u>Livestock barn</u>		
	<u>2x6, sheathing &</u>		
ACCESSIBLE: <u>Yes with</u>	<u>1x12 vertical siding</u>		
<u>permission</u>	WALLS: <u>with battens.</u>		
STORIES: <u>2</u>		SIGNIFICANT PERSON: <u>Art Iverson</u>	
*DATE OF CONSTRUCTION: <u>Early 1900's</u>		CULTURAL AFFILIATION: <u>Norwegian</u>

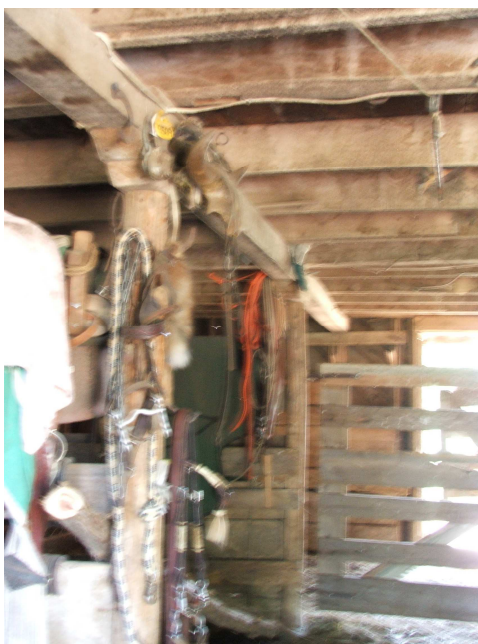
ROLL NUMBER: _____
PHOTO NUMBER: 4
CAMERA DIRECTION: First floor, looking West,
stalls on North wall

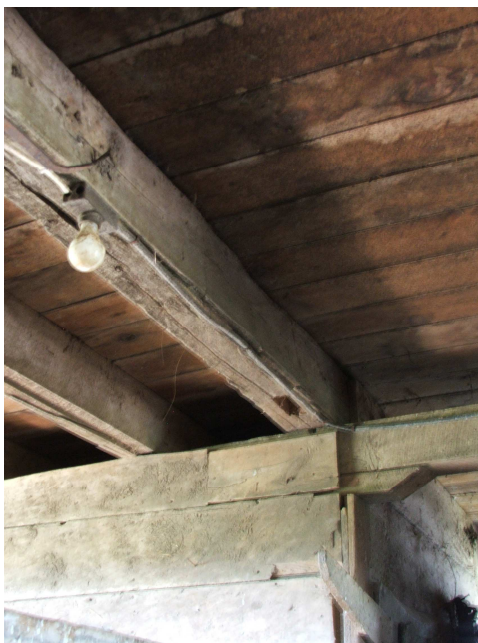
ROLL NUMBER: _____
PHOTO NUMBER: 5

INTERIOR NOTES: Has two rows 6x6 posts and 6x6 beams to support hayloft floor. Joists were 2x8. All of the 2x6's for studs, rafters and bracing, 2x8 floor joists, 6x6 posts and 6x6 beams were rough sawn cottonwood. There are four hand hewn cottonwood beams running North to South above the lower beams. These beams have mortise's, which suggest they were from the original barn. There are eight hand hewn 6x6 posts that support the ends of these beams. The posts also have mortise's.

Looking North, Re-
cycled hand hewn beam
possibly from original
barn

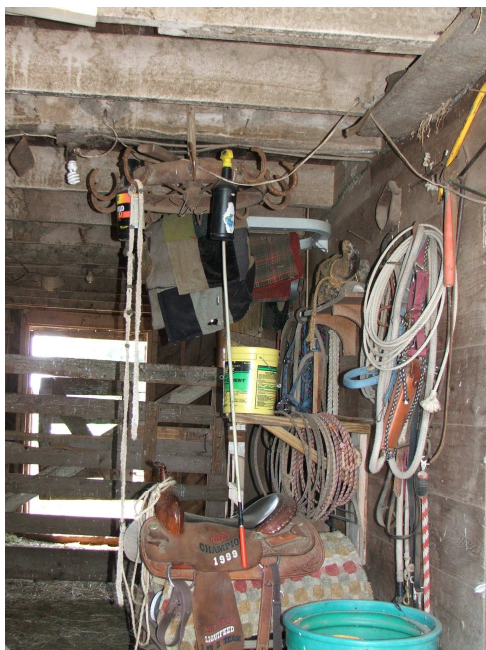
ROLL NUMBER: _____
PHOTO NUMBER: 6

First floor, looking West,
horse stalls on South
wall .

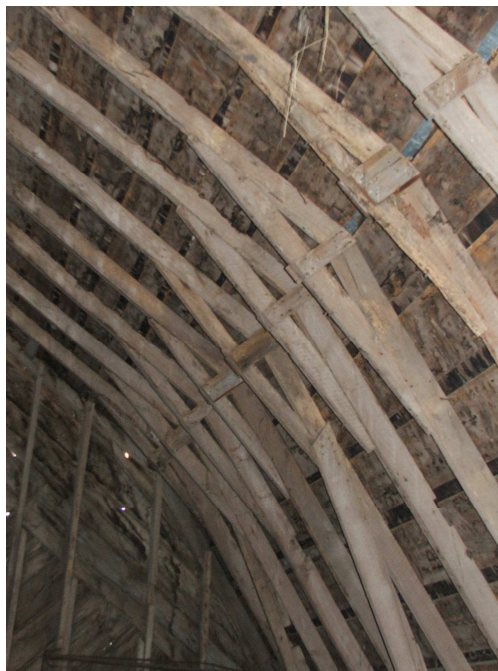
ROLL NUMBER:
PHOTO NUMBER: 7

OTHER NOTES: Windows were 9"x12" four light. Walls have diagonal sheathing with 1x12 vertical board and batten siding, except the East wall that has been replaced with 1x6 #106 drop siding. Rafters are 2x6 with 2x6 bracing for a modified braced rafter system.

CAMERA DIRECTION: Hayloft, looking West,
rafters and bracing.

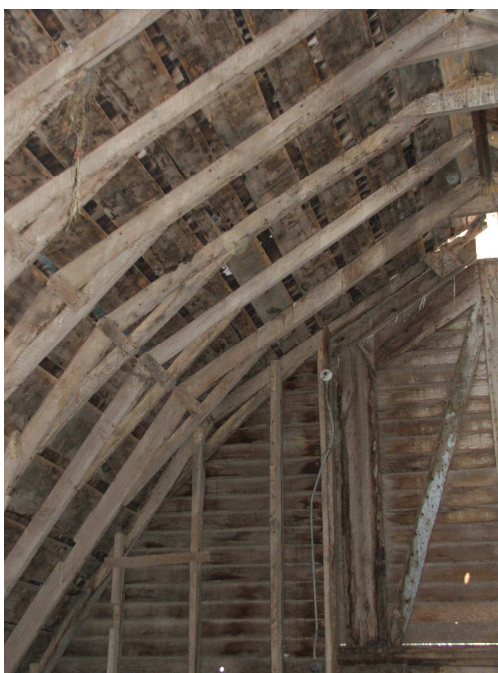
ROLL NUMBER:
PHOTO NUMBER: 8

ALTERED/MOVED NOTES: Original site. Siding and sheathing have been removed from the East gable wall and replaced with 1x6 Pattern 106 drop siding. The North wall has 1/2"x6" cedar lap siding over the sheathing. Some of the 6x6 posts have been replaced with round posts.

CAMERA DIRECTION: Hayloft, looking East,
rafters, bracing and East
gable wall.
