SOUTH DAKOTA STATE HISTORIC PRESERVATION OFFICE
HISTORIC SITES SURVEY STRUCTURE FORM

*ADDRESS: 46849 S. D Hwy. 46
*COUNTY: Clay
*CITY: Beresford

CURRENT FUNCTION: <u>Vacant</u>	FOUNDATION: <u>Poured concrete</u> <u>Asphalt shingles</u> <u>over cedar</u> <u>shingles</u>
CURRENT SUBFUNCTION: <u>Vacant</u>	ROOF MATERIAL: <u>shingles</u>
HISTORIC FUNCTION: <u>Dairy barn</u>	ROOF SHAPE: <u>Gable</u>
HISTORIC SUBFUNCTION: <u>Hay and grain storage</u>	STRUCTURAL SYSTEM: <u>Balloon framing</u> <u>Western feeder</u> <u>barn</u>
OCCUPIED: <u>Yes</u>	STYLE: <u>barn</u>
ACCESSIBLE: <u>Yes with</u> <u>permission</u>	TYPE: <u>Livestock barn</u> <u>2x4 studs, 1x6</u> <u>#106 drop siding</u>
STORIES: <u>2</u>	WALLS: _____
*DATE OF CONSTRUCTION: <u>Early 1900's</u>	SIGNIFICANT PERSON: <u>August Soderstrom</u>
	CULTURAL AFFILIATION: <u>Swedish</u>

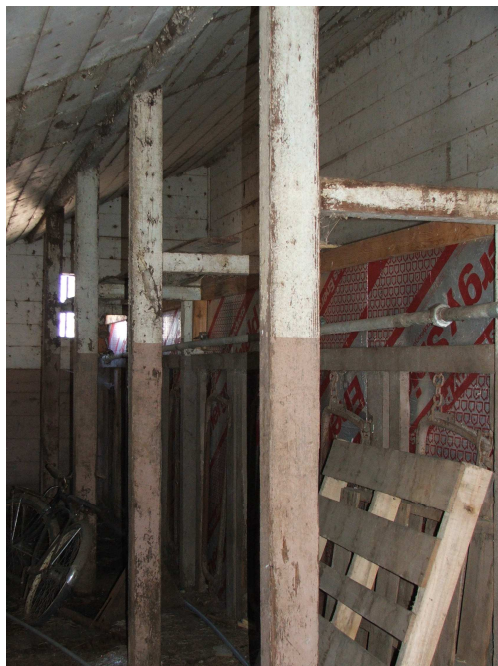
ROLL NUMBER: 5
PHOTO NUMBER: 5

INTERIOR NOTES: The original barn has two rows of posts and 4x4 for a beams. The posts have been
removed and replaced with steel pipe posts. The floor joists for the hayloft floor are 2x8's.
Milk cow stanchions are still in place in West lean-to. Gutters in the main barn prove that there were two
rows of milk cow stanchions there also.

CAMERA DIRECTION: First floor, West lean-to, looking NE, milk cow stanchions still in place.

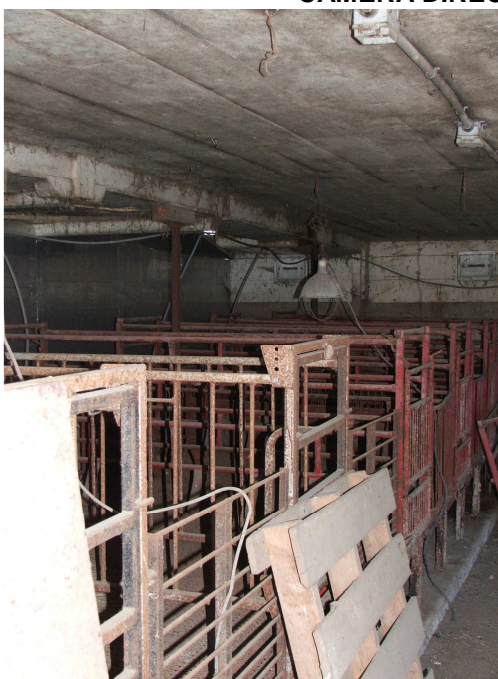
ROLL NUMBER: 6
PHOTO NUMBER: 6

ALTERED/MOVED NOTES: Original site. Any evidence of horse stalls and milk cow stanchions has
been removed, except in the West lean-to. Asphalt shingles over cedar shingles. The milk room has
been added. Double 2x6 posts added in hayloft to support center of rafters. Walls and ceiling are
covered when the barn was remodeled for farrowing hogs.

CAMERA DIRECTION: First floor, main barn, looking NW, remodeled for farrowing swine.

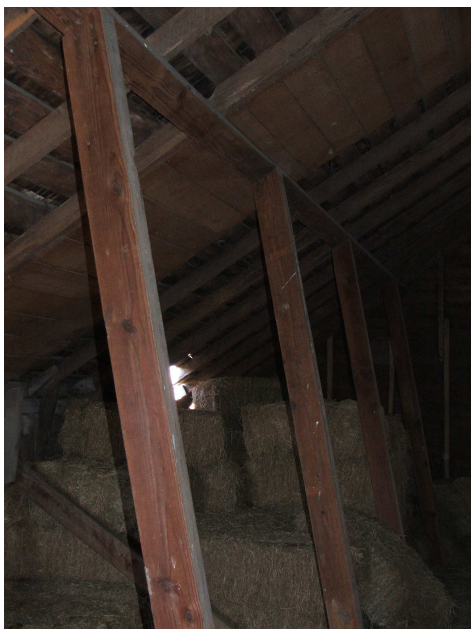
ROLL NUMBER: _____
PHOTO NUMBER: 7

OTHER NOTES: 2x4 stud walls with 1x6 #106 drop siding. The East and West walls of the main barn
are 2x4 studs with 1x8 shiplap. Double 2x6 posts in the hayloft to support center of rafters. These posts
are 4'-7'-7'-6'-5' -5' O. C. from the North wall. Rafters are 2x4's. All of the 2x4's, 2x6's and 2x8's are
Rough sawn cottonwood. Windows are 8"x10" four light. Metal cupola still in place.

CAMERA DIRECTION: Hayloft, looking NW,
double 2x6's supporting
center of rafters

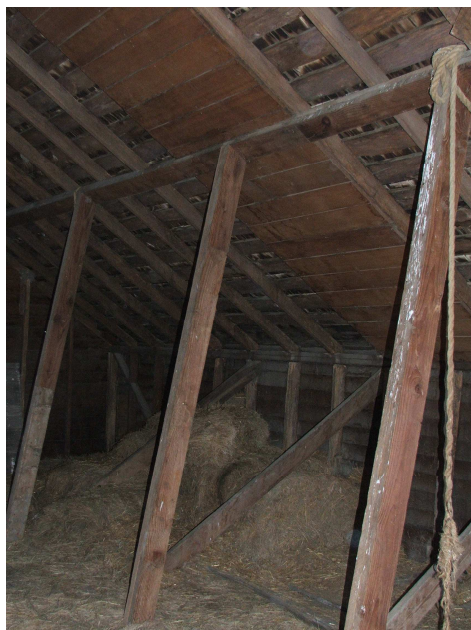
ROLL NUMBER: _____
PHOTO NUMBER: 8

CAMERA DIRECTION: Hayloft, looking NE,
Double 2x6 posts
supporting center of
rafters and 2x6 brace
from top of wall down to
floor
