**SOUTH DAKOTA STATE HISTORIC PRESERVATION OFFICE
HISTORIC SITES SURVEY STRUCTURE FORM**

*SURVEY DATE: October 28, 2012 *ADDRESS: 4235 East Main Street
*SURVEYOR: Jim Stone *COUNTY: Clay
*CITY: Vermillion

CURRENT FUNCTION: <u>Storage</u>	FOUNDATION: <u>Poured concrete foundation</u>
CURRENT SUBFUNCTION: <u>Storage</u>	ROOF MATERIAL: <u>Asphalt shingles over cedar shingles</u>
HISTORIC FUNCTION: <u>Livestock barn</u>	ROOF SHAPE: <u>Gothic round</u>
HISTORIC SUBFUNCTION: <u>Hay and grain storage</u>	STRUCTURAL SYSTEM: <u>Balloon framing</u>
	STYLE: <u>Gothic round roof barn</u>
OCCUPIED: <u>Yes</u>	TYPE: <u>Livestock barn</u>
	<u>2x6 stud, sheathing and 1/2"x6" cedar lap siding</u>
ACCESSIBLE: <u>Yes with permission</u>	WALLS: <u>lap siding</u>
STORIES: <u>2</u>	SIGNIFICANT PERSON: <u>Carrie L. Burgess</u>
*DATE OF CONSTRUCTION: <u>1920 to 1930</u>	CULTURAL AFFILIATION: <u>?</u>

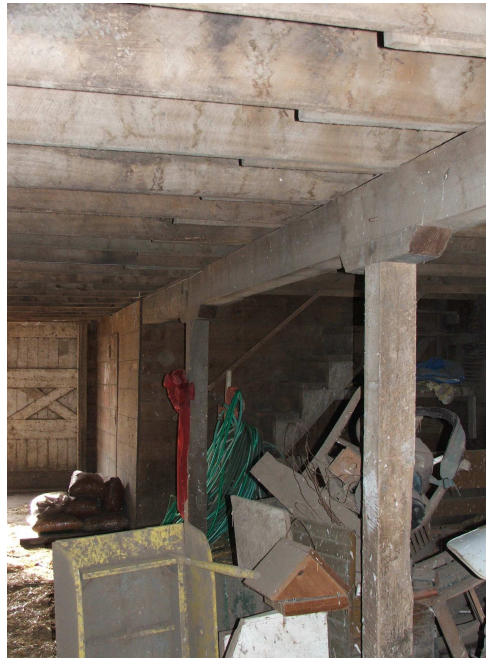
ROLL NUMBER: _____
PHOTO NUMBER: 5

INTERIOR NOTES: Has two rows of 6x6 posts with 6x10 for beams. 2x10 floor joists. Granary and feed room and stairs are still in place. Granary still in hayloft. All 2x6's, 2x10's, 6x6's, and 6 x10's are rough sawn cottonwood. Cottonwood lumber most likely came from saw mill on Wallace Cusick's farm by Burbank. Wallace Cusick was father of Harold Cusick.

**First floor, looking NW,
posts, 6x10 beam,
granary and stairs in the**

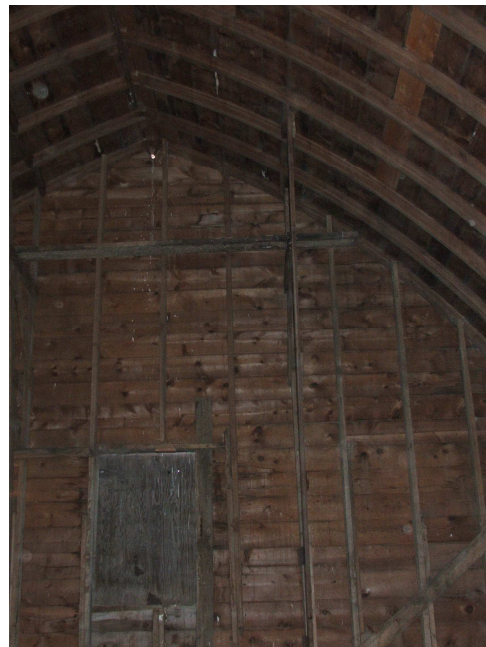
ROLL NUMBER: _____
PHOTO NUMBER: 6

OTHER NOTES: 2x6 stud walls with 1x8 sheathing and 1/2"x6" cedar lap siding. Rafters are six plies of 3/4"x 1-1/2" cedar. Rafters are manufactured and each rafter has a stamp M. Slagle Co. Elk Point, So. Dak. 1x10 sheathing on roof. Asphalt shingles over cedar shingles. 8"x10" four light windows on first floor. Has two 8"x10" six light windows in West wall of hayloft.

**Hayloft, looking East,
3/4" x 1-1/2" six ply cedar
manufactured rafters**

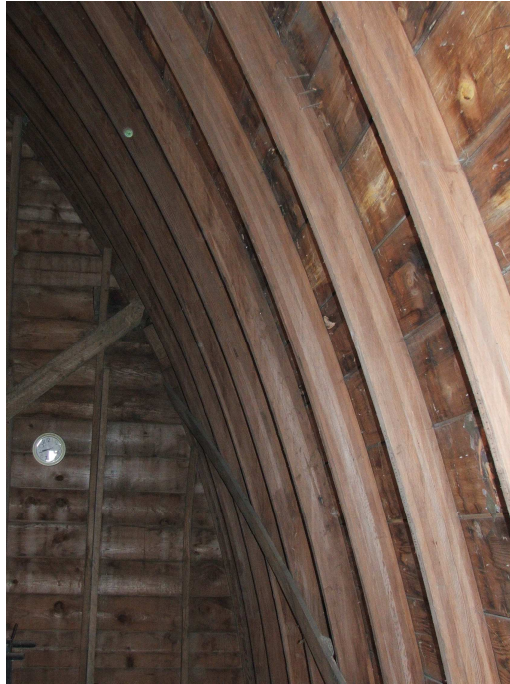
ROLL NUMBER: _____
PHOTO NUMBER: 7
CAMERA DIRECTION: Hayloft, looking East,
Gable end

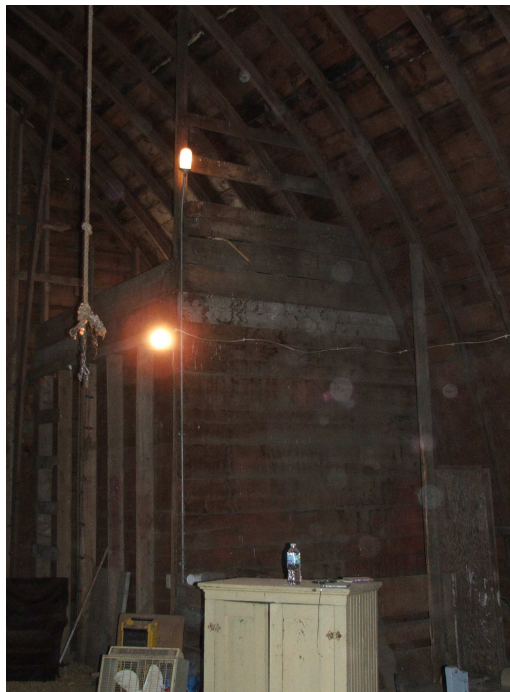
ROLL NUMBER: _____
PHOTO NUMBER: 8
CAMERA DIRECTION: Hayloft, looking NW,
Granary in NW corner,
above granary below
