**SOUTH DAKOTA STATE HISTORIC PRESERVATION OFFICE  
HISTORIC SITES SURVEY STRUCTURE FORM**

\*SURVEY DATE: June 25, 2012 \*ADDRESS: 31214 454<sup>th</sup> Ave.  
\*SURVEYOR: Jim Stone \*COUNTY: Clay  
\*CITY: Vermillion

CURRENT FUNCTION:	<u>Farm machinery storage</u>	FOUNDATION:	<u>Poured concrete Asphalt shingles over cedar shingles</u>
CURRENT SUBFUNCTION:	<u>Storage</u>	ROOF MATERIAL:	<u>shingles</u>
HISTORIC FUNCTION:	<u>Livestock barn</u>	ROOF SHAPE:	<u>Gambrel</u>
HISTORIC SUBFUNCTION:	<u>Hay and grain storage</u>	STRUCTURAL SYSTEM:	<u>Balloon framing</u>
		STYLE:	<u>Gambrel roof barn</u>
OCCUPIED:	<u>Yes</u>	TYPE:	<u>Livestock barn</u>
	<u>Yes with</u>		<u>2x6, 1x6 # 106 drop</u>
ACCESSIBLE:	<u>permission</u>	WALLS:	<u>siding</u>
STORIES:	<u>2</u>	SIGNIFICANT PERSON:	<u>Jake Iverson</u>
*DATE OF CONSTRUCTION:	<u>1925 to 1940</u>	CULTURAL AFFILIATION:	<u>Norwegian</u>

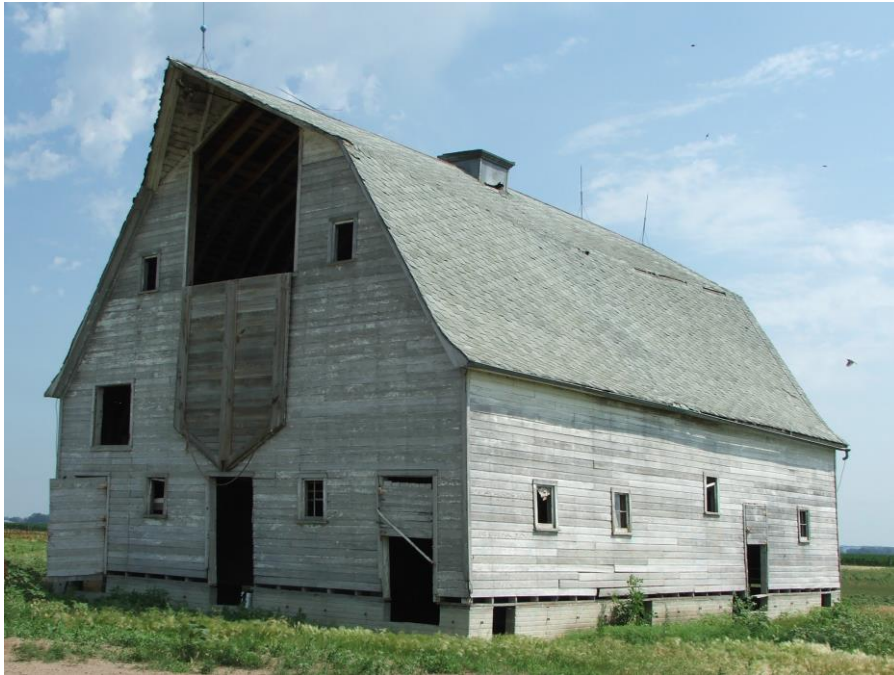
**ROLL NUMBER:** \_\_\_\_\_  
**PHOTO NUMBER:** 1  
**CAMERA DIRECTION:** Looking SE, NW corner

**\*PHYSICAL NOTES:** Barn was in good condition. Since it has been moved, nothing has been done. It needs the 6x6 posts put back in place to support the hayloft floor, the floor is starting to sag in several places. The barn is starting to lean some and the roof is starting to sag at the hip on the West side. Some of the siding is loose on the South wall. The hayloft door is down which allows the North wind to put a lot of pressure against the South wall from the inside. I think that the owner has lost the land and just moved away.

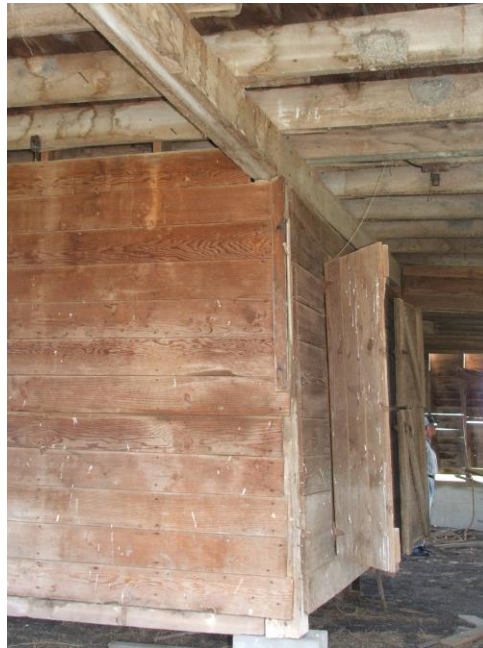
**ROLL NUMBER:** \_\_\_\_\_  
**PHOTO NUMBER:** 5

**INTERIOR NOTES:** Had four rows 6x6 posts and 6x6 beams to support hayloft floor. Joists were 2x8. All of the 2x6's for studs, rafters and bracing, 2x8 floor joists, 6x6 posts and 6x6 beams were rough sawn cottonwood. Two 8'x16' granaries still in place on the East wall. 8'x12' self feeder still in place on the West wall. Rafters are 2x6 with 2x6 bracing, almost one half of a modified Shawver truss.

**First floor, looking South, granaries on East wall, (3) 2x8's beam & 6x6 post**

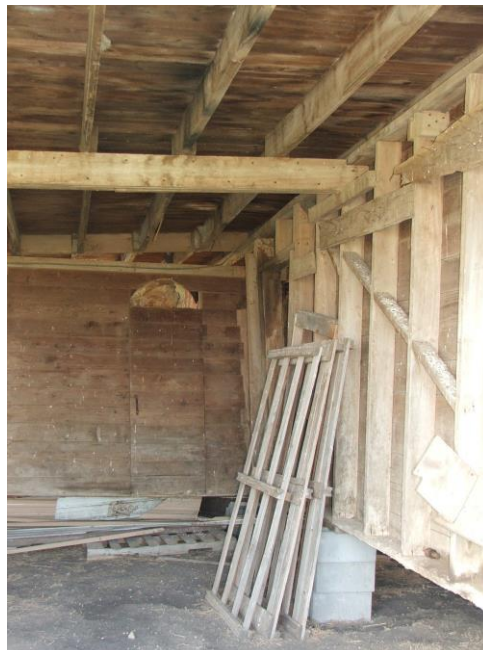
**ROLL NUMBER:** \_\_\_\_\_  
**PHOTO NUMBER:** 6

**First floor, looking West, solid stud wall dividing barn**

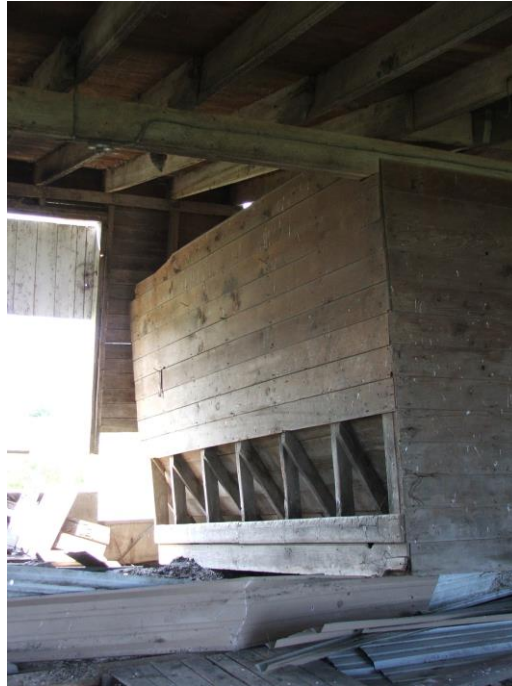
**ROLL NUMBER:** \_\_\_\_\_  
**PHOTO NUMBER:** 7

**First floor, looking West,  
built-in self-feeder, feeds  
from two sides of wall.**

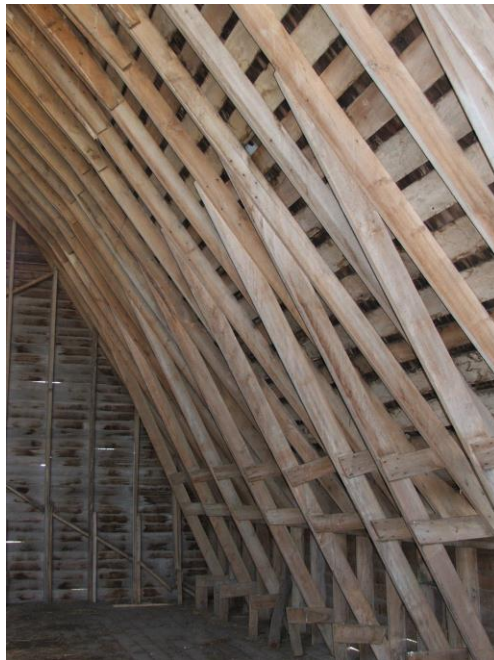
**ROLL NUMBER:** \_\_\_\_\_  
**PHOTO NUMBER:** 8

**OTHER NOTES:** Windows were 9"x12" four light. Stairs are still in place. Has a 2x6 with a vertical support on almost all of the studs in the hayloft. I am wondering if it was to support planks for Seating, when they had barn dances.

**Hayloft, looking North,  
rafter bracing and  
supports on the wall  
studs**
