**SOUTH DAKOTA STATE HISTORIC PRESERVATION OFFICE**  
**HISTORIC SITES SURVEY STRUCTURE FORM**

\*SURVEY DATE: Aug. 10, 2012

\*ADDRESS: 30514 469<sup>th</sup> Ave.

HISTORIC FUNCTION: Dairy barn

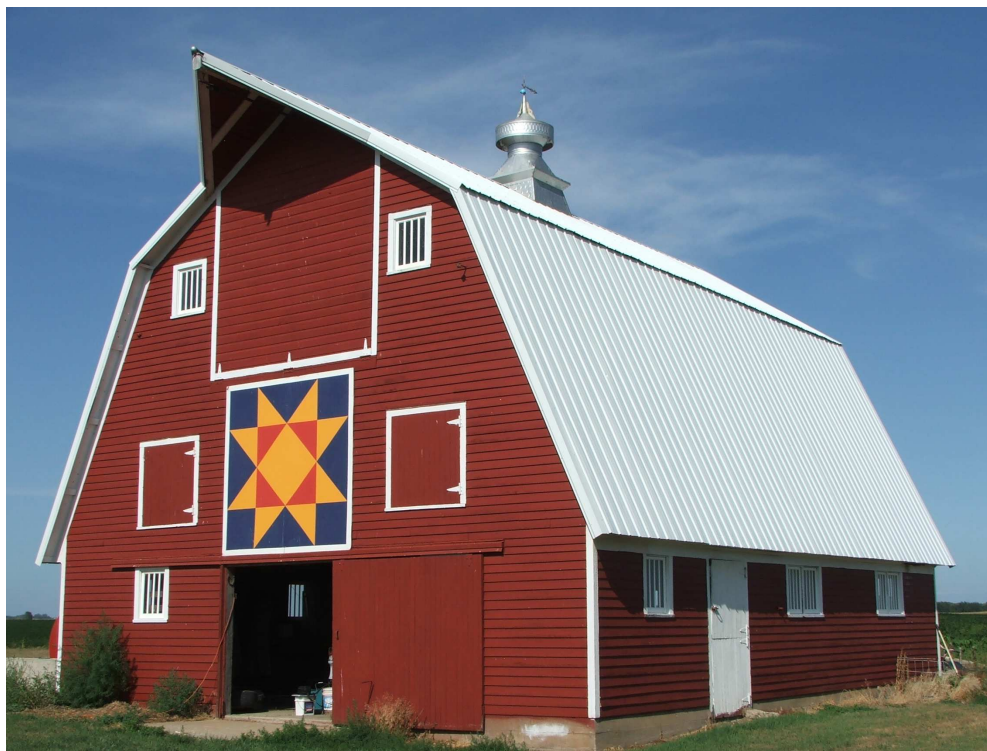
ROLL NUMBER: \_\_\_\_\_  
PHOTO NUMBER: 1  
CAMERA DIRECTION: Looking NE, SW corner

\*PHYSICAL NOTES: Barn is in good condition.

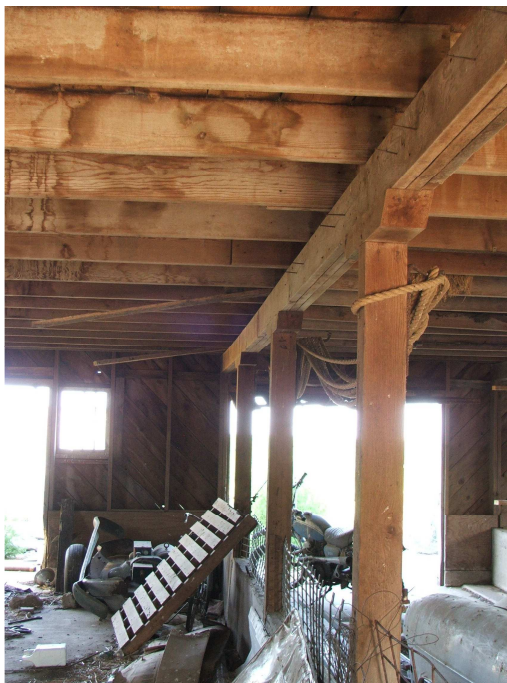
**ROLL NUMBER:** \_\_\_\_\_  
**PHOTO NUMBER:** 5

INTERIOR NOTES: Has two rows 4x6 posts and (2) 2x8's for beam. 2x8 floor joists.

**First floor, looking East,  
posts, beam and floor  
joists**

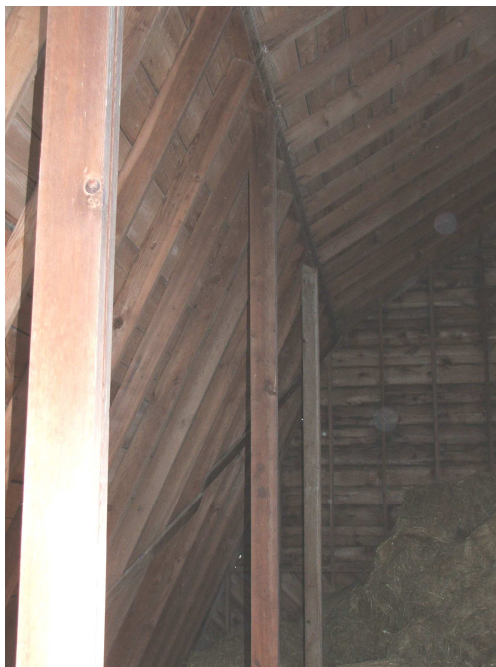
**ROLL NUMBER:** \_\_\_\_\_  
**PHOTO NUMBER:** 6

OTHER NOTES: Windows were 4"x24" four light. Walls are 2x6 with diagonal sheathing on all four  
walls and 1/2"x6" cedar lap siding. Top 16' of walls on gable ends has horizontal sheathing. Three 2x6  
posts (spaced with short blocks), 10' O. C. support (2) 2x6's for a plate at the hip. Still has the metal  
cupola.

**Hayloft, looking East,  
posts 10' O. C.  
supporting roof hip**
