**SOUTH DAKOTA STATE HISTORIC PRESERVATION OFFICE  
HISTORIC SITES SURVEY STRUCTURE FORM**

\*SURVEY DATE: April 21, 2012 \*ADDRESS: Vacated farmstead  
\*SURVEYOR: Jim Stone \*COUNTY: Clay  
\*CITY: Wakonda

SIGNIFICANCE NOTES: A very fine example of a large western livestock feeder barn.

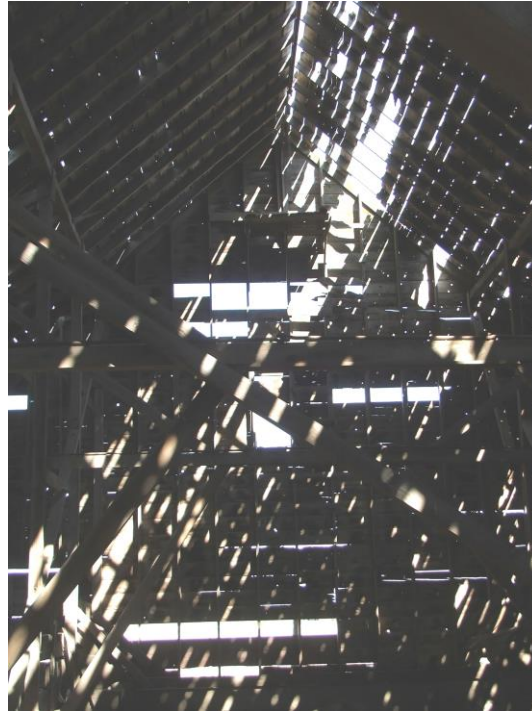
OTHER NOTES: 2x6x8' walls on the North and South sides. 2x6 walls on the gable ends ballooned framed. 6x6 posts are 8' O. C. with extensive 6x6 bracing 16' O.C. Four 1" steel rods tie the North and South walls over the top of the 16' O. C. bracing. These rods appear to have been made by a blacksmith. The rods are about 20' long with closed hooks on each end. The rod is hooked into a large clevis that is bolted into the bottom of a rafter. 2x6 rafters with spaced sheathing and cedar shingles.

**ROLL NUMBER:** 5  
**PHOTO NUMBER:** 5  
**CAMERA DIRECTION:** First floor, looking East,  
center bracing 16' O.C.

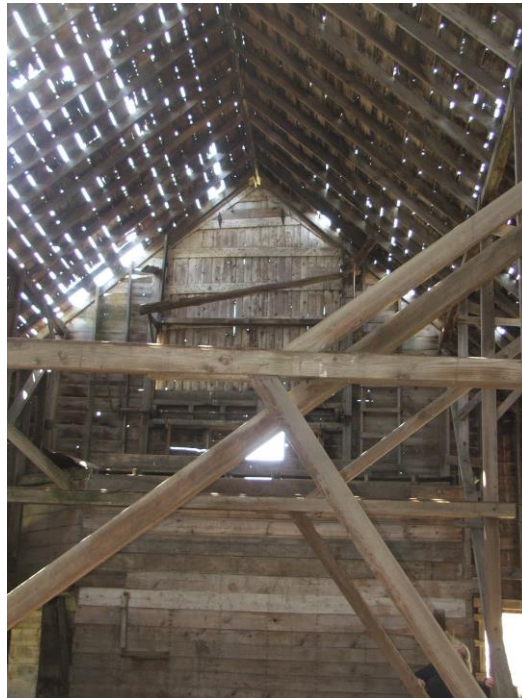
\*PHYSICAL NOTES: Large granary on the West wall in the center. Hay storage area in the center is 20' wide, 80' long and 34' from the ground to the peak. Roof is in poor shape and is leaking. Owner thinks she will cover the roof with steel roofing to save the barn. Solid wall on the North side of horse stalls has doors that you lift up to feed horses hay and grain.

**ROLL NUMBER:** 6  
**PHOTO NUMBER:** 6  
**CAMERA DIRECTION:** First floor, looking West,  
roof needs roofing

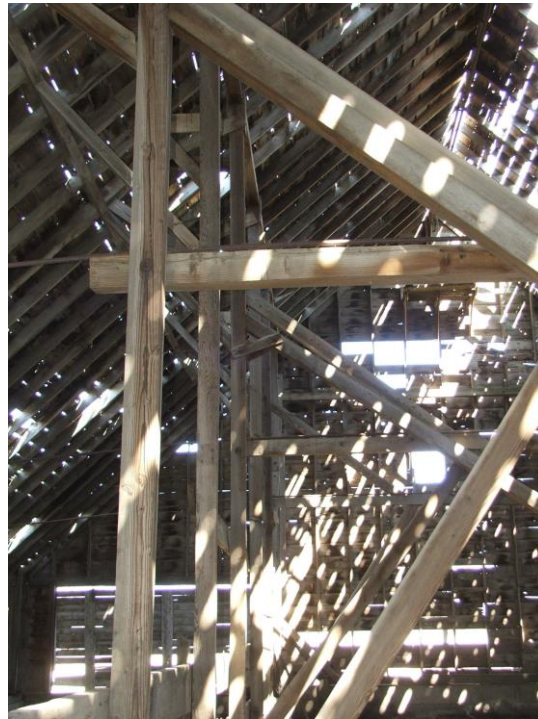
**ROLL NUMBER:** \_\_\_\_\_  
**PHOTO NUMBER:** 7

INTERIOR NOTES: Horse stalls are still in place. Four double horse stalls are enclosed by a solid wall East and North sides, with a hayloft above. 6x6x23' posts and 6x6 beams support the roof on each side of the 20' center hay storage area. 80' feed rack on the North and 40' feed rack on the South.

**CAMERA DIRECTION:** First floor, looking East,  
6x6 posts and bracing on  
North side of center hay  
storage area

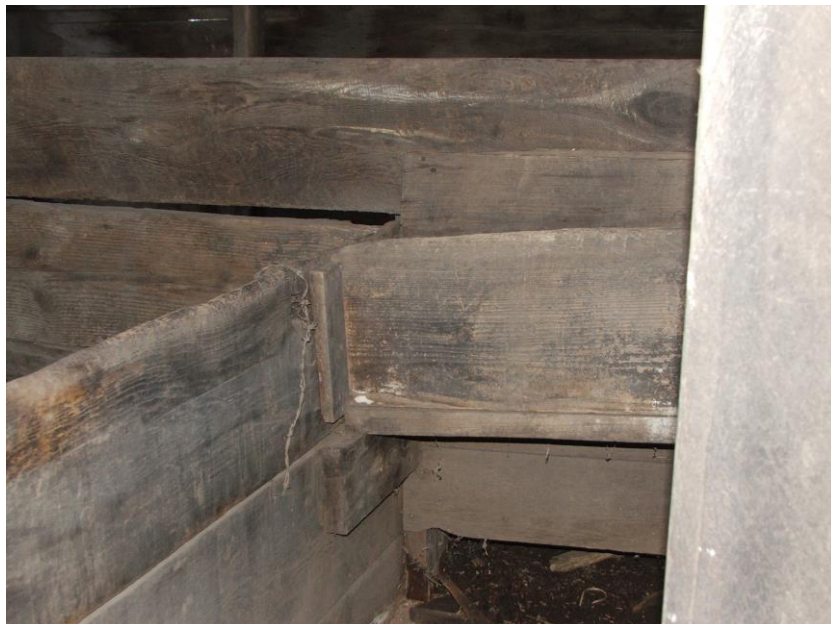
**ROLL NUMBER:** \_\_\_\_\_  
**PHOTO NUMBER:** 8

**CAMERA DIRECTION:** First floor, looking North,  
Horse stalls

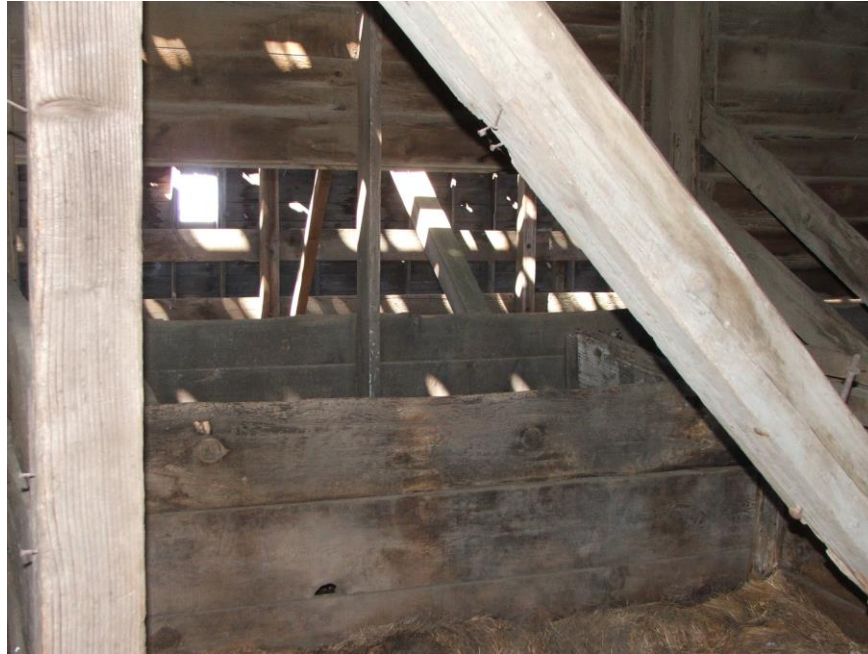
**ROLL NUMBER:** \_\_\_\_\_  
**PHOTO NUMBER:** 9  
**CAMERA DIRECTION:** First floor, looking South, horse stall manger
