**SOUTH DAKOTA STATE HISTORIC PRESERVATION OFFICE
HISTORIC SITES SURVEY STRUCTURE FORM**

*SURVEY DATE: Aug. 2, 2012 *ADDRESS: 29819 Greenfield Road
*SURVEYOR: Jim Stone *COUNTY: Clay
*CITY: Beresford

SIGNIFICANCE NOTES: Sundstrom barn

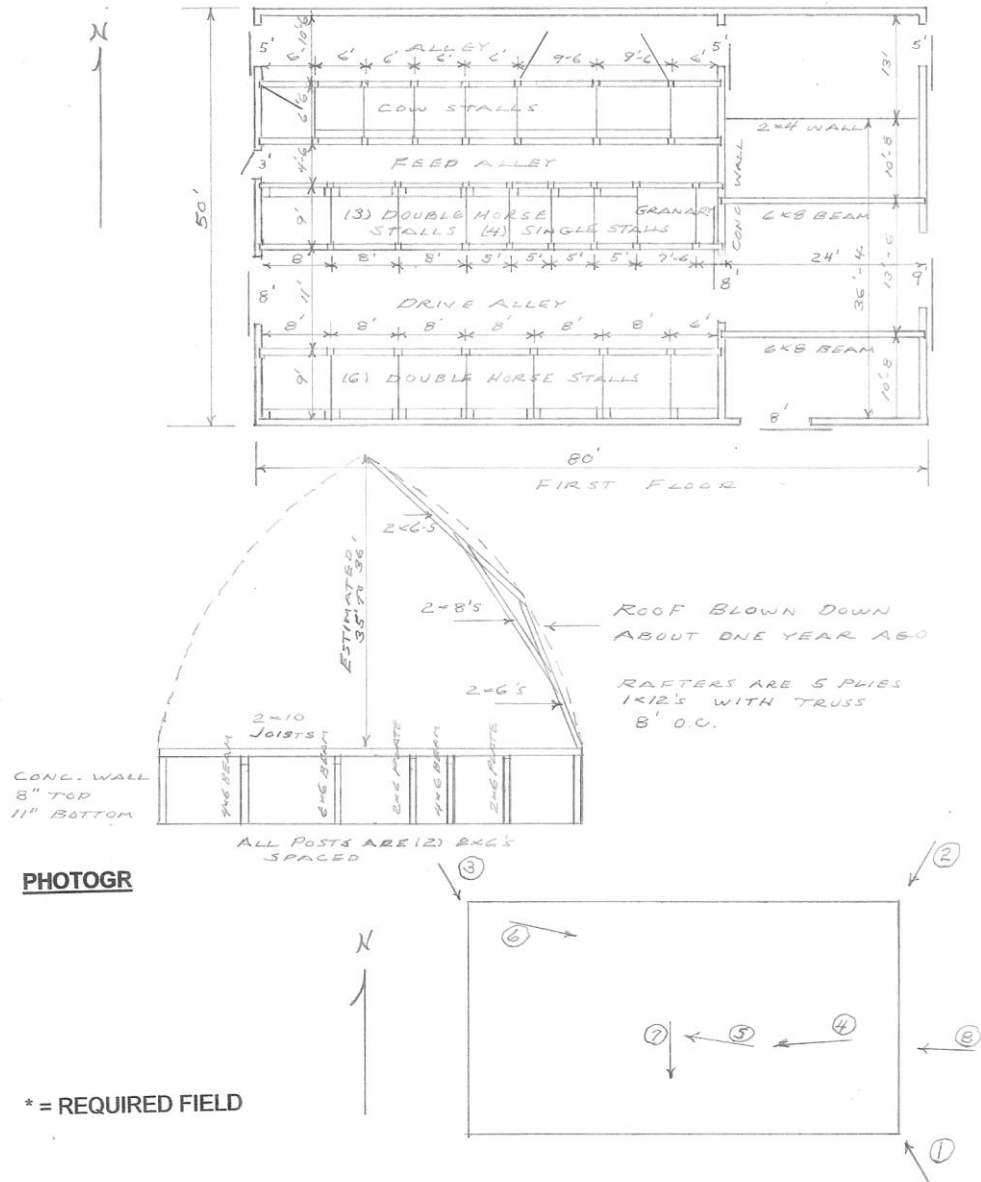
INTERIOR NOTES: Has 2x6 (spaced with short 2x6 spacers or sides of stalls) for posts. From the South wall, first row in 9' has a 4x6 beam, second row in 20' has a 6x6 beam, third row in 29' has 2x6 plate, fourth row in 33'- 6" has a 4x6 beam, fifth row in 40' has a 2x6 plate. See drawing.

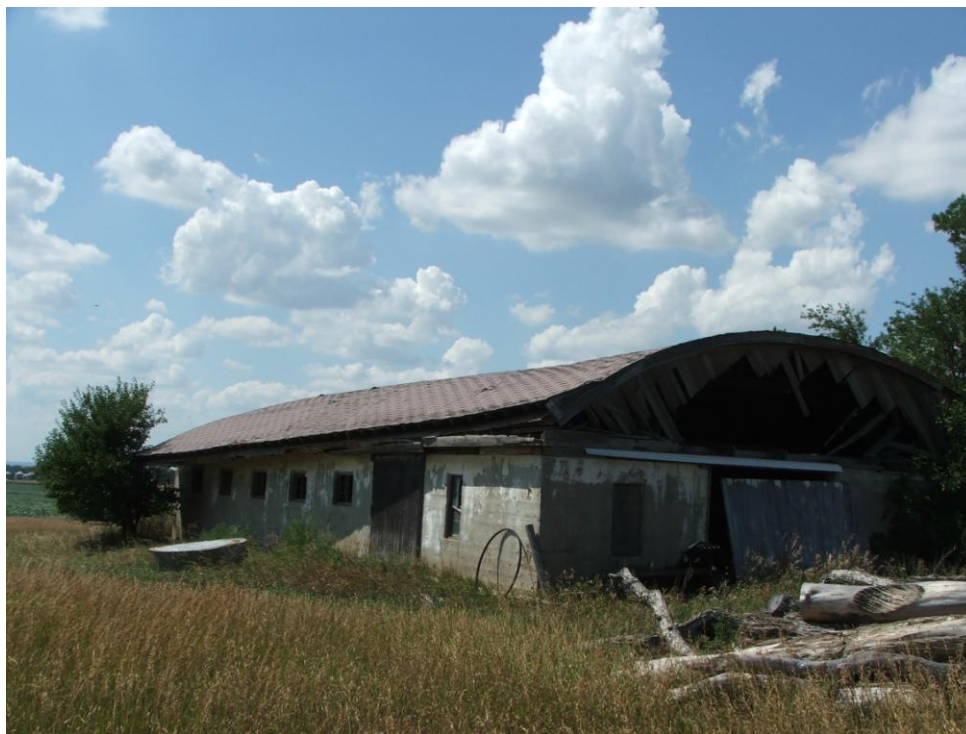
ROLL NUMBER: _____
PHOTO NUMBER: 1
CAMERA DIRECTION: Looking NW, SE corner

***PHYSICAL NOTES:** Interior of the barn is in fair condition. Now with it open to the weather it will be rotting away.

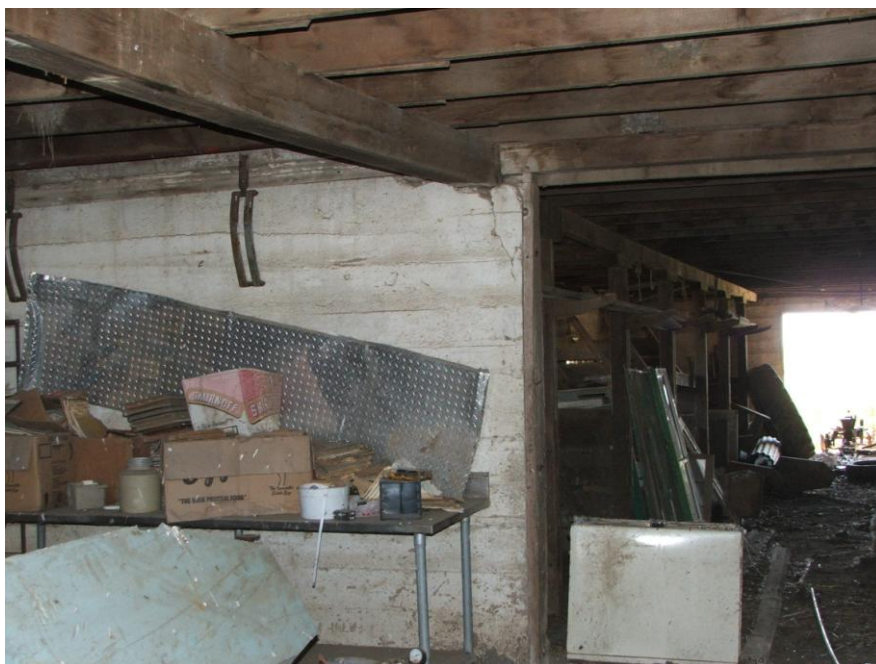
ROLL NUMBER: _____
PHOTO NUMBER: 4
CAMERA DIRECTION: First floor, looking West,
8" concrete wall in 24'
from East wall and
looking down driveway

In 24' from the East wall there is a concrete wall South to North with a sliding door the divides the barn. This is a very large barn with a very interesting floor plan. Horse stalls, cow stalls and granary are still in place.

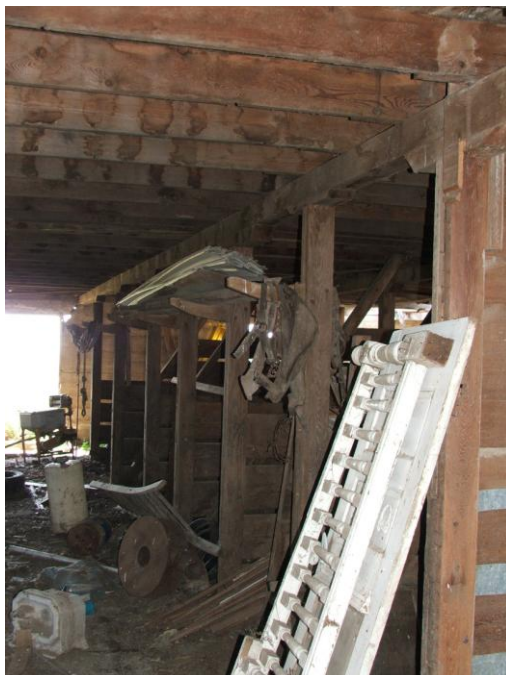
ROLL NUMBER: _____
PHOTO NUMBER: 5

CAMERA DIRECTION: First floor, looking West,
horse stalls on the North
side of drive alley

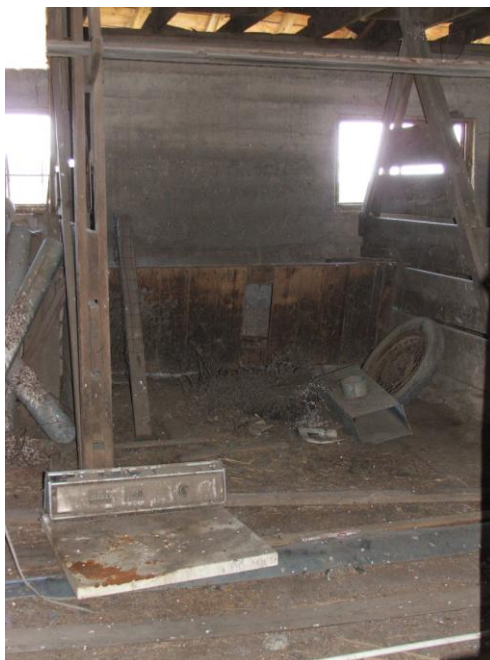
ROLL NUMBER: _____
PHOTO NUMBER: 6

CAMERA DIRECTION: First floor, looking South
into a double horse stall

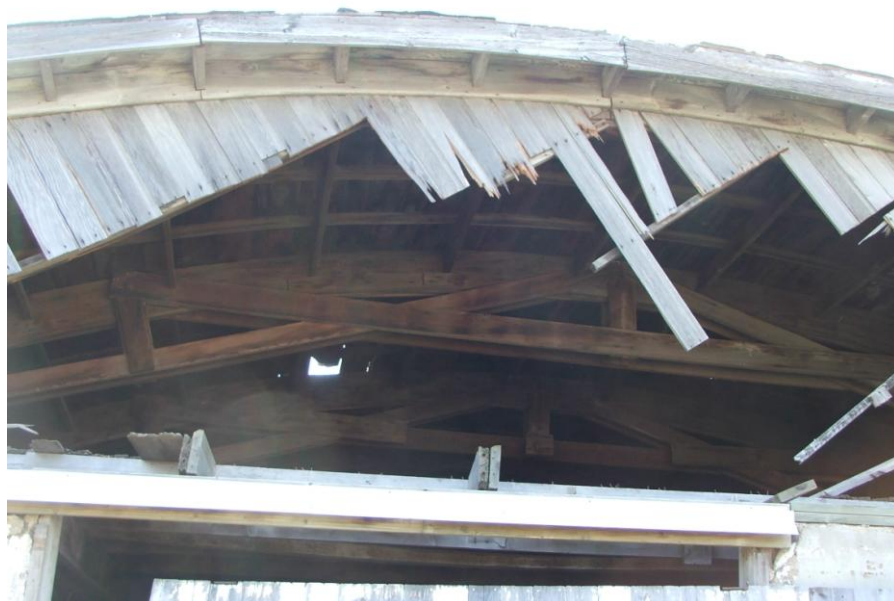
ROLL NUMBER: _____
PHOTO NUMBER: 7

OTHER NOTES: Windows were 8"x10" six light (3 wide, 2 high) beside a 8"x10" six light for a slider window that can be opened for ventilation. Walls are poured concrete 8' high, 11" thick at floor up to 8" thick at the top. Rafters were 5 plies of 1x12' (short lengths) and sawn to the arch of the rafters. Two 2x6's and a 2x8 made a truss on each rafter. These are 8' O. C. , 2x6 purlins are notched into the 1x12's 2' O.C. horizontally, 1x4's (2 plies) applied vertically 2' O.C. and roof sheathing applied horizontally over them.

**Looking West into
hayloft, 5 ply 1x12 rafters
with 2x6 and 2x8 truss
bracing**

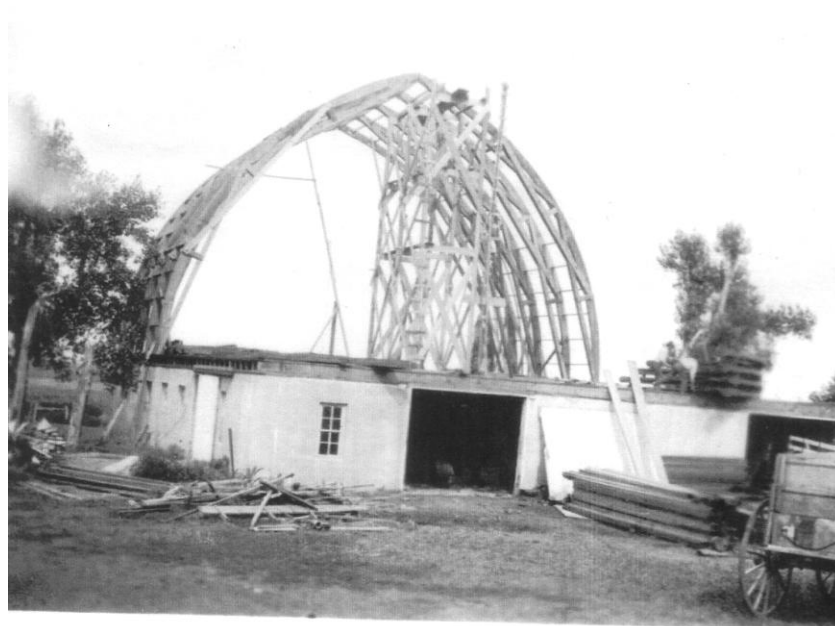
ROLL NUMBER: _____
PHOTO NUMBER: 8

ALTERED/MOVED NOTES: Original site. Original barn had a gambrel roof. It was destroyed by a windstorm. Barn was rebuilt on top of the existing concrete walls. South side of roof was shingled with asphalt shingles. The North side has been leaking for years. The rafters and floor joists have rotted out. In 2011 a South wind from a windstorm blew the roof over and down on top of hayloft floor. John Sundstrom would have built the original barn, which had a gambrel roof. His wife Hannah and his son Arthur would have built the second barn in the 1920's on top of the original poured concrete walls.

**Rebuilding the barn after
a windstorm blew the
roof off.**

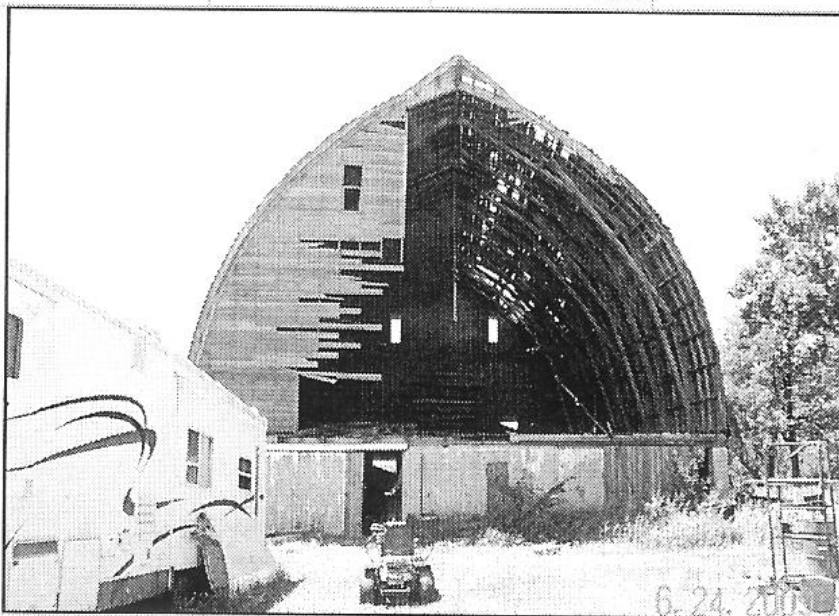
ROLL NUMBER:
PHOTO NUMBER: 9

CAMERA DIRECTION: Looking SE, NW corner,
windstorm blew out the
east gable wall
