**SOUTH DAKOTA STATE HISTORIC PRESERVATION OFFICE  
HISTORIC SITES SURVEY STRUCTURE FORM**

\*SURVEY DATE: July 18, 2013 \*ADDRESS: 30284 458<sup>th</sup> Ave.  
\*SURVEYOR: Jim Stone \*COUNTY: Clay  
\*CITY: Wakonda

CURRENT FUNCTION:	<u>Calving barn</u>	FOUNDATION:	<u>Poured concrete</u>
CURRENT SUBFUNCTION:	<u>Storage</u>	ROOF MATERIAL:	<u>Asphalt shingles over cedar shingles</u>
HISTORIC FUNCTION:	<u>Horse barn</u>	ROOF SHAPE:	<u>Gambrel roof</u>
HISTORIC SUBFUNCTION:	<u>Hay storage</u>	STRUCTURAL SYSTEM:	<u>Balloon framing</u>
OCCUPIED:	<u>Yes</u>	STYLE:	<u>Gambrel roof barn</u>
ACCESSIBLE:	<u>Yes with permission</u>	TYPE:	<u>Livestock barn</u>
		WALLS:	<u>2x6 studs, 1x8 #106 drop siding</u>
STORIES:	<u>2</u>	SIGNIFICANT PERSON:	<u>Joseph Sherk</u>
*DATE OF CONSTRUCTION:	<u>1910 to 1920</u>	CULTURAL AFFILIATION:	<u>?</u>

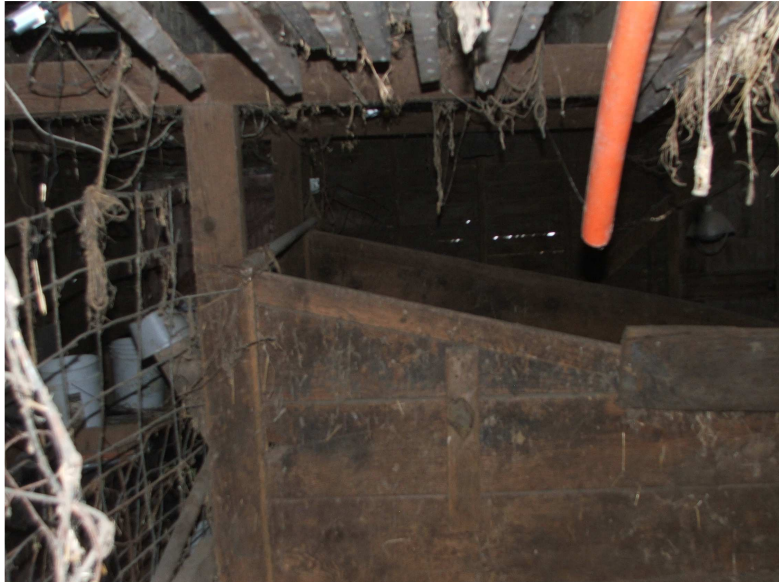
**ROLL NUMBER:** \_\_\_\_\_  
**PHOTO NUMBER:** 5

INTERIOR NOTES: Three rows of 6x6 posts, and (3) 2x6's for a beam to support the 2x8 joists for hayloft floor. Three double and one 3/4 horse stalls still on place on the North side and the same on the South side.

**CAMERA DIRECTION:** First floor, looking West, across horse stalls on North side.

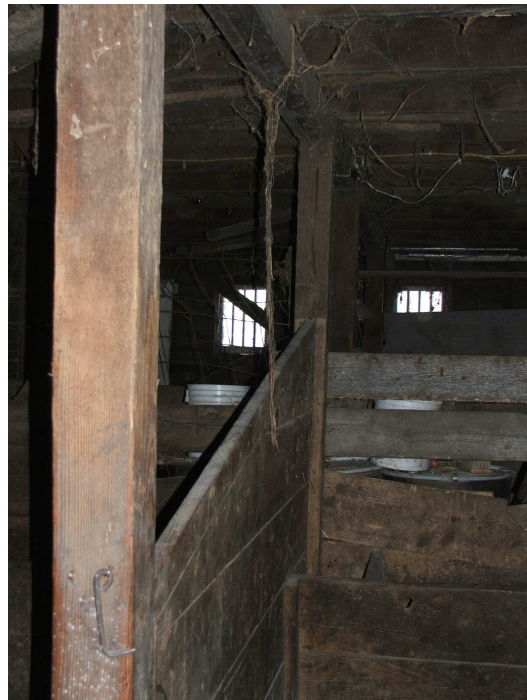
**ROLL NUMBER:** \_\_\_\_\_  
**PHOTO NUMBER:** 6

**CAMERA DIRECTION:** First floor, looking North, into horse stall on the South side, 6x6 posts, (3) 2x8's beam and 2x8 floor joists.
