**SOUTH DAKOTA STATE HISTORIC PRESERVATION OFFICE
HISTORIC SITES SURVEY STRUCTURE FORM**

*SURVEY DATE: April 21, 2012 *ADDRESS: 30337 Frog Creek Road
*SURVEYOR: Jim Stone *COUNTY: Clay
*CITY: Wakonda

CURRENT FUNCTION: <u>Vacant</u>	FOUNDATION: <u>Poured concrete</u> <u>Asphalt shingles</u> <u>over cedar</u> <u>shingles</u>
CURRENT SUBFUNCTION: <u>Vacant</u>	ROOF MATERIAL: <u>shingles</u>
HISTORIC FUNCTION: <u>Livestock barn</u>	ROOF SHAPE: <u>Gambrel</u>
HISTORIC SUBFUNCTION: <u>Hay storage</u>	STRUCTURAL SYSTEM: <u>Balloon framing</u>
	STYLE: <u>Gambrel roof barn</u>
OCCUPIED: <u>No</u>	TYPE: <u>Livestock barn</u>
	<u>2x6 w/ #106 drop</u>
ACCESSIBLE: <u>Yes with</u> <u>permission</u>	WALLS: <u>siding</u>

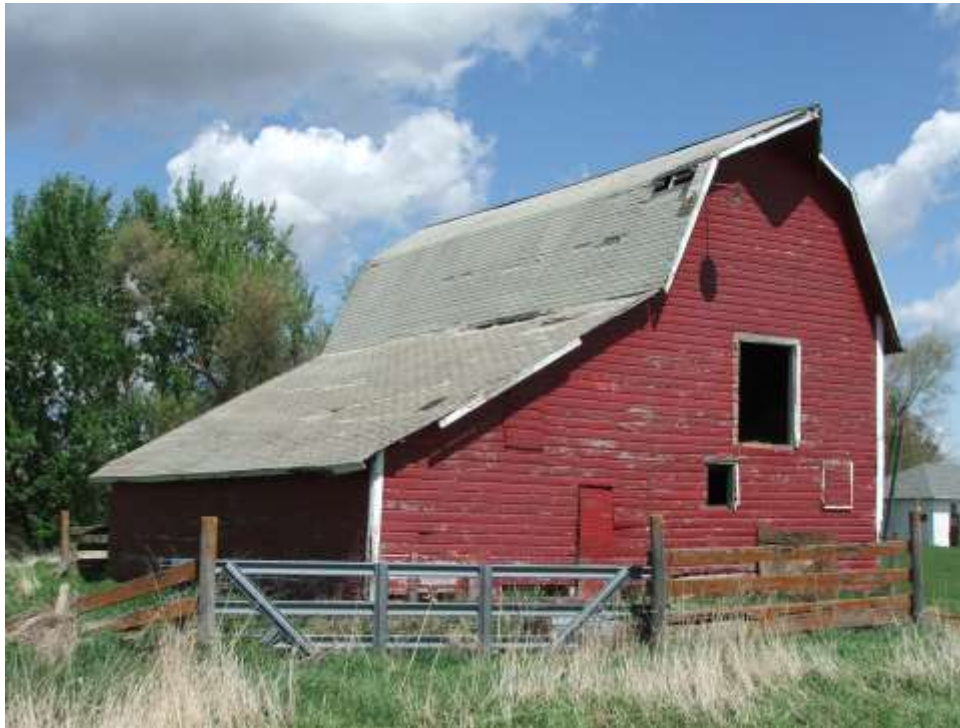
ROLL NUMBER: _____
PHOTO NUMBER: 1
CAMERA DIRECTION: Looking NE, SW corner

*PHYSICAL NOTES: Barn is in fair condition. Needs some maintance.

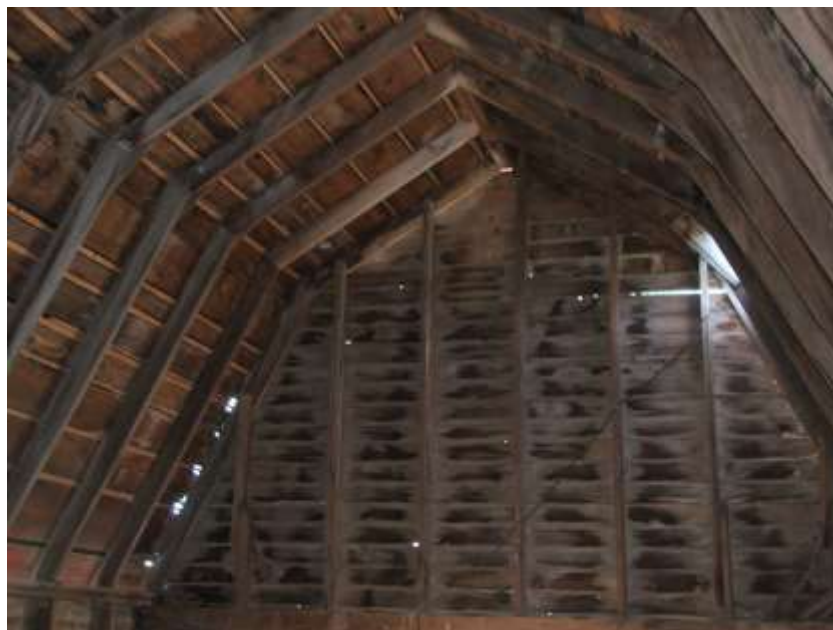
ROLL NUMBER: _____
PHOTO NUMBER: 4
CAMERA DIRECTION: Hayloft, looking South

INTERIOR NOTES: One row 4x6 beam in the center, with 4x6 posts 6' - 7' - 6' - 6' - 7' O. C. from the South wall. 2x6 floor joists for hayloft floor. Horse stalls sill in place.

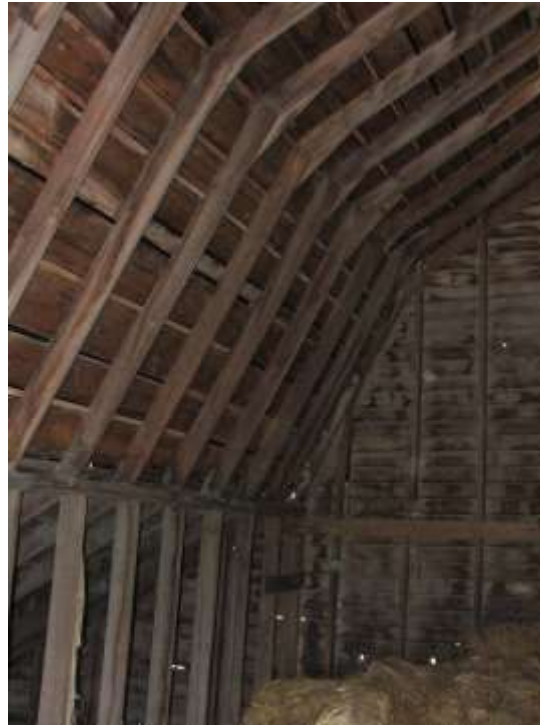
ROLL NUMBER: _____
PHOTO NUMBER: 5
CAMERA DIRECTION: Hayloft, looking NW

OTHER NOTES: 2x6 walls 14' high on the East and West. 2x6 balloon frame walls on the North and South gable end walls, No sheathing, #106 1x6 siding. Rafters are 2x6 with 3x4" sheathing, cedar shingles and asphalt shingles. Lean-to on the West side has 2x6 stud wall 7' high on the West side and 2x6 stud walls on the North and South. Rafters are 2x6. Windows are 8"x10" four light windows.
