**SOUTH DAKOTA STATE HISTORIC PRESERVATION OFFICE
HISTORIC SITES SURVEY STRUCTURE FORM**

*SURVEY DATE: July 8, 2013 *ADDRESS: 45713 302nd Street
*SURVEYOR: Jim Stone *COUNTY: Clay
*CITY: Wakonda

CURRENT FUNCTION: <u>Calving barn</u>	FOUNDATION: <u>Poured concrete</u>
CURRENT SUBFUNCTION: <u>Storage</u>	ROOF MATERIAL: <u>Steel roofing over cedar shingles</u>
HISTORIC FUNCTION: <u>Horse barn</u>	ROOF SHAPE: <u>Gambrel roof</u>
HISTORIC SUBFUNCTION: <u>Hay and grain storage</u>	STRUCTURAL SYSTEM: <u>Balloon framing</u>
OCCUPIED: <u>Yes</u>	STYLE: <u>Gambrel roof barn</u>
ACCESSIBLE: <u>Yes with permission</u>	TYPE: <u>Livestock barn</u> <u>2x6 studs, 1x6 #106 drop siding and 1/2"x8" cedar lap siding</u>
STORIES: <u>2</u>	WALLS: _____
*DATE OF CONSTRUCTION: <u>1910 to 1920</u>	SIGNIFICANT PERSON: <u>Peter C. Jensen</u>
	CULTURAL AFFILIATION: <u>Danish</u>

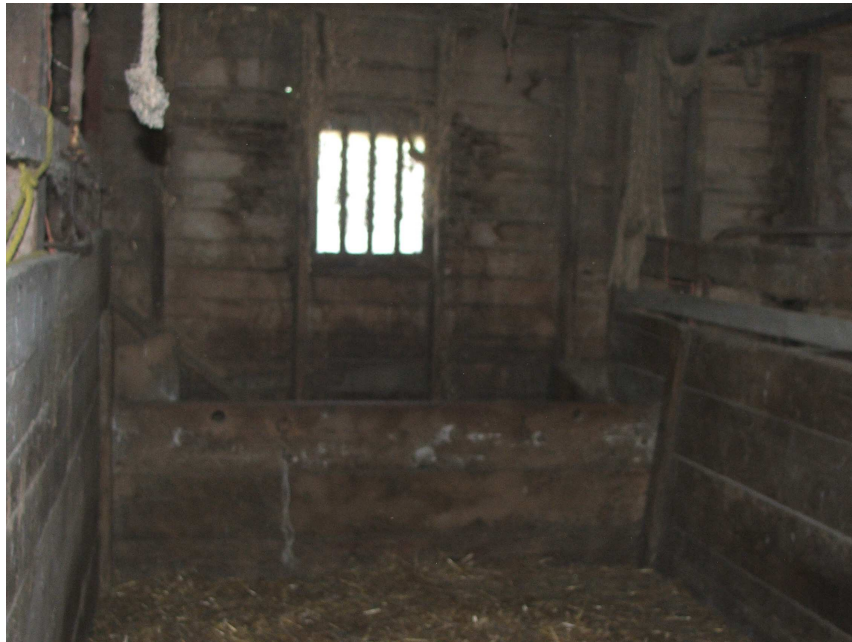
ROLL NUMBER: _____
PHOTO NUMBER: 5

INTERIOR NOTES: Two rows of 6x6 posts, and 6x6 beam support the 2x8 joists for the hayloft floor. 8' x 10' granary is still in the SE corner. Two milk cow stanchions still in the SW stall. Most of three double horse stalls are still in place on the North wall. Most of one double horse stall still in place in the center of the South wall. Feed alley 3' wide, along South wall in front of stalls.

**First floor, looking North,
one of three double
horse stalls on North
wall.**

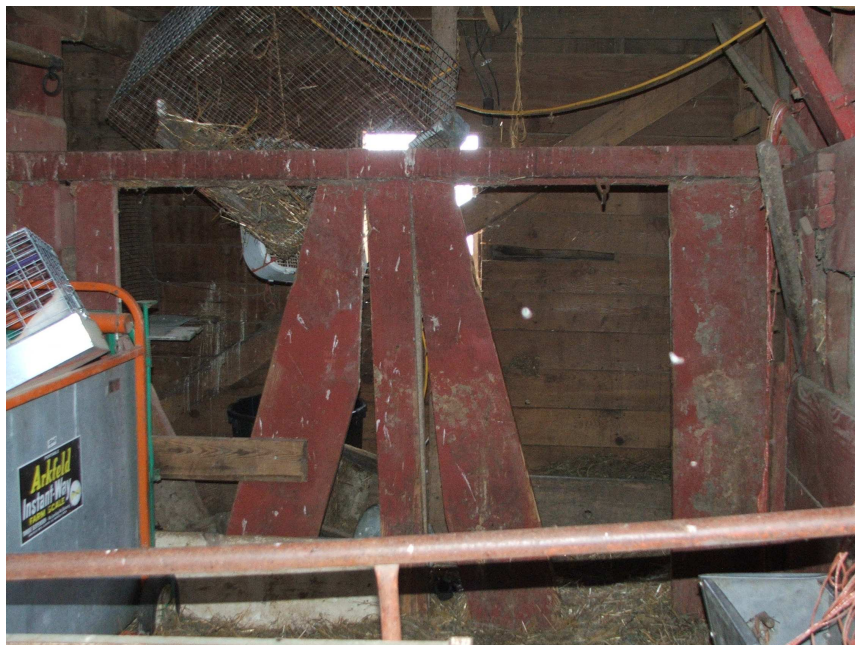
ROLL NUMBER: _____
PHOTO NUMBER: 6

**First floor, looking
South, two milk cow
stanchions in stall on
South wall**

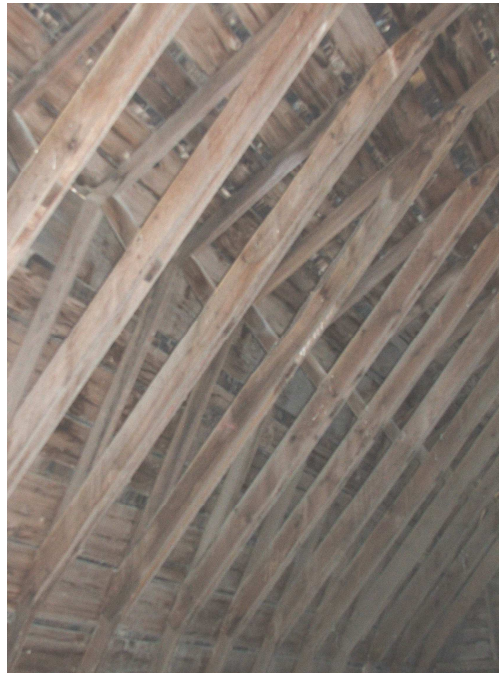
ROLL NUMBER: _____
PHOTO NUMBER: 7

OTHER NOTES: 2x6 stud walls, with 1x6 #106 drop siding on all four walls and lean-to. Rafters are 2x6's With double 1x6's bracing each hip, 2' O. C. Two 2x8's brace the top of the wall down to the floor in the Hayloft. Some windows are 8" x 10" four light, some are 8"x10" six light and some are 4"x24" four light. Very ornate cupola from the 19-teens. Floor plan is a English barn plan. Exposed exterior walls have 1/2"x8" cedar lap siding over drop siding.

CAMERA DIRECTION: Hayloft, looking NW, 2x6
rafters. (2) 1x6's bracing
hip, 2' O. C.

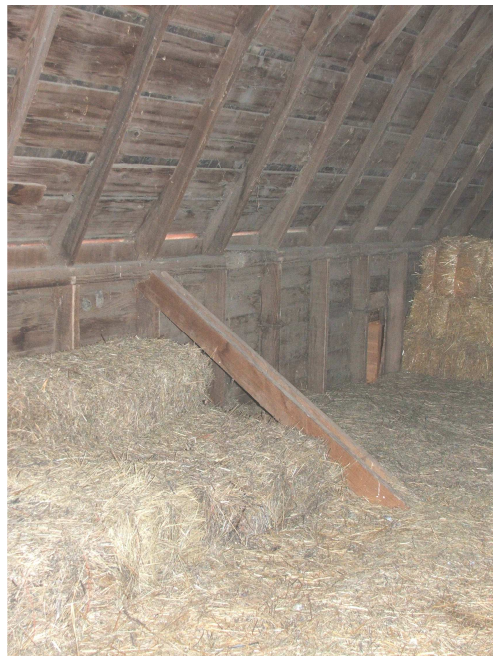
ROLL NUMBER: _____
PHOTO NUMBER: 8

CAMERA DIRECTION: Hayloft, looking NW, (2)
2x8's bracing top of wall
down to floor, 16' O. C.

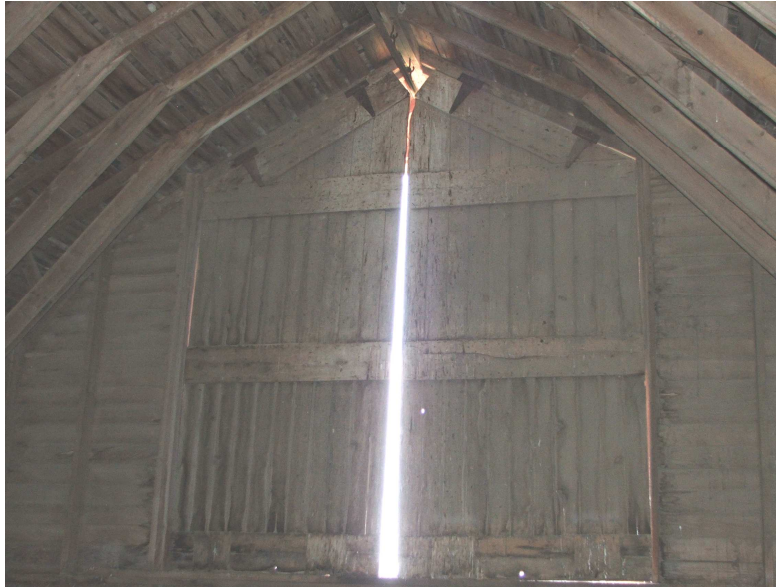
ROLL NUMBER: _____
PHOTO NUMBER: 9

CAMERA DIRECTION: Hayloft, looking South,
South gable end wall,
hayloft door.
