**SOUTH DAKOTA STATE HISTORIC PRESERVATION OFFICE**  
**HISTORIC SITES SURVEY STRUCTURE FORM**

\*ADDRESS: 31062 452<sup>nd</sup> Ave.  
\*COUNTY: Clay  
\*CITY: Gayville

CURRENT FUNCTION:	<u>Vacant</u>	FOUNDATION:	<u>Poured concrete</u>
CURRENT SUBFUNCTION:	<u>Storage</u>	ROOF MATERIAL:	<u>Steel roofing over cedar shingles</u>
HISTORIC FUNCTION:	<u>Livestock barn</u>	ROOF SHAPE:	<u>Gable roof</u>
HISTORIC SUBFUNCTION:	<u>Hay storage</u>	STRUCTURAL SYSTEM:	<u>Balloon framing</u>
		STYLE:	<u>Gable roof barn</u>
OCCUPIED:	<u>No</u>	TYPE:	<u>Livestock barn</u>
	<u>Yes with permission</u>		<u>2x4 studs, 1x10 shiplap, 1/2"x6" cedar lap siding</u>
ACCESSIBLE:		WALLS:	
STORIES:	<u>2</u>	SIGNIFICANT PERSON:	<u>Thomas Wadsworth</u>
*DATE OF CONSTRUCTION:	<u>1910 to 1920</u>	CULTURAL AFFILIATION:	<u>?</u>

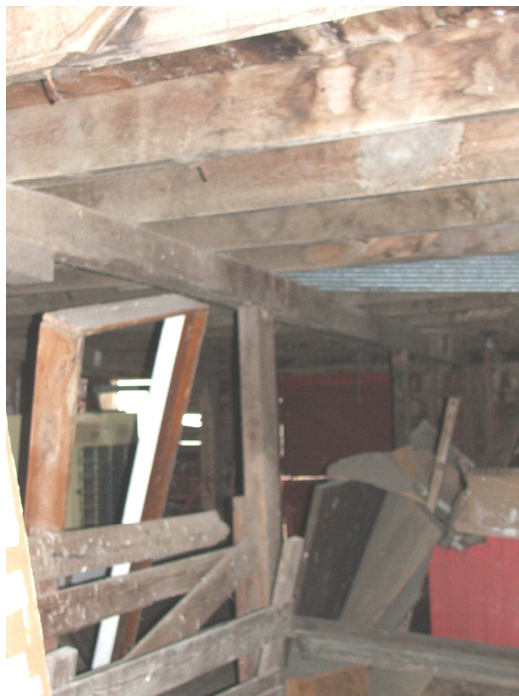
ROLL NUMBER: \_\_\_\_\_  
PHOTO NUMBER: 5

INTERIOR NOTES: Two rows of 4x6 posts with a 4x6 beam supporting 2x8 floor joists for hayloft floor. 2x8 ceiling joists 8' O. C. in East lean-to. 1x10 rafter bracing 8' O. C. in East lean-to. 2x4 braces from center of rafters down to exterior wall at floor level, 4' O. C. and a 2x8 from the bottom of rafters down to the floor, 4' O. C.

CAMERA DIRECTION: First floor, looking SE,  
4x6 posts, 4x6 beam and  
2x8 hayloft floor joists.

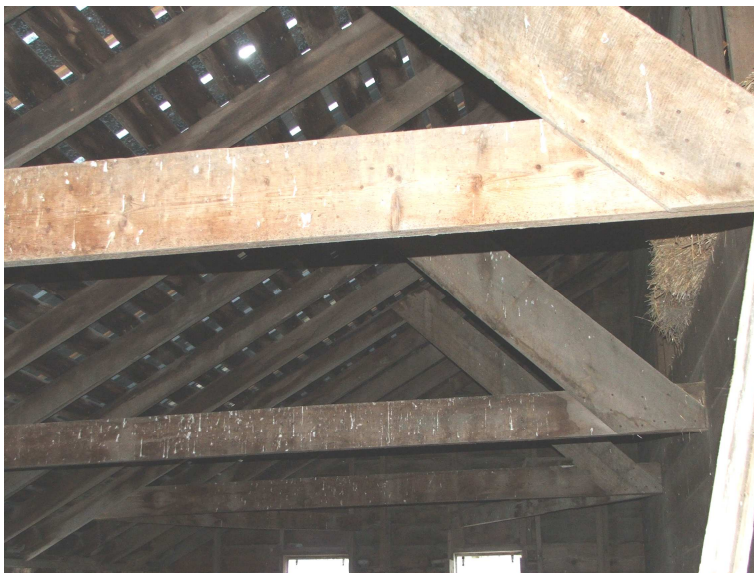
ROLL NUMBER: \_\_\_\_\_  
PHOTO NUMBER: 6

CAMERA DIRECTION: First floor, East lean-to,  
looking South, 2x8  
ceiling joists and 1x10  
rafter bracing 8' O. C.

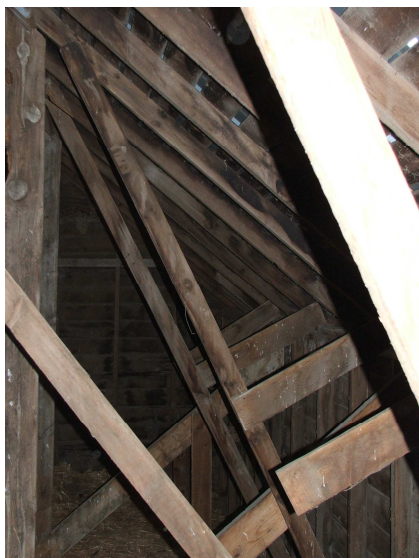
**ROLL NUMBER:** \_\_\_\_\_  
**PHOTO NUMBER:** 7

**Hayloft, looking South,  
2x4 rafters, 2x4 bracing  
from center of rafters  
down to exterior wall and  
2x8 bracing from bottom  
of rafters down to hayloft  
floor, 4' O. C.**

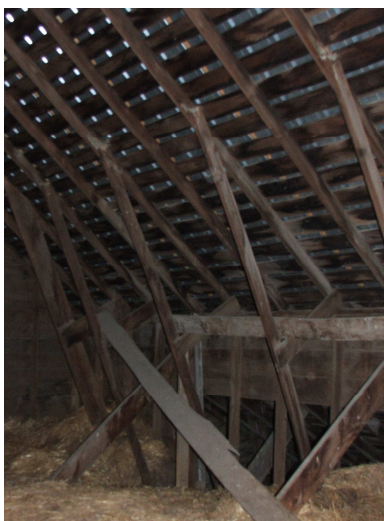
**ROLL NUMBER:** \_\_\_\_\_  
**PHOTO NUMBER:** 8

**Hayloft, looking NE, 2x4  
rafters with 2x4 bracing  
from center of rafters  
down to exterior wall and  
2x8 bracing from the  
bottom of rafters down  
to floor, 4' O. C.**
