**SOUTH DAKOTA STATE HISTORIC PRESERVATION OFFICE  
HISTORIC SITES SURVEY STRUCTURE FORM**

CURRENT FUNCTION: <u>Vacant</u>	FOUNDATION: <u>Poured concrete</u>
CURRENT SUBFUNCTION: <u>Vacant</u>	ROOF MATERIAL: <u>Steel roofing over cedar shingles</u>
HISTORIC FUNCTION: <u>Double ear corn crib</u>	ROOF SHAPE: <u>Gable roof</u>
HISTORIC SUBFUNCTION: <u>Double ear corn crib</u>	STRUCTURAL SYSTEM: <u>Balloon framing</u>
OCCUPIED: <u>No</u>	STYLE: <u>Double corn crib</u>
ACCESSIBLE: <u>Yes with permission</u>	TYPE: <u>Double corn crib</u> <u>2x6 studs, 1x6 spaced siding, 1x6 drop siding on gable ends</u>
STORIES: <u>2</u>	WALLS: _____
*DATE OF CONSTRUCTION: <u>1920's</u>	SIGNIFICANT PERSON: <u>J. F. Hickson</u>
	CULTURAL AFFILIATION: <u>?</u>

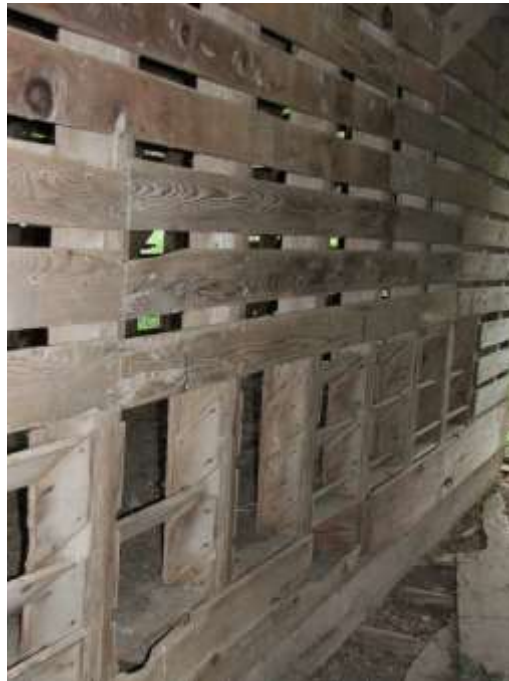
**ROLL NUMBER:** 5  
**PHOTO NUMBER:** 5  
**CAMERA DIRECTION:** In the alley looking NW into west corn crib.

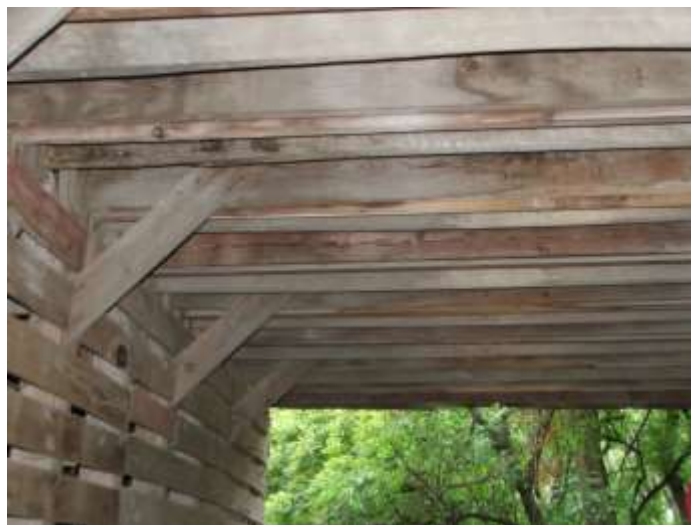
ALTERED/MOVED NOTES: Roof has steel roofing. Doubled 2x8 floor joists have been added above 10' alley and grain bins were built above.

**ROLL NUMBER:** 6  
**PHOTO NUMBER:** 6  
**CAMERA DIRECTION:** In alley looking NW up at 2x10 joists. Light single joists are original rough sawn cottonwood, the darker doubled 2x10 joists were added when the granaries were built above the alley.

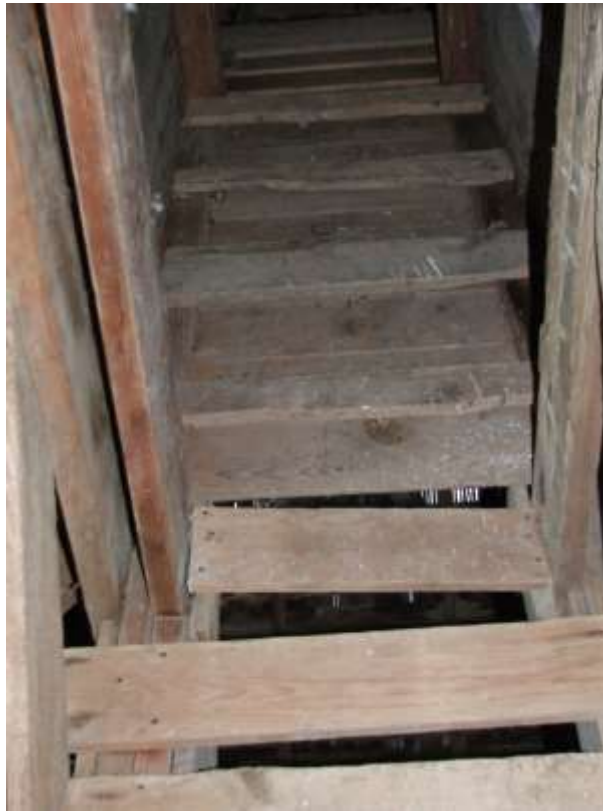
**ROLL NUMBER:** \_\_\_\_\_  
**PHOTO NUMBER:** 7

**CAMERA DIRECTION:** Looking west up into opening to granaries above alley. Note ladder above, it was removed below.
